**UNDERWATER BRIDGE INSPECTION  
SUPPLEMENTAL REPORT  
for**

**Bridge 2440  
Minnesota Trunk Highway 65  
over  
Mississippi River**

PREPARED FOR:  
**Minnesota Department of Transportation**

PERFORMED BY:  
**Parsons Brinckerhoff Quade and Douglas, Inc.**

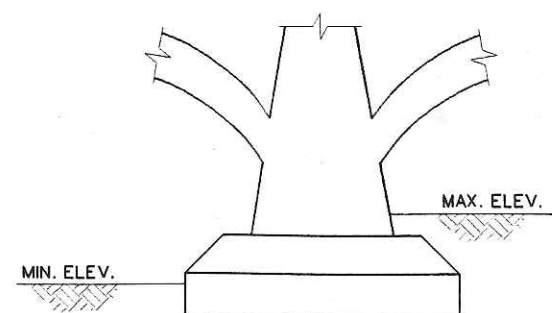
**TYPICAL END VIEW OF PIERS**  
N.T.S.

- ALL OF THE PIER SHAFTS EXHIBITED MODERATE TO HEAVY SCALING WITH EXPOSED AGGREGATE FROM THE WATERLINE TO THE TOP OF THE FOOTING BELL (EL. -2.5'). THE TYPICAL PENETRATION OF THIS SCALING WAS BETWEEN 1" AND 2". AREAS OF HEAVIER SCALING AND/OR SPALLING ARE IDENTIFIED IN THE INSPECTION NOTES.

- LOCALIZED AREAS OF 2' TO 3' HIGH UP TO 18' LONG x 1' TO 1.5' DEEP SCALE. PREVIOUS SHOTCRETE REPAIRS ARE SEVERELY DETEIORATED.
- ±10' LONG SPALLED AREA EXTENDING FROM WATERLINE TO EL. -2.5, WITH MAXIMUM PENETRATION OF 4"-6".

- ±10' LONG SPALLED AREA EXTENDING FROM EL. +6' TO EL. -2.5', WITH MAXIMUM PENETRATION OF ±6" AND EXPOSED REINFORCING STEEL.
- ±8' LONG SPALLED AREA EXTENDING FROM EL. +5' TO EL. -2.5', WITH MAXIMUM PENETRATION OF ±6".

- LIGHT ACCUMULATION OF TIMBER DEBRIS ON CHANNEL BOTTOM.
- HEAVY SCALE 2.5' x 10' WIDE x 1.2' DEEP. AGGREGATE VERY LOOSE.
- 1/16" WIDE CRACK FROM TOP OF PIER WALL TO FOOTING.

- 1.4' HIGH x 8.3' WIDE x 8" DEEP SCALE @ MUDLINE
- 1.3' HIGH x 2.7' WIDE x 4" DEEP SCALE @ MUDLINE.

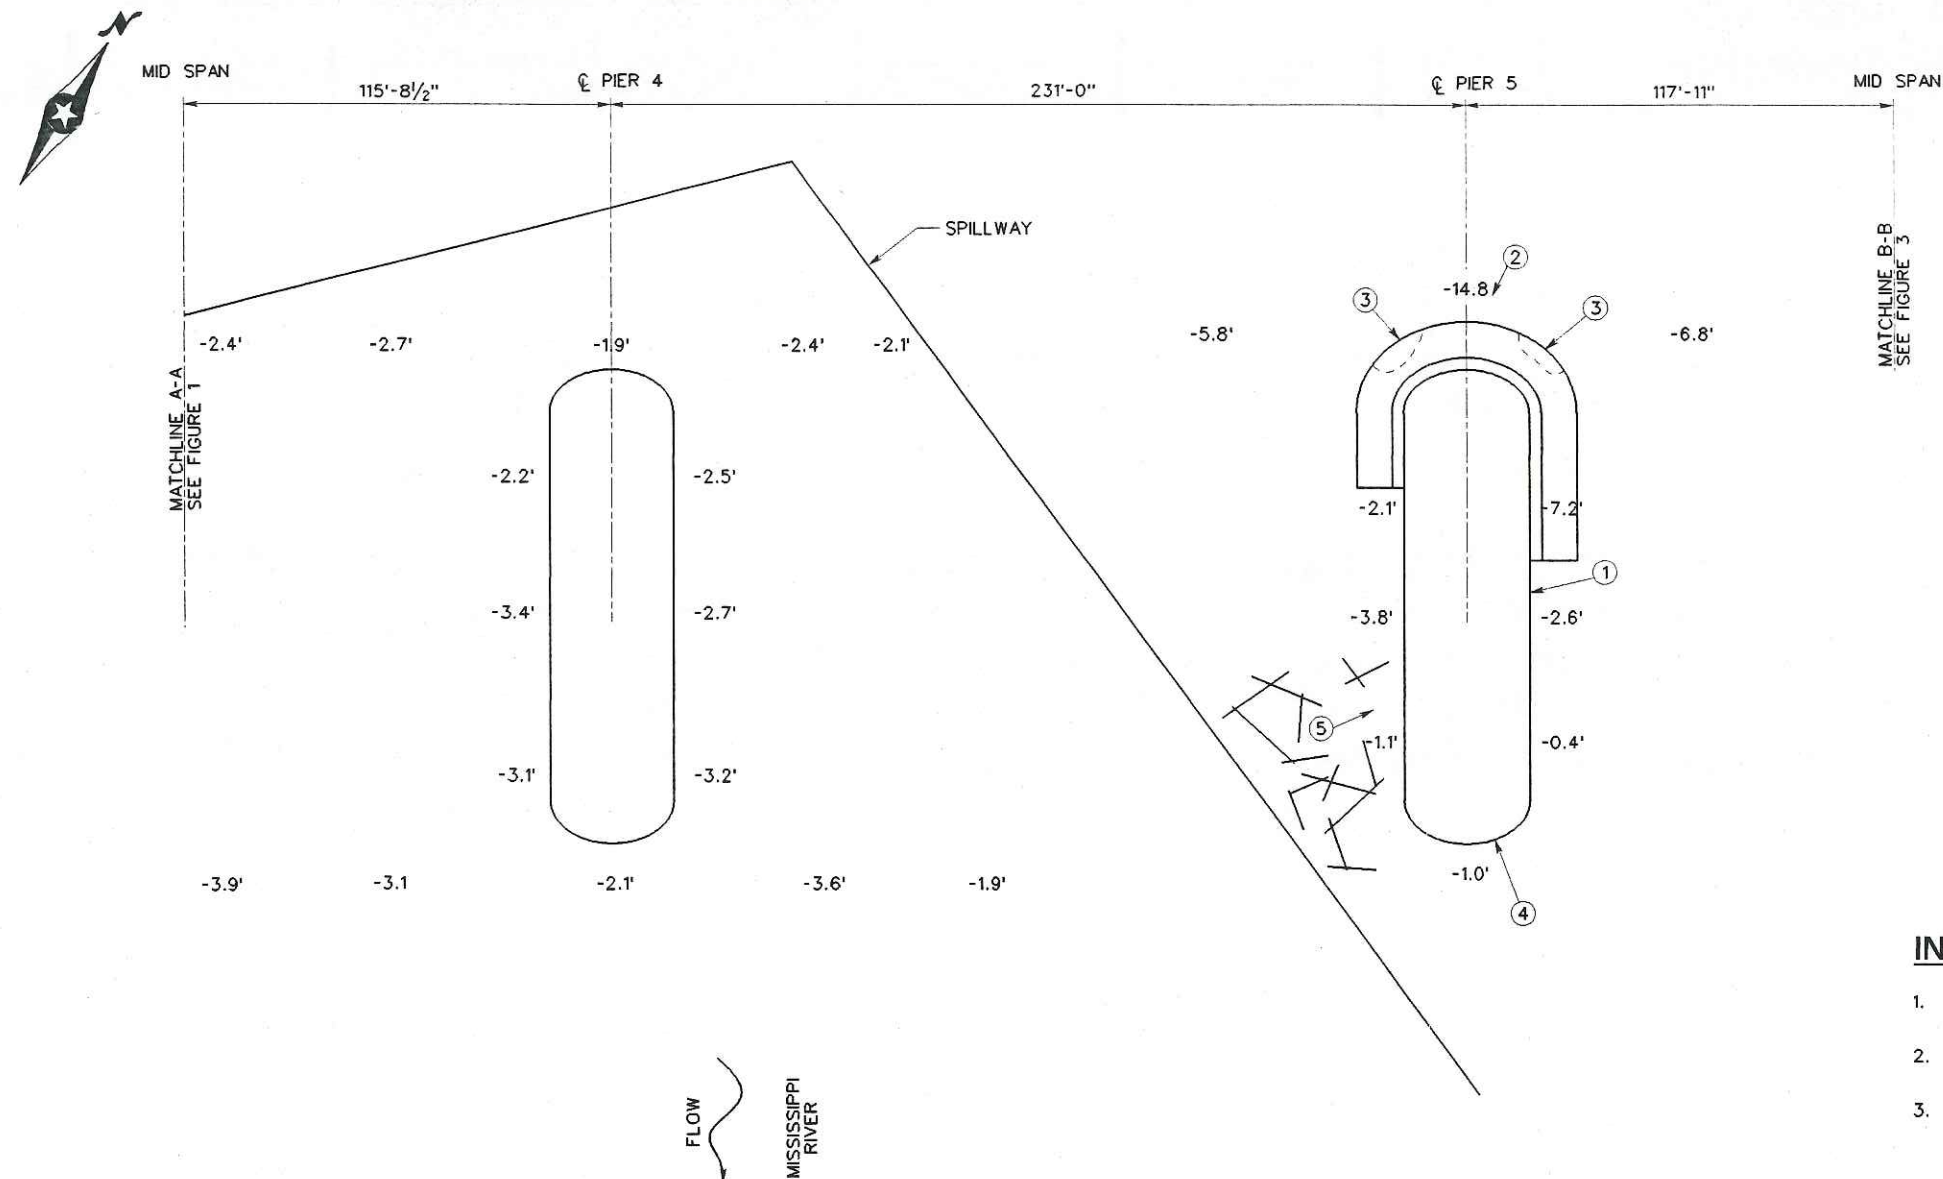
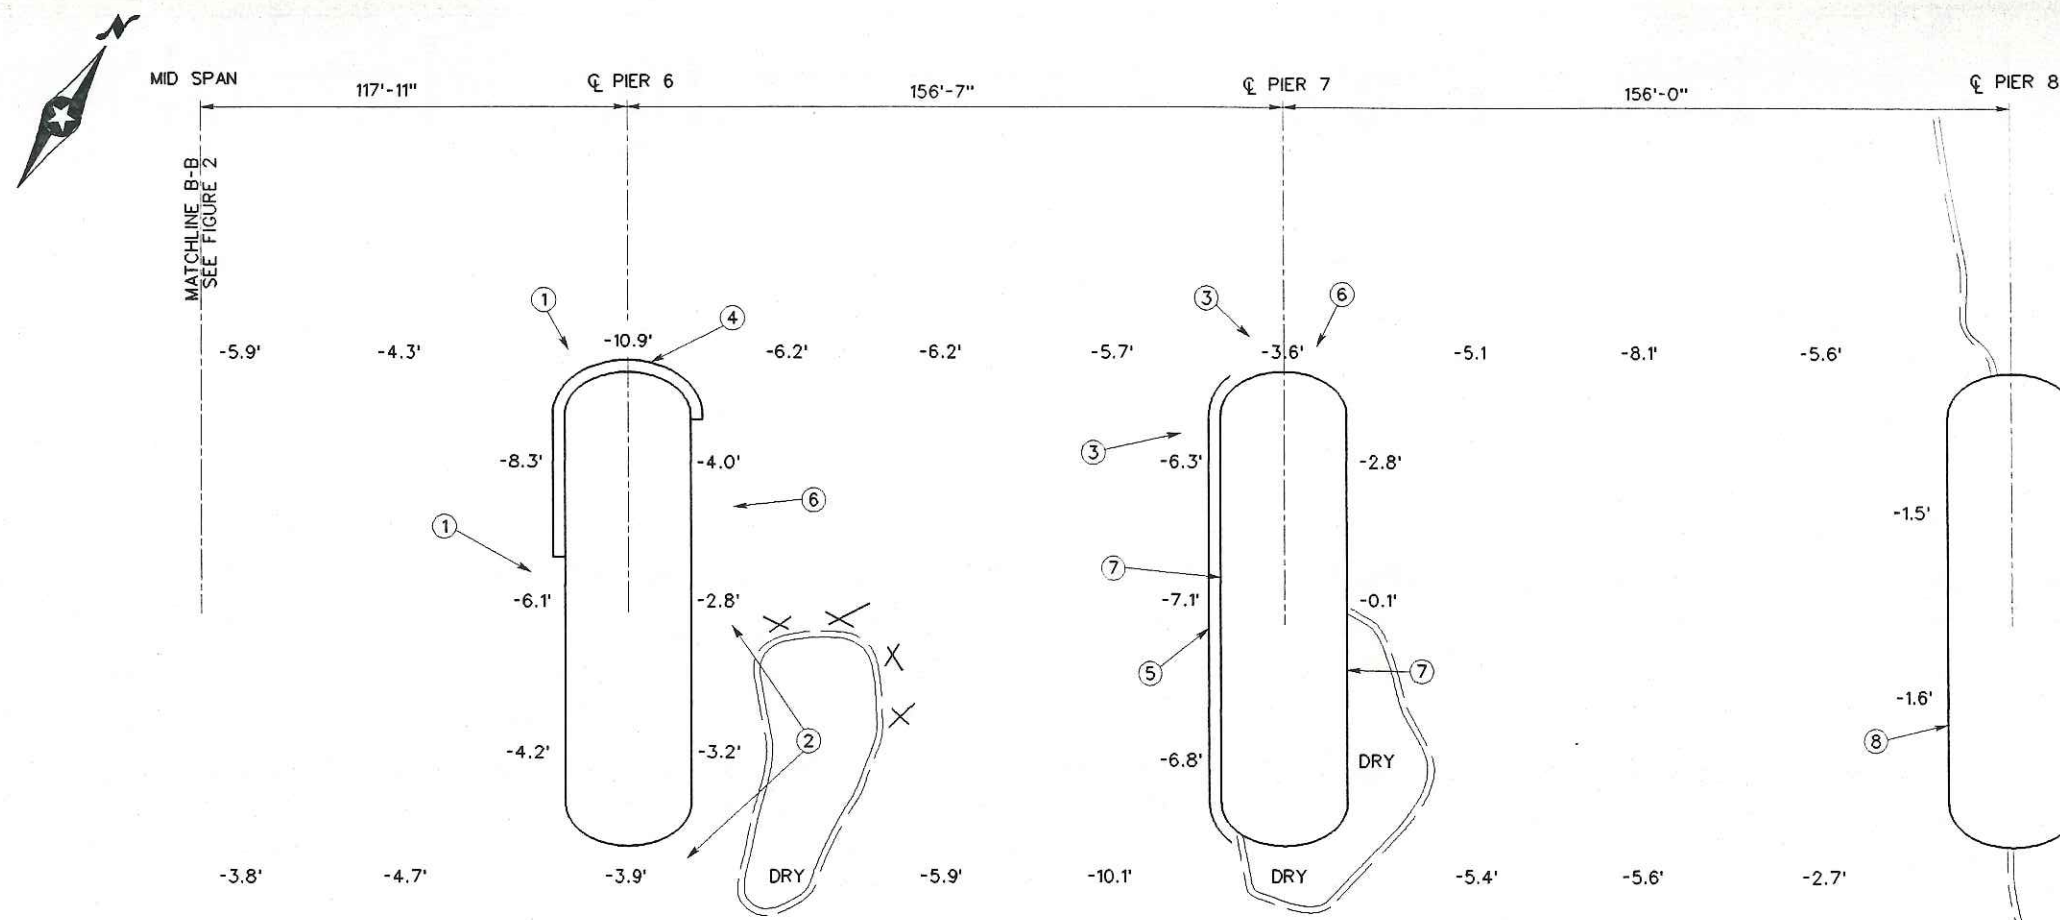
MINNESOTA DEPARTMENT OF TRANSPORTATION UNDERWATER BRIDGE INSPECTION	
BRIDGE NO. 2440 T.H. 65 OVER THE MINNESOTA RIVER DISTRICT 5, HENNEPIN COUNTY INSPECTION AND SOUNDING PLAN	
DRAWN BY: EAL	CHECKED BY: JFE
DATE: AUGUST, 1996	FIGURE 3

3. ALL OF THE PIER SHAFTS EXHIBITED MODERATE TO HEAVY SCALING WITH EXPOSED AGGREGATE FROM THE WATERLINE TO THE TOP OF THE FOOTING BELL (EL. -2.5'). THE TYPICAL PENETRATION OF THIS SCALING WAS BETWEEN 1" AND 2". AREAS OF HEAVIER SCALING AND/OR SPALLING ARE IDENTIFIED IN THE INSPECTION NOTES.
