Minnesota Department of Transportation (Mn/DOT)

Historic Bridge Management Plan

Bridge Number: 2440

Executive Summary

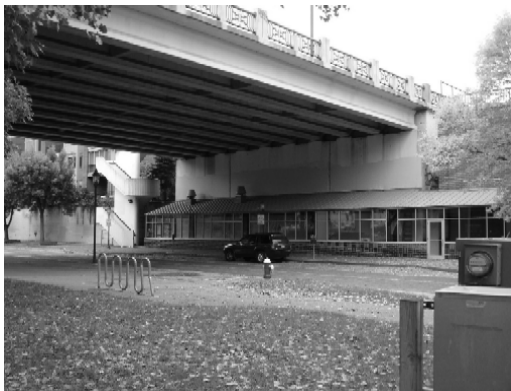
Figure 6. Looking northwest at the north abutment. A recently installed stairway of modern design to access the west sidewalk on the bridge is visible just to left of the building attached to the abutment.
