## Asset Management Memorandum

**Re:** *Asset Management*  
*TH 11 Corridor Assessment*  
*WSB Project No. 03063-000*

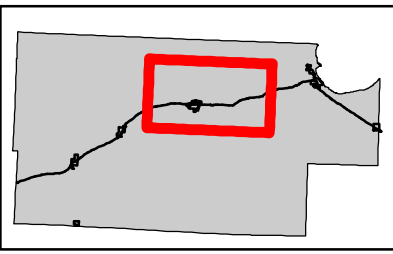
**Figure 3**  
**2014 Pavement Condition**  
**Roseau**

As of 2014, nearly the entire TH 11 corridor was considered to have good pavement condition. Only two segments had an RQI below 3.1. Segment 5 has an RQI of 2.3. This segment is a 1.2 mile segment of TH 11 in the center of Roseau, from TH 89/TH 310 to 14th Avenue NE. The RQI for this segment indicates an immediate need for reconditioning. No pavement reconditioning activities have occurred since 2006.

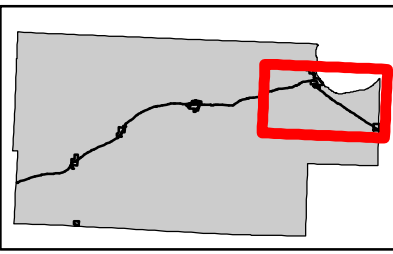
**Figure 4**  
**2014 Pavement Condition**  
**Warroad**

Segment 10 has an RQI of 3, at the upper limit of fair pavement condition. This is an 800-foot segment of TH 11 at the southern city limits of Warroad (300 feet north of CSAH 5 to 500 feet southeast of CSAH 5). The most recent maintenance on this segment was a thin mill and overlay in 2008. MnDOT is completing a 2 inch mill and overlay on segments 8-10 in 2015. Following the mill and overlay RQI is expected to be at 4.0 or above, which should extend the life of these segments until 2030. Pavement maintenance history on TH 11 indicates that the life of a mill and overlay is approximately 15 years. While **Table 1** shows that a thin mill and overlay was performed on segments 8-10 in 2008, the pavement seams near the wheel path have rapidly raveled between 2013 and 2014. As a result, MnDOT plans to accelerate the normal maintenance schedule for this segment.

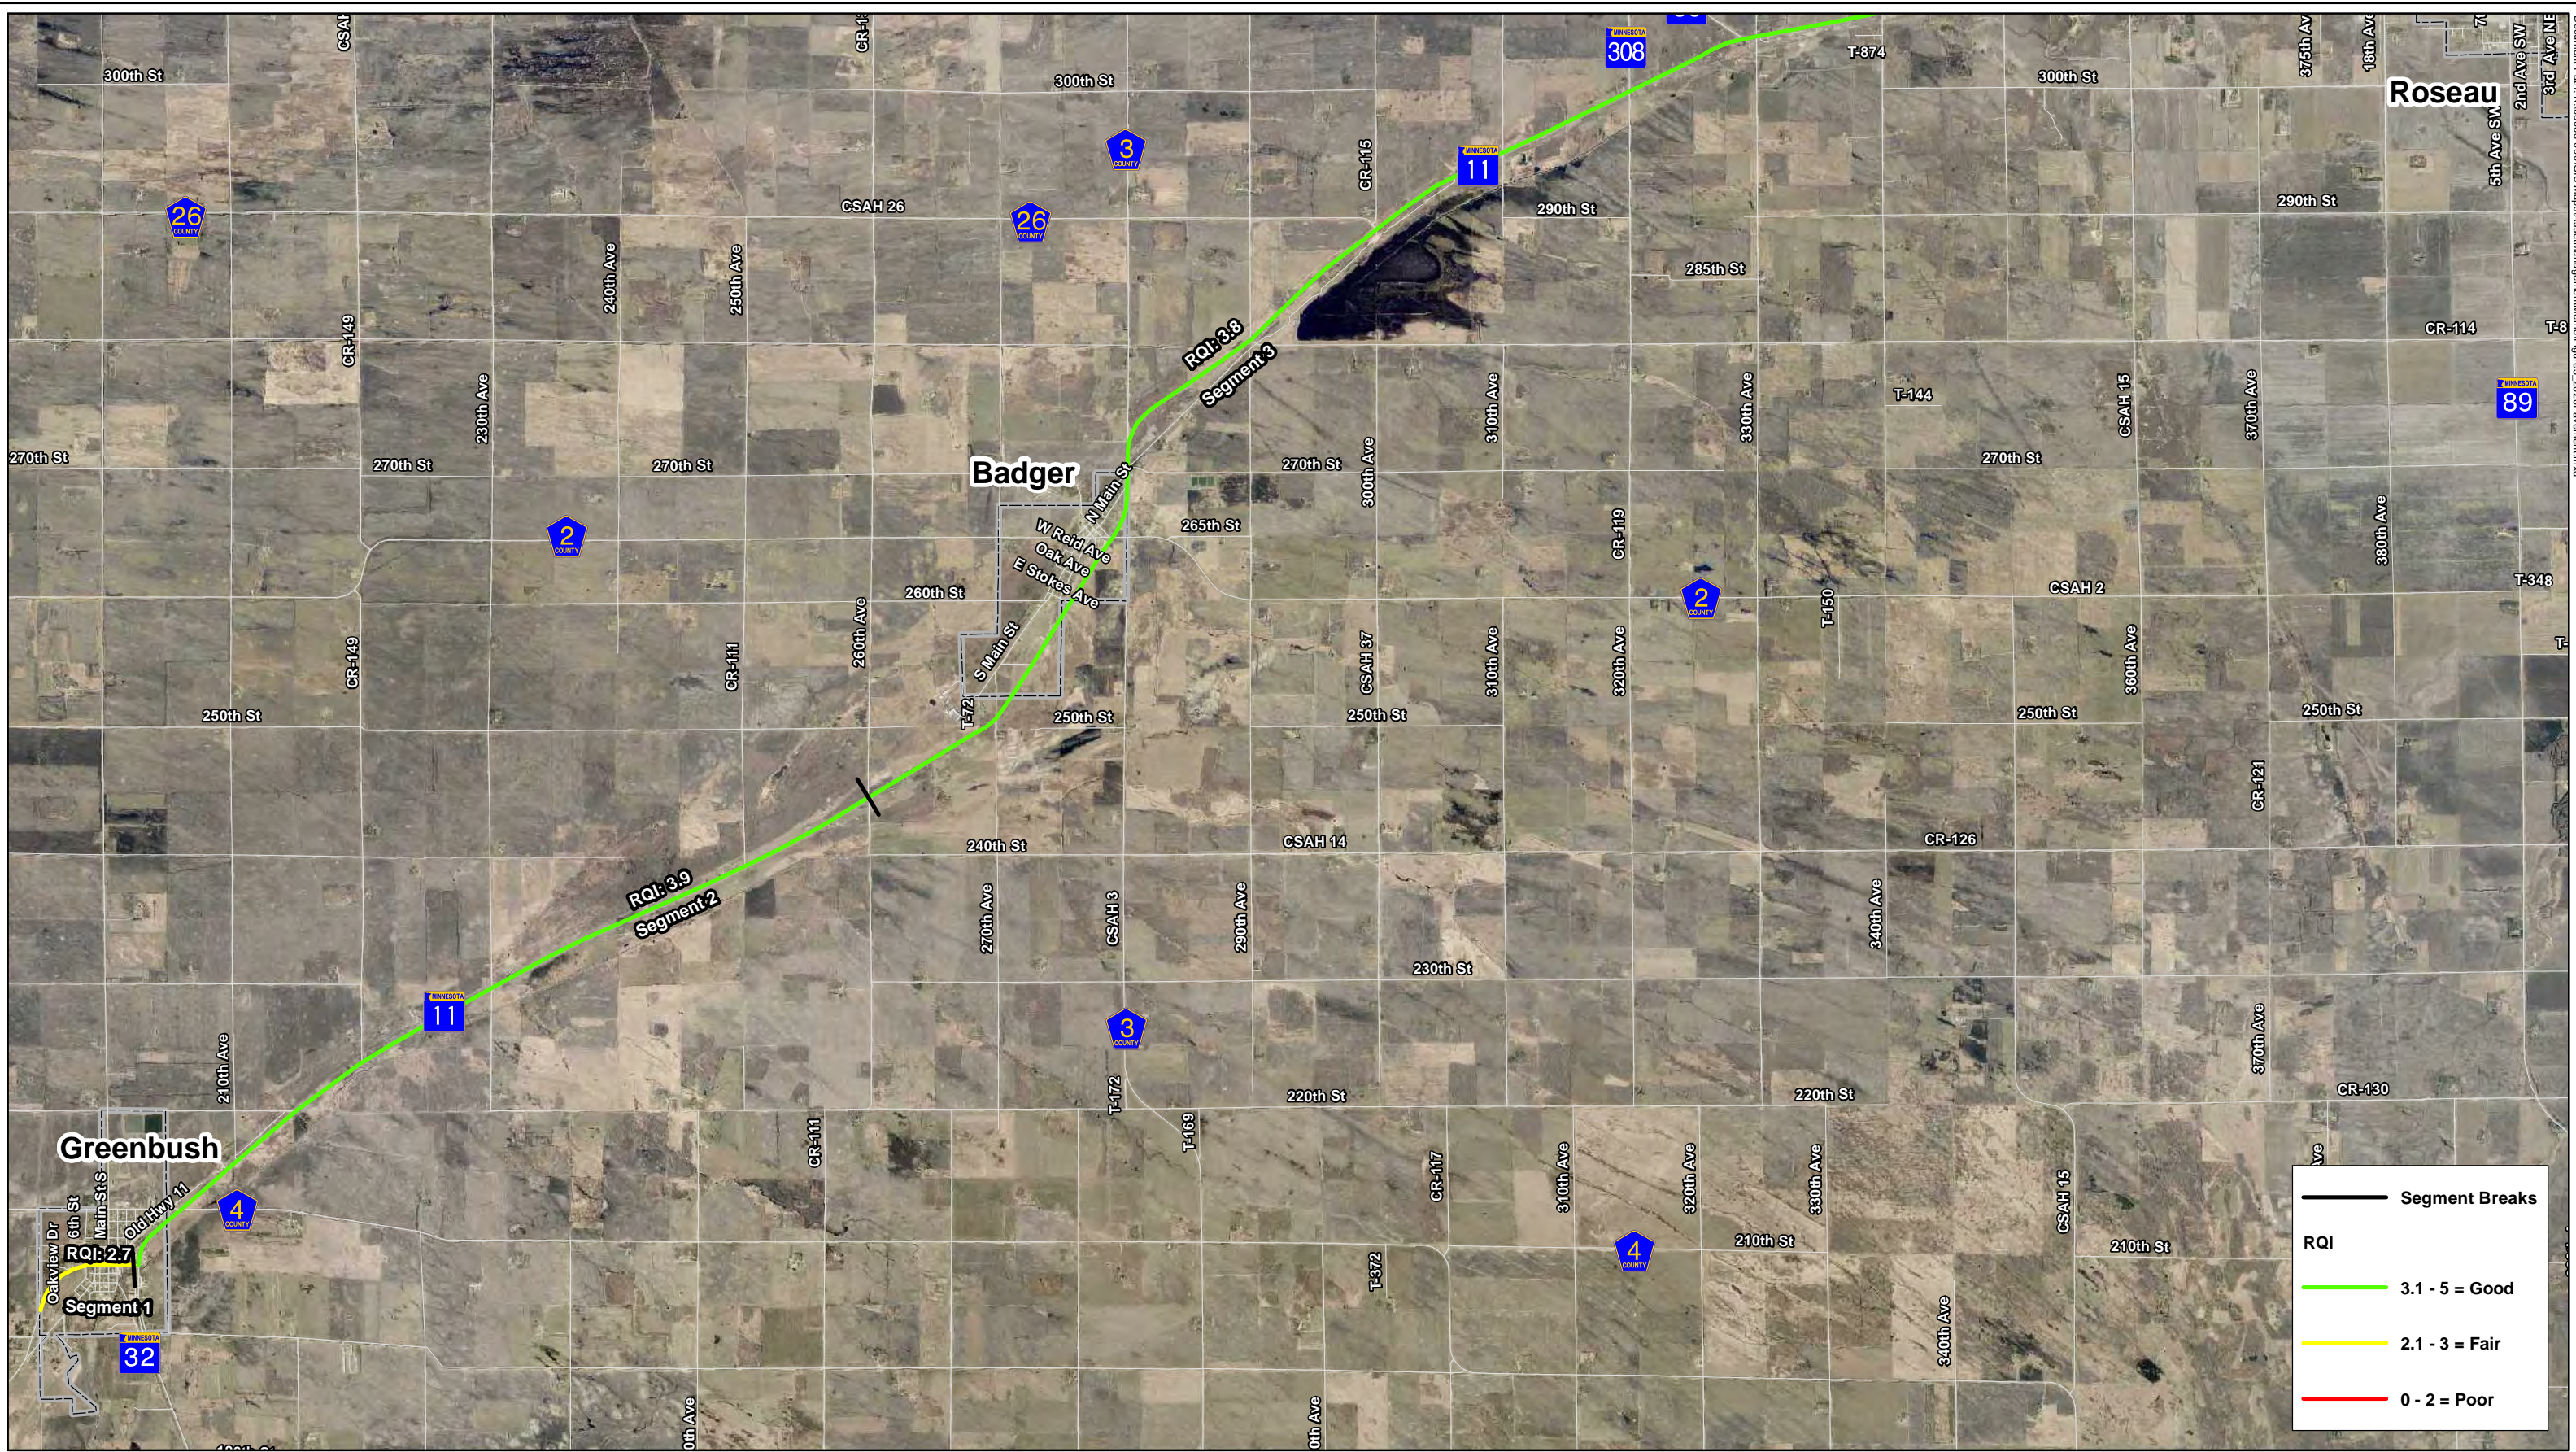
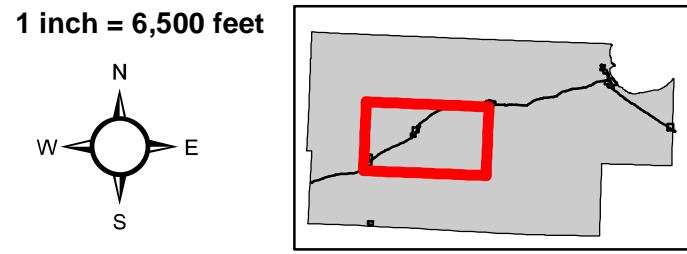
**Figure 5**  
**Predicted 2020 Pavement Condition**  
**Greenbush-Badger**

Based on the data presented in Table 3, MnDOT is predicting that three segments of TH 11 will have good pavement condition (RQI of 3.1 or greater). Those include Segments 2 and 3 at the western end of the corridor between TH 32 in Greenbush and 360th Avenue near Roseau and Segment 7. Segment 7 includes the area just west of the Warroad city limits to TH 313/Cedar Avenue.

Following completion of the 2014 pavement condition evaluation and prior to the start of the TH 11 Corridor Study, MnDOT identified proposed pavement projects to address the deficiencies identified in Table 3. These improvements included the sections in Warroad between TH 313 and 500 feet southeast of CSAH 5 (Segments 8-10) in 2015 and a reclaim and overlay in Roseau from CSAH 15 to just east of TH 89 (Segment 4) in 2015. The 2015 improvements should increase RQI above 4.0, with an expected RQI of approximately 3.5-3.9 in 2020.

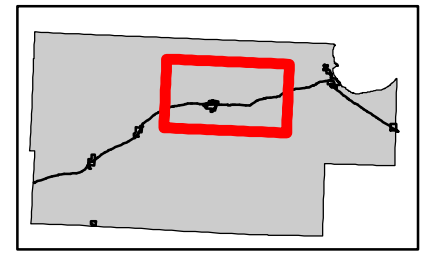
**Figure 6**  
**Predicted 2020 Pavement Condition**  
**Roseau**

As a result of planned maintenance activity before 2020, only one segment of TH 11 will remain below the 2.5 RQI threshold. Segment 5 in the center of Roseau (TH 89/TH 310 to 14th Avenue NE) is predicted to have an RQI of 1.9. No maintenance activities are planned for this segment prior to 2020; however, preventative maintenance is needed on this segment to extend the life of the roadway and reduce the need for roadway reconstruction. It should be noted that RQI measured in urban areas can be skewed because the measure is based on a 50 mph speed. In urban areas, there are also more manholes and utilities in the pavement that affect ride quality.

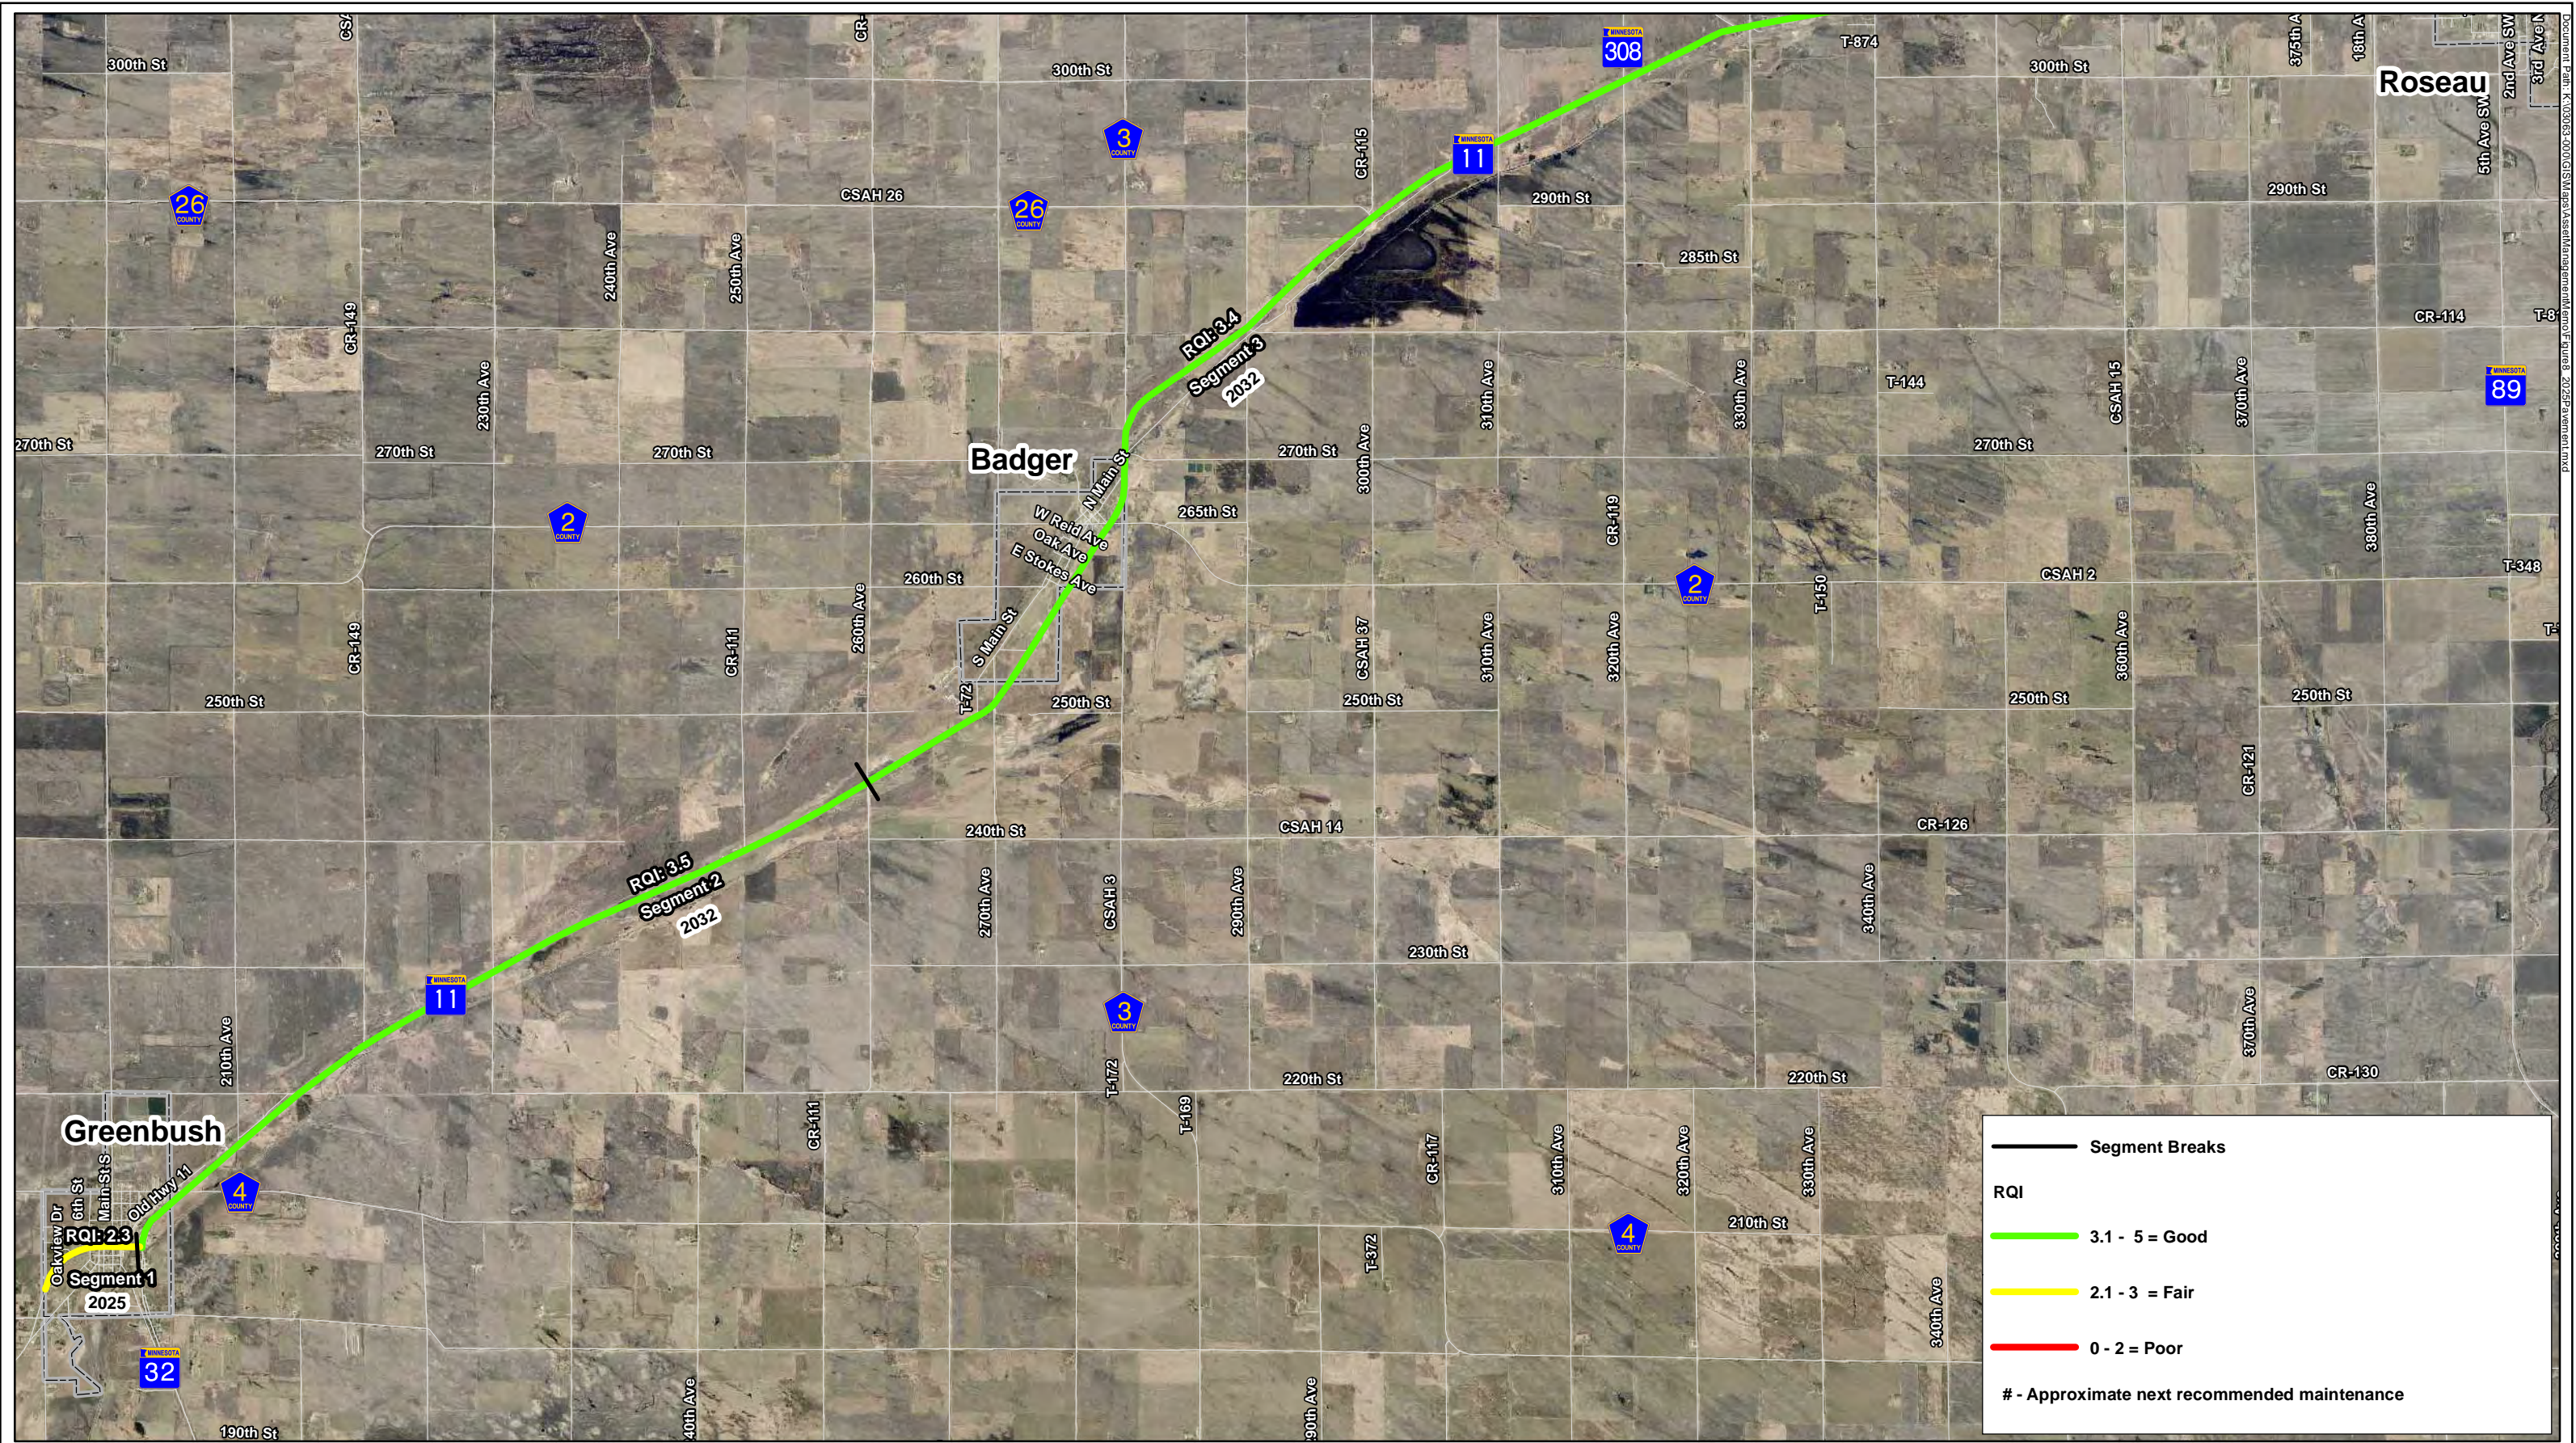
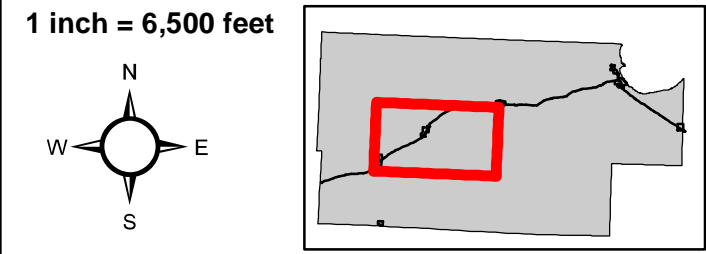
**Figure 8**  
**Predicted 2025 Pavement Condition**  
**Greenbush & Badger**

Following these maintenance projects, all but one segment of TH 11 is expected to have an RQI above 2.5 in 2030. Segment 1 in Greenbush is expected to have an RQI of 2.3 in 2025. A mill and overlay is recommended on this segment between 2020 and 2025 to address expected pavement condition issues.

Assuming regular maintenance occurs, it is not expected that any segments of TH 11 will need to be reconstructed prior to 2040. To prevent the need for reconstruction during this timeframe, mill and overlays should be completed approximately every 15-20 years. RQI should continue to be monitored to refine the need for pavement maintenance. Some segments may deteriorate more quickly than others. Based upon the information above and the improvements that were completed in 2015, 2016 and 2024, a number of additional mill and overlay projects are likely needed to address pavement condition prior to 2040. The list below and **Table 5** indicate the time period when RQI is expected to fall into the category of 2.5 or below and pavement rehabilitation will be needed.

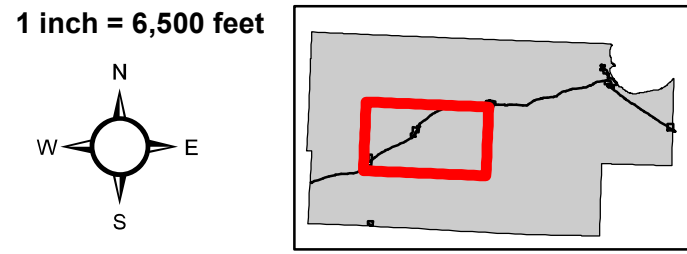
**Figure 15**  
**Current Culvert Conditions**  
**Greenbush & Badger**

Based on the most recent inspection reports available, most culverts in the corridor should be inspected every six years, with the next inspections recommended in 2021. Based on 2015 inspections, 47 culverts should be inspected every 2-4 years, with the next inspections in the 2017-2019 timeframe.

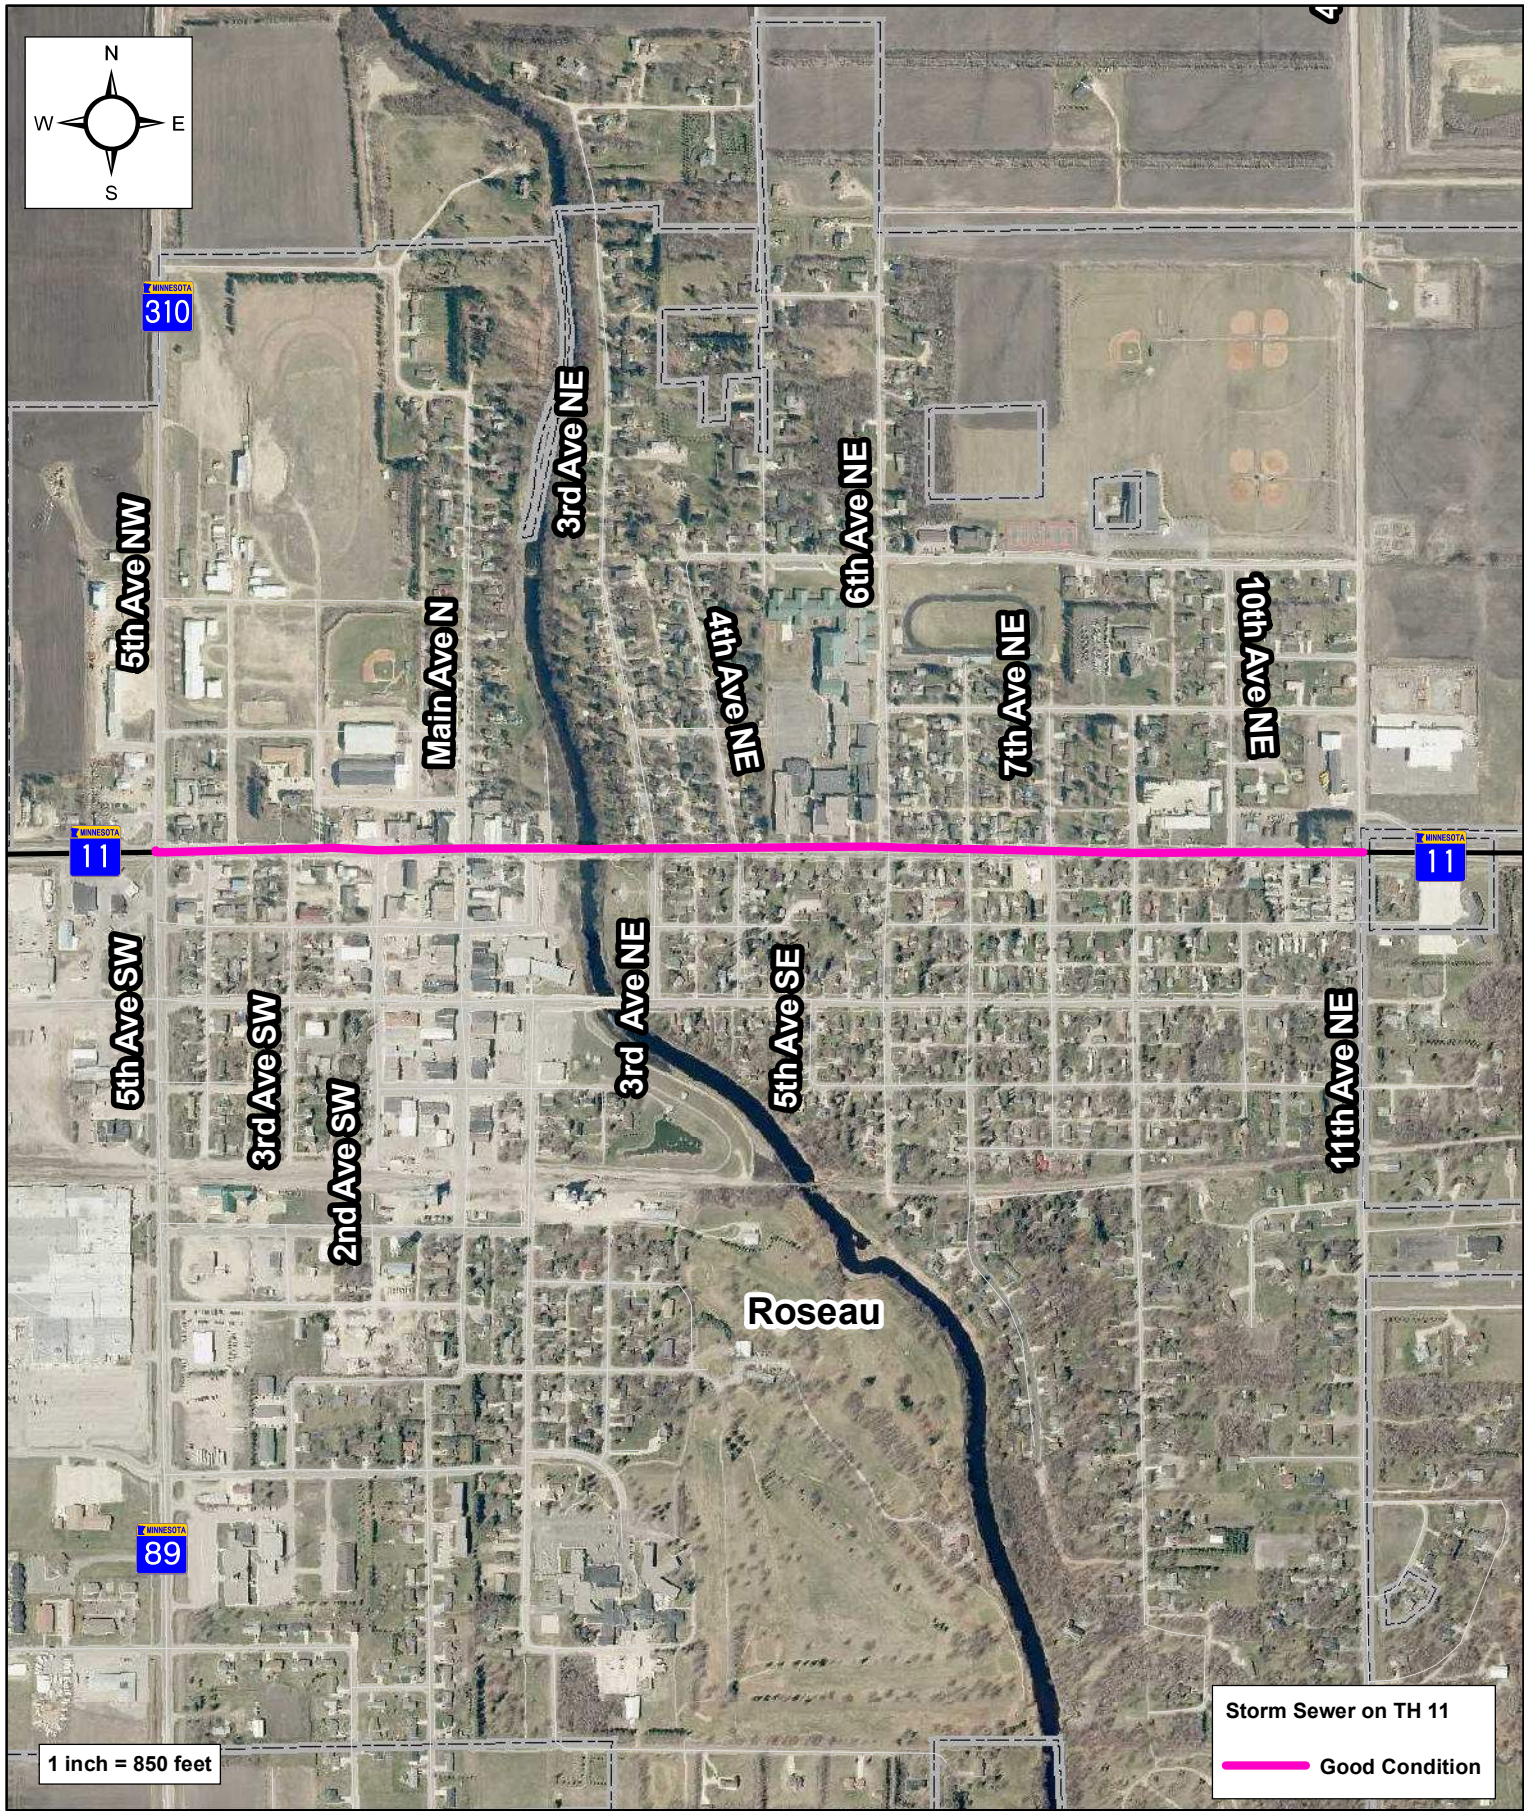
Storm sewer between Elk Street and Lincoln Street is in poor condition and is recommended to be replaced. The 2015 inspection report identifies approximately \$234,000 worth of storm sewer replacements in this area. The report recommends including storm sewer replacements with planned ADA, sidewalk, and signal improvements programmed for 2019. The new storm sewer will need to include sump catch basins or storm sewer treatment devices prior to out-letting into the Warroad River.

Storm sewer should generally be inspected every five years to comply with MS4 permit requirements, with the next inspection recommended in 2020. Subsequent inspections should follow in 2025 2030, 2035 and 2040. Inspections should identify needs to clean drains, clean sediment in storage ponds, and address erosion around open inlets or grates.
