FINAL MIDTOWN CORRIDOR INDIVIDUAL BRIDGE SUMMARY AND MANAGEMENT PLAN

Prepared By: Olson & Nesvold Engineers, P.S.C.
SRF Consulting Group, Inc.
Gemini Research
Braun Intertec
MacDonald & Mack Architects

Bridge 90437
Cedar Ave S

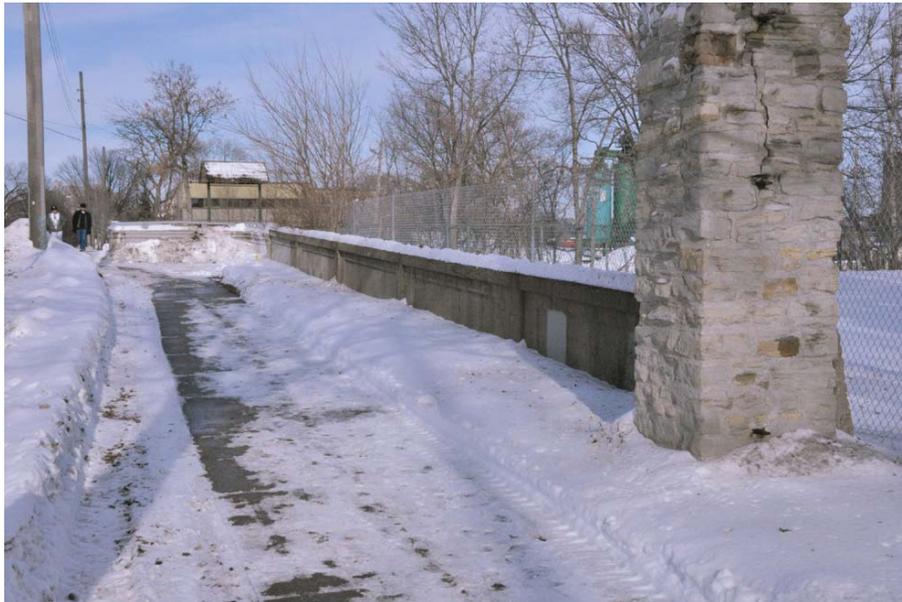
Attached to the southeast corner of the bridge is the circa 1928 wall of Pioneer and Soldiers Memorial Cemetery (at right in photo). The cemetery is both listed on the National Register of Historic Places and a Minneapolis HPC site.

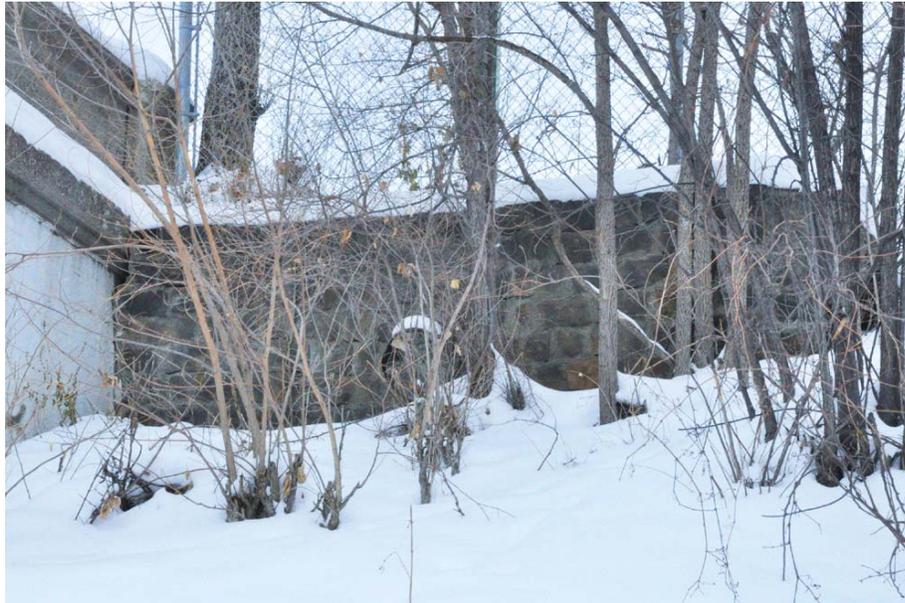
Mortared stone retaining walls are attached to the northeast (shown above) and northwest corners of the bridge. They were built to support private property, probably soon after the bridge was built.
