## FINAL MIDTOWN CORRIDOR INDIVIDUAL BRIDGE SUMMARY AND MANAGEMENT PLAN

The Fremont Avenue Bridge (Bridge L8901) carries vehicular and pedestrian traffic over the Midtown Greenway in the city of Minneapolis. The bridge was constructed in 1912-1913 and is a contributing element in the Chicago, Milwaukee, and St. Paul Railroad Grade Separation Historic District.

**Bridge L8901  
Fremont Ave S**

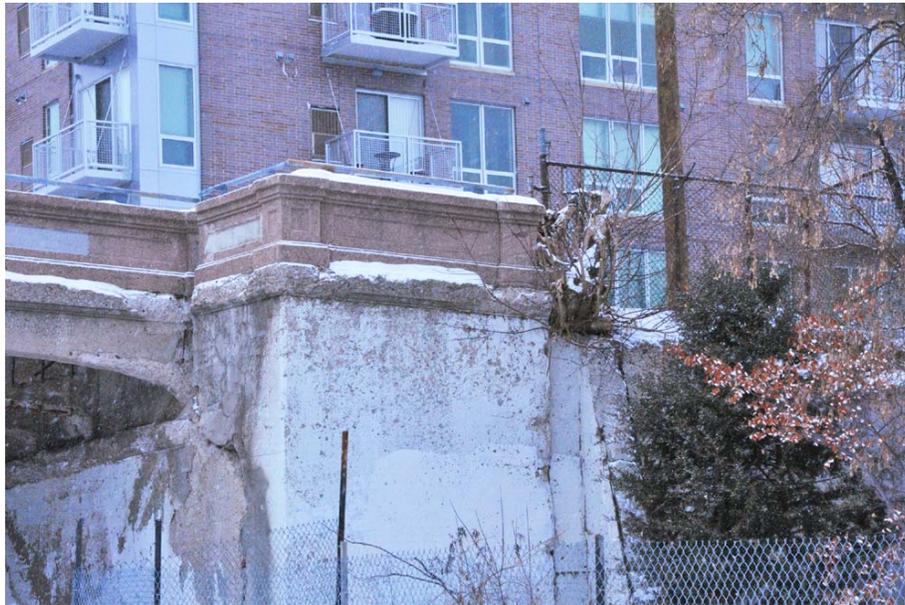
Attached to the northeast corner of the bridge is an original, railroad-built, buttressed poured concrete retaining wall (behind conifer) that helps support Fremont Avenue.
