Collapse of I-35W Highway Bridge
Minneapolis, Minnesota
August 1, 2007

ACCIDENT REPORT

NTSB/HAR-08/03
PB2008-916203

Highway Accident Report

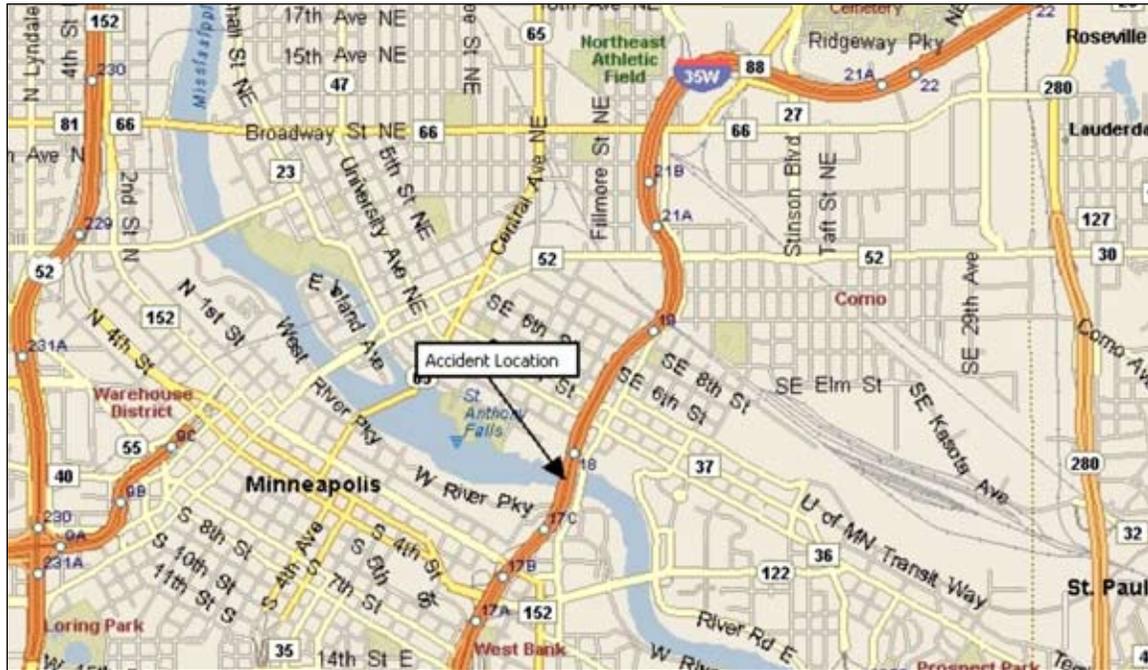
Figure 2. Accident location.

The accident occurred in the city of Minneapolis in Hennepin County, Minnesota. The I-35W bridge was located about 1 mile northeast of the junction of I-35W with Interstate 94. (See figure 2.) In addition to spanning the Mississippi River, the bridge also extended across Minnesota Commercial Railway railroad tracks and three roadways: West River Parkway, 2nd Street, and the access road to the lock and dam.

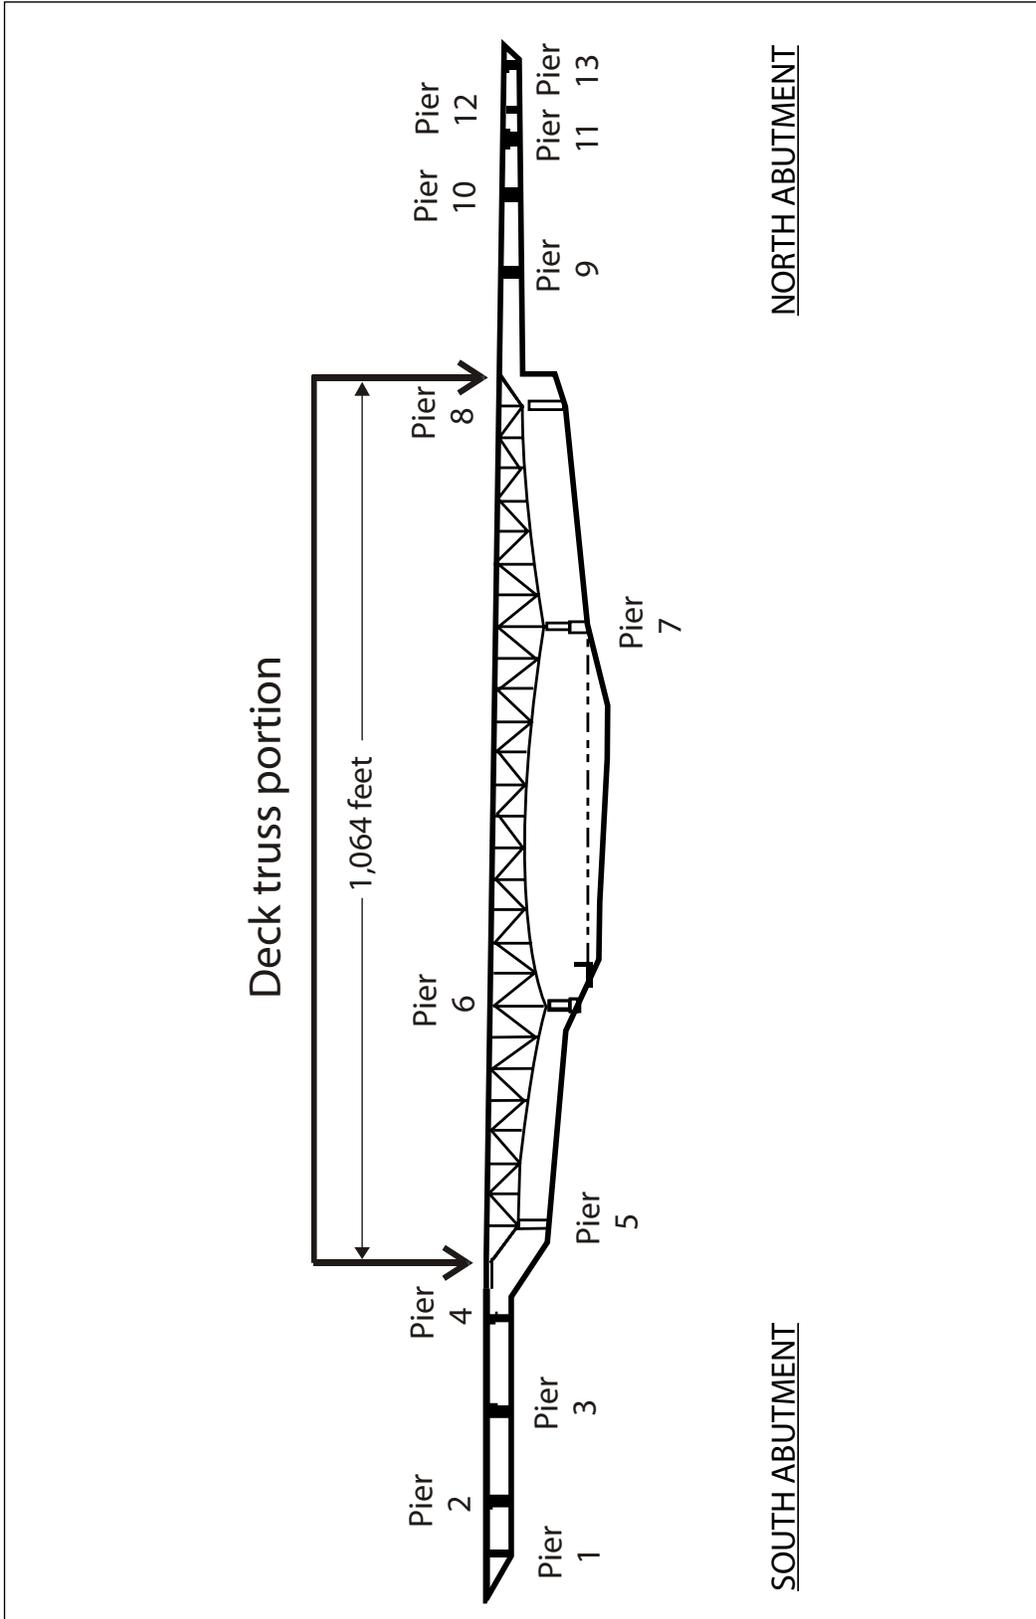
The bridge had 13 reinforced concrete piers and 14 spans, numbered south to north. (See figure 3.) Eleven of the 14 spans were approach spans to the deck truss portion. The bridge deck in the approach spans either was supported by continuous welded steel plate girders or by continuous voided slab concrete spans. The south approach spans were supported by the south abutment; by

Figure 3. East elevation of I-35W bridge. The deck truss portion of the bridge extends from just south of pier 5 to just north of pier 8. (Source: Adapted from Mn/DOT graphic)

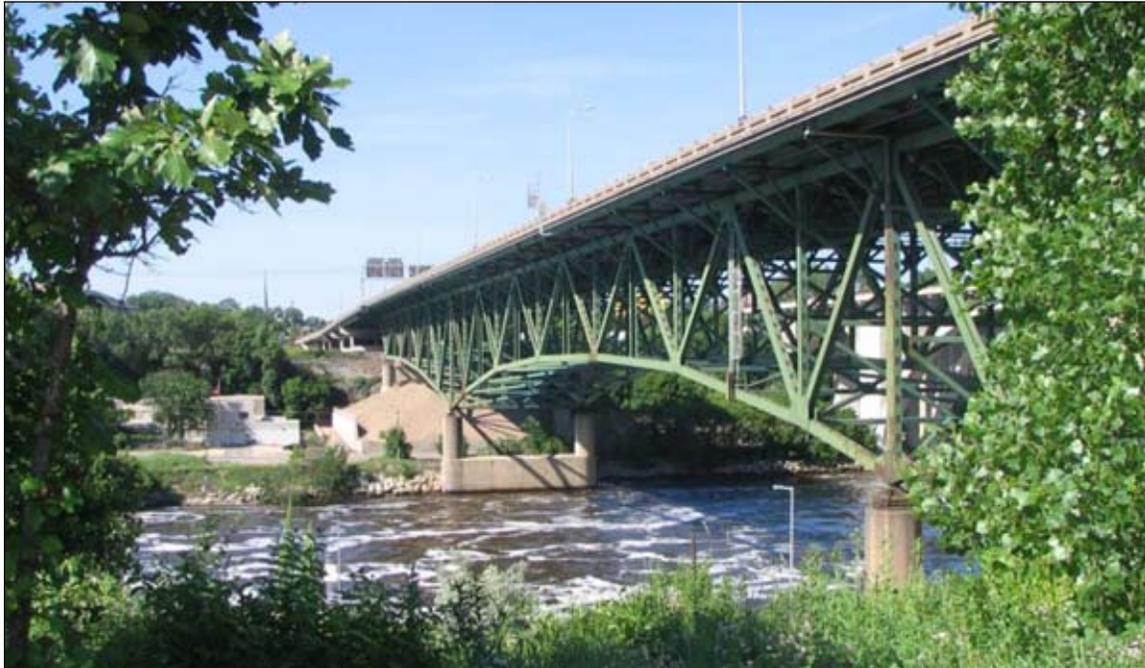
Figure 4. Center span of I-35W bridge, looking northeast. The center span is supported by pier 6 on the near (south) riverbank and pier 7 on the far (north) riverbank.

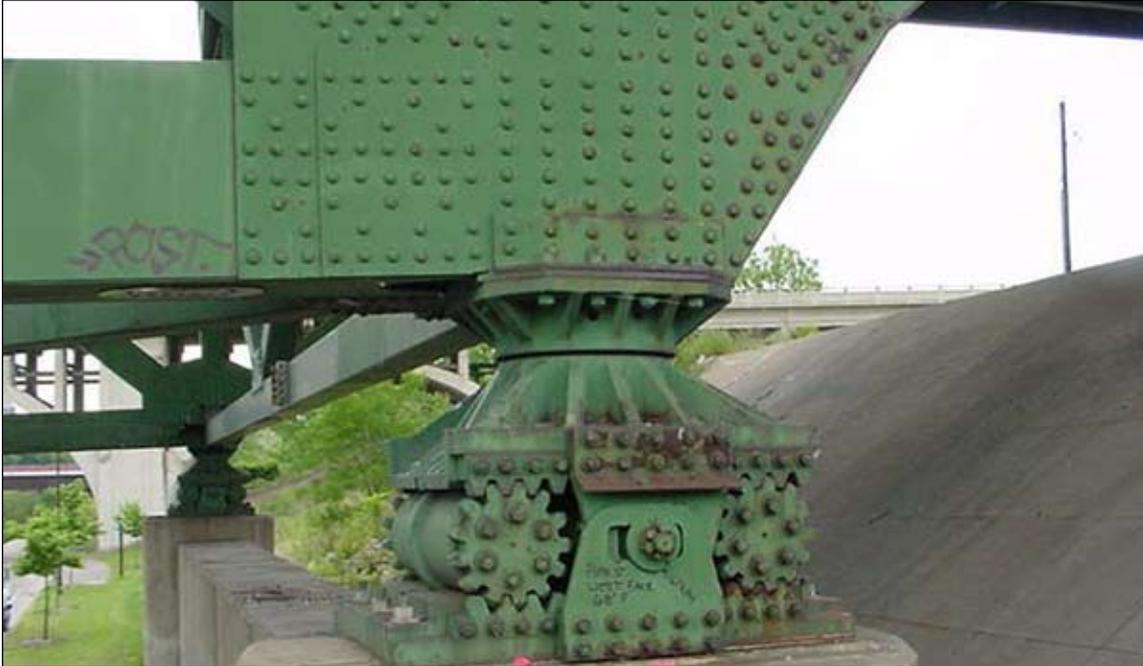
The original bridge design accounted for thermal expansion using a combination of fixed and expansion bearings for the bridge/pier interfaces. The fixed bearing assemblies were located at piers 1, 3, 7, 9, 12, and 13. Expansion (sliding) bearings were used at the south and north abutments and at piers 2, 4, 10, and 11. Expansion roller bearings were used at piers 5, 6, and 8. The roller bearings at pier 6 contained four large-diameter rollers; those at piers 5 and 8 were similar in design but contained only three large-diameter rollers. (See figure 5.)

Figure 5. Expansion roller bearings at pier 5, looking east. (Source: URS Corporation)

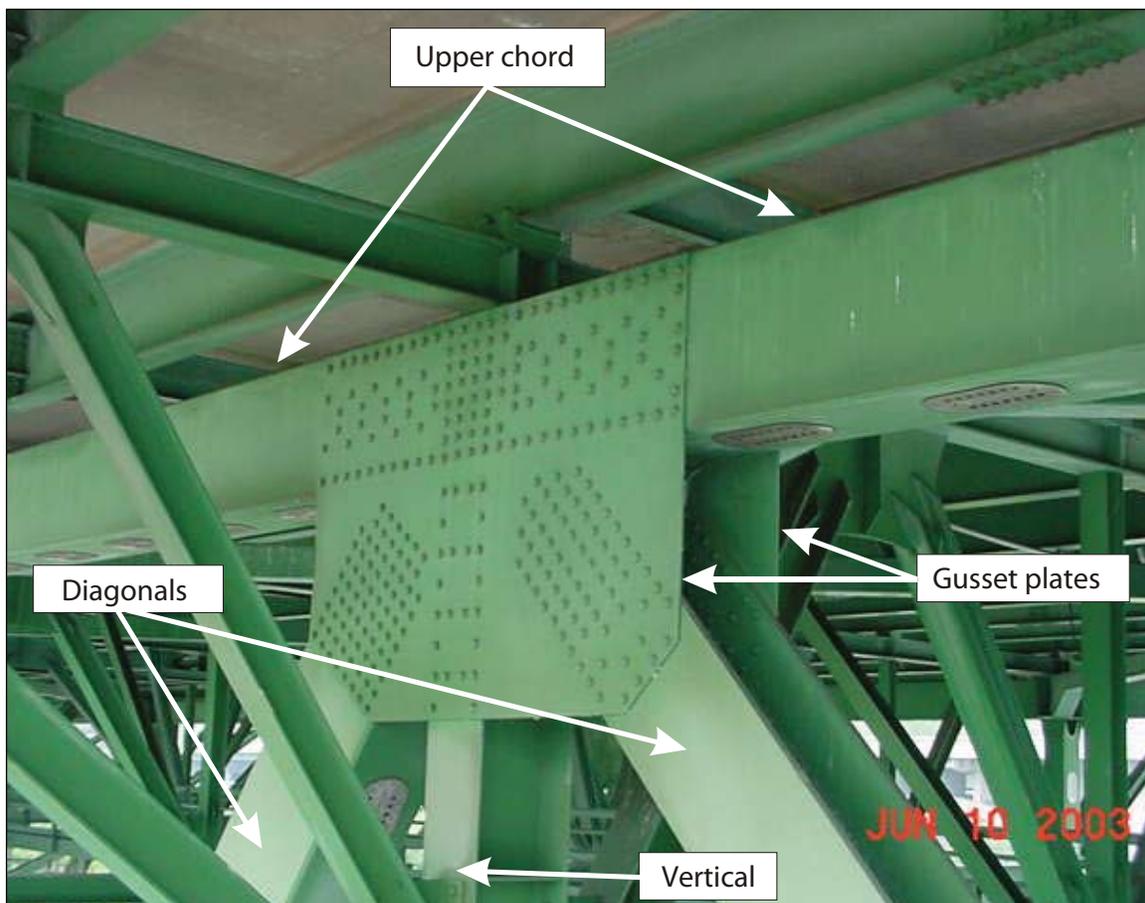
Riveted steel gusset plates at each of the 112 nodes (connection points) of the two main trusses tied the ends of the truss members to one another and to the rest of the structure.⁷ The gusset plates were riveted to the side plates of the box members and to the flanges of the H members. All nodes had at least two gusset plates, one on either side of the connection point.⁸ A typical I-35W main truss node, with gusset plates, is shown in figure 6.

Figure 6. Typical five-member node (two upper chord members, one vertical member, and two diagonal members) on I-35W bridge. (Source: URS Corporation)

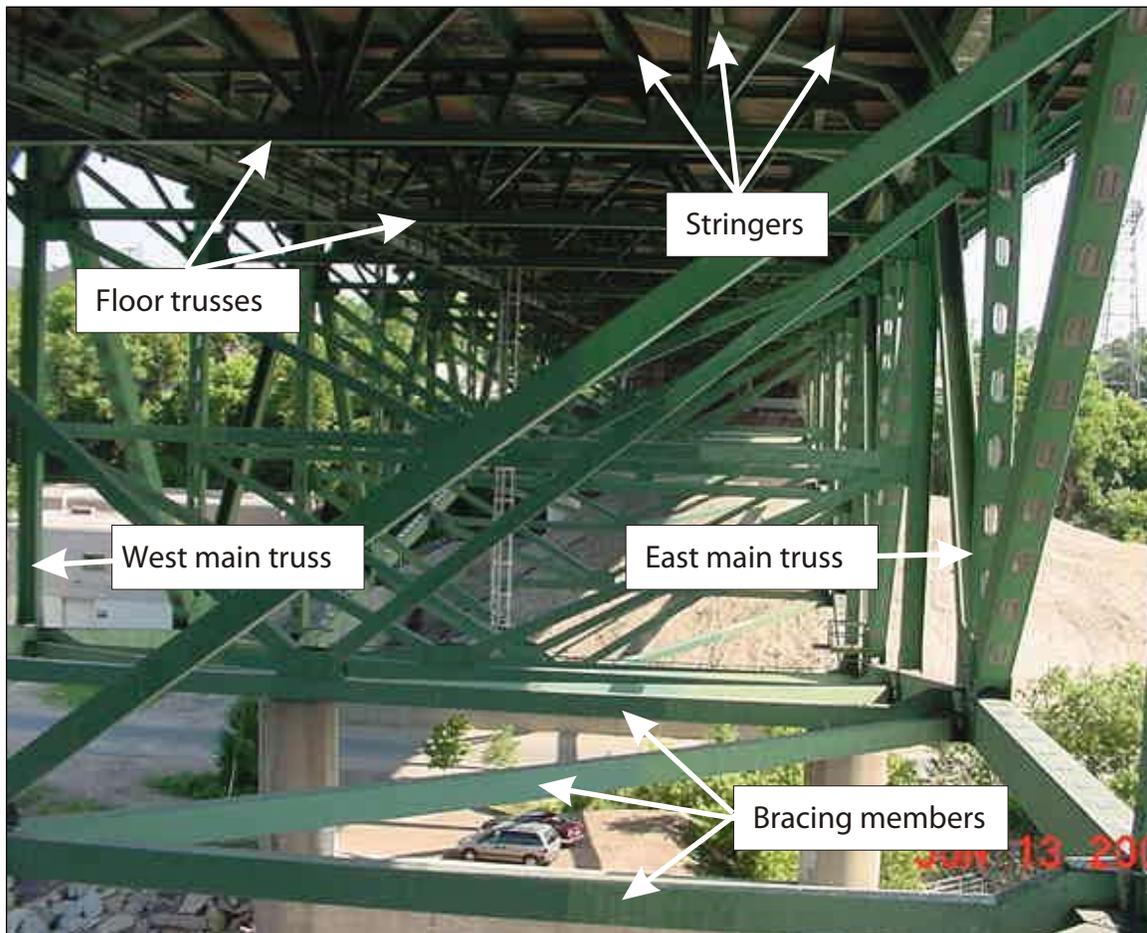
Figure 7. Interior structure of north portion of deck truss, looking north. (Source: URS Corporation)

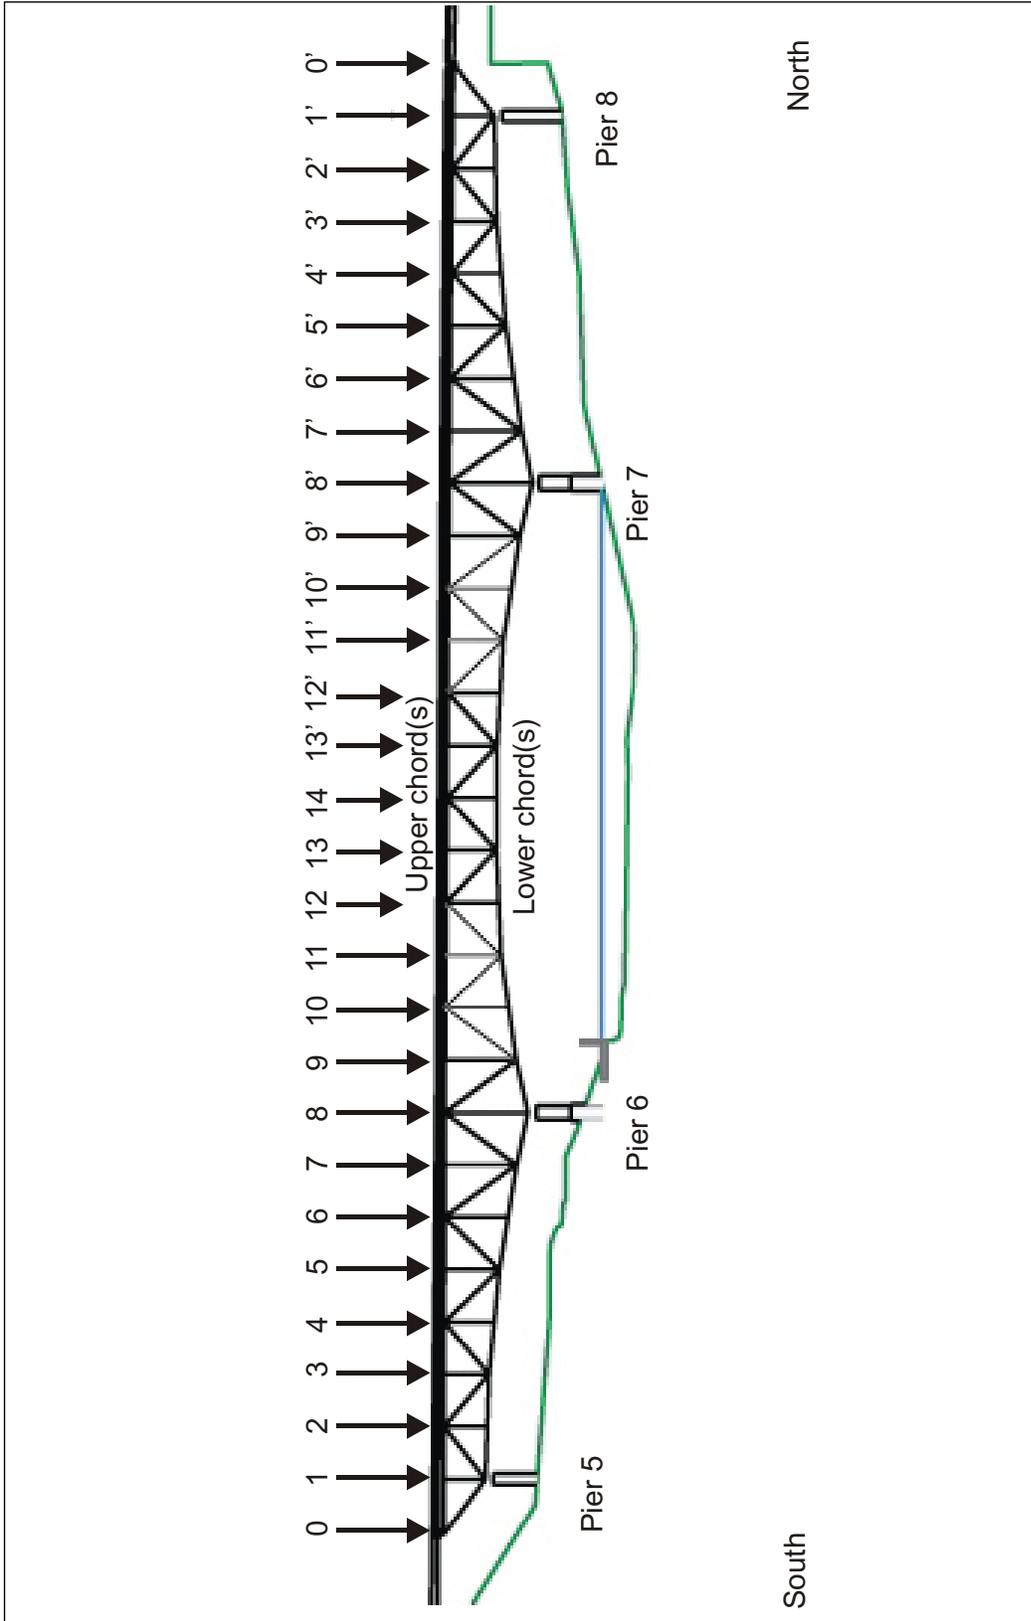
The bridge design documents and inspection records identified the 112 main truss nodes (29 upper and 27 lower nodes⁹ on each of the two main trusses) by number. Because the bridge was longitudinally symmetrical (the north and south halves were almost mirror images), the nodes were numbered from each end starting at 0 on the south end and at 0' (0 "prime") on the north end. The node numbers increased from each end until reaching node 14, which was at the center of the bridge. Thus, n and n' identified the corresponding nodes on the bridge's south and north halves, respectively. The letters U (for upper chord) and L (for lower chord) further identified the nodes, along with E or W to specify the east or west main truss. For example, the "U5E" node refers to the sixth node from the south end of the bridge (because the node number begins at 0) on the upper chord of the east main truss. The "U5'E" node refers to the corresponding node on the north half of the bridge. (See figure 8.)

Figure 8. Nodes (connection points) on main trusses of I-35W bridge, designated by number. The nodes were further referenced by “U” for upper nodes (connecting members at the upper chord) and “L” for lower nodes (connecting members at the lower chord). Location of nodes on the east or west main truss was designated by “E” or “W,” respectively. (Source: Adapted from Mn/DOT graphic)

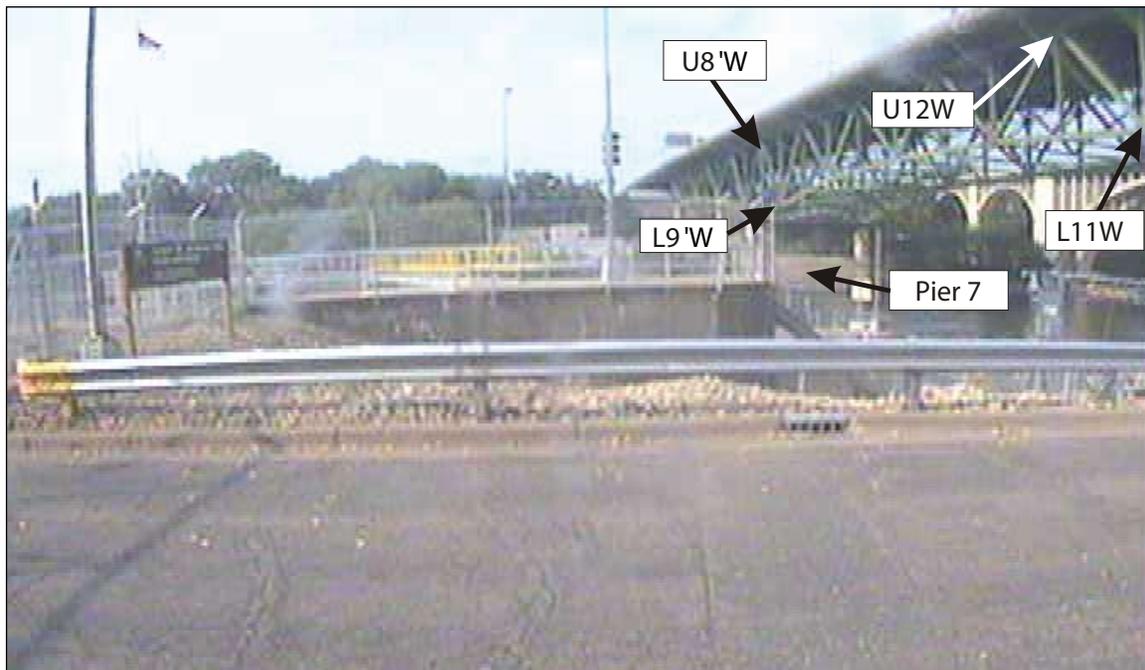
The primary structure visible in the video is the west truss of span 7, the bridge center span that crossed the river. Portions of the east truss are also visible behind the west truss. The visible section of the lower chord of the west truss extends from the L11W node, which is partially visible, northward through the L9'W node. The visible section of the upper chord extends from U11W northward through U8'W. Some upper nodes north of U8'W can also be seen, but they are generally too far away to be resolved clearly. Most of the west truss members are visible within this region. Most of pier 7 (on the north riverbank) can be seen, though a fence in the foreground obscures the west pier column. (See figure 9.)

Figure 9. View of a portion of the west side of I-35W bridge center span about 8 minutes before collapse. (Image extracted from surveillance camera video.)

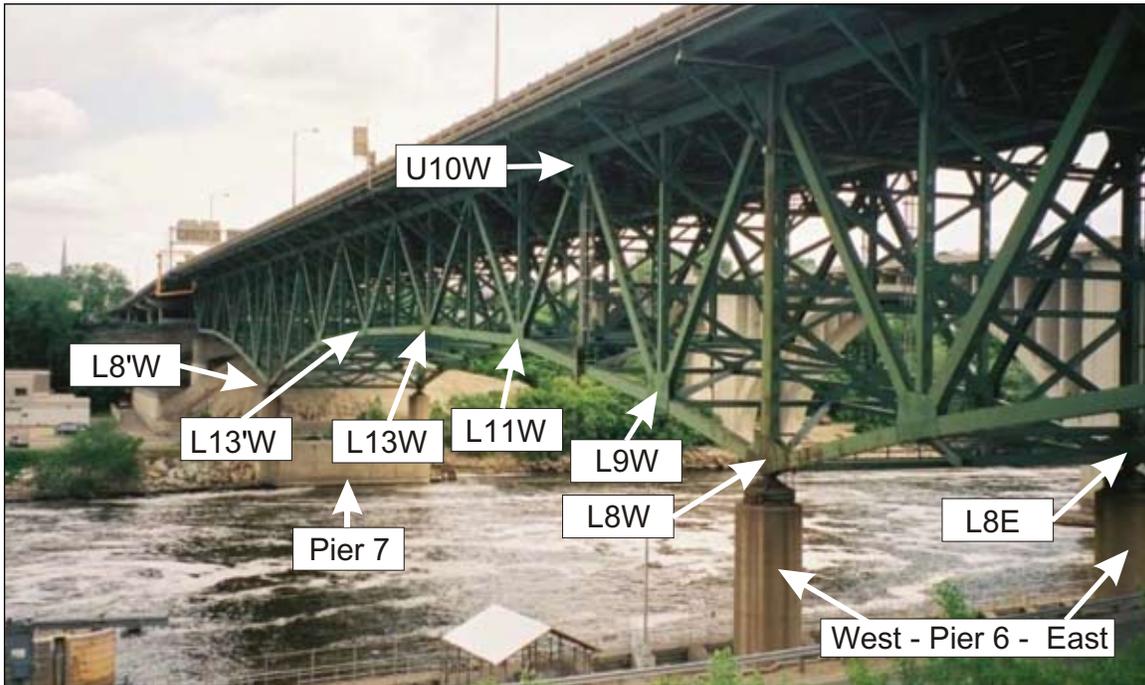
Center Section. See figure 13 for a photograph of the center span before collapse. In the postcollapse position, the center section of the truss was relatively flat and almost directly below its original location. (See figure 14.) As noted previously, the video of a portion of the collapse sequence captured by a nearby surveillance camera showed that the south end of the center section (just north of pier 6) dropped before the north end (just south of pier 7) and that the center section remained relatively level east to west as it fell. Many of the vehicles in the inner northbound lanes of the bridge remained in their lanes as the collapse occurred, indicating that the east and west main trusses at the south end of the center section fractured at about the same time and that the center section dropped into the river with a minimum of lateral roll.

Figure 13. Center span of I-35W bridge (before collapse), looking northeast, with certain nodes labeled.

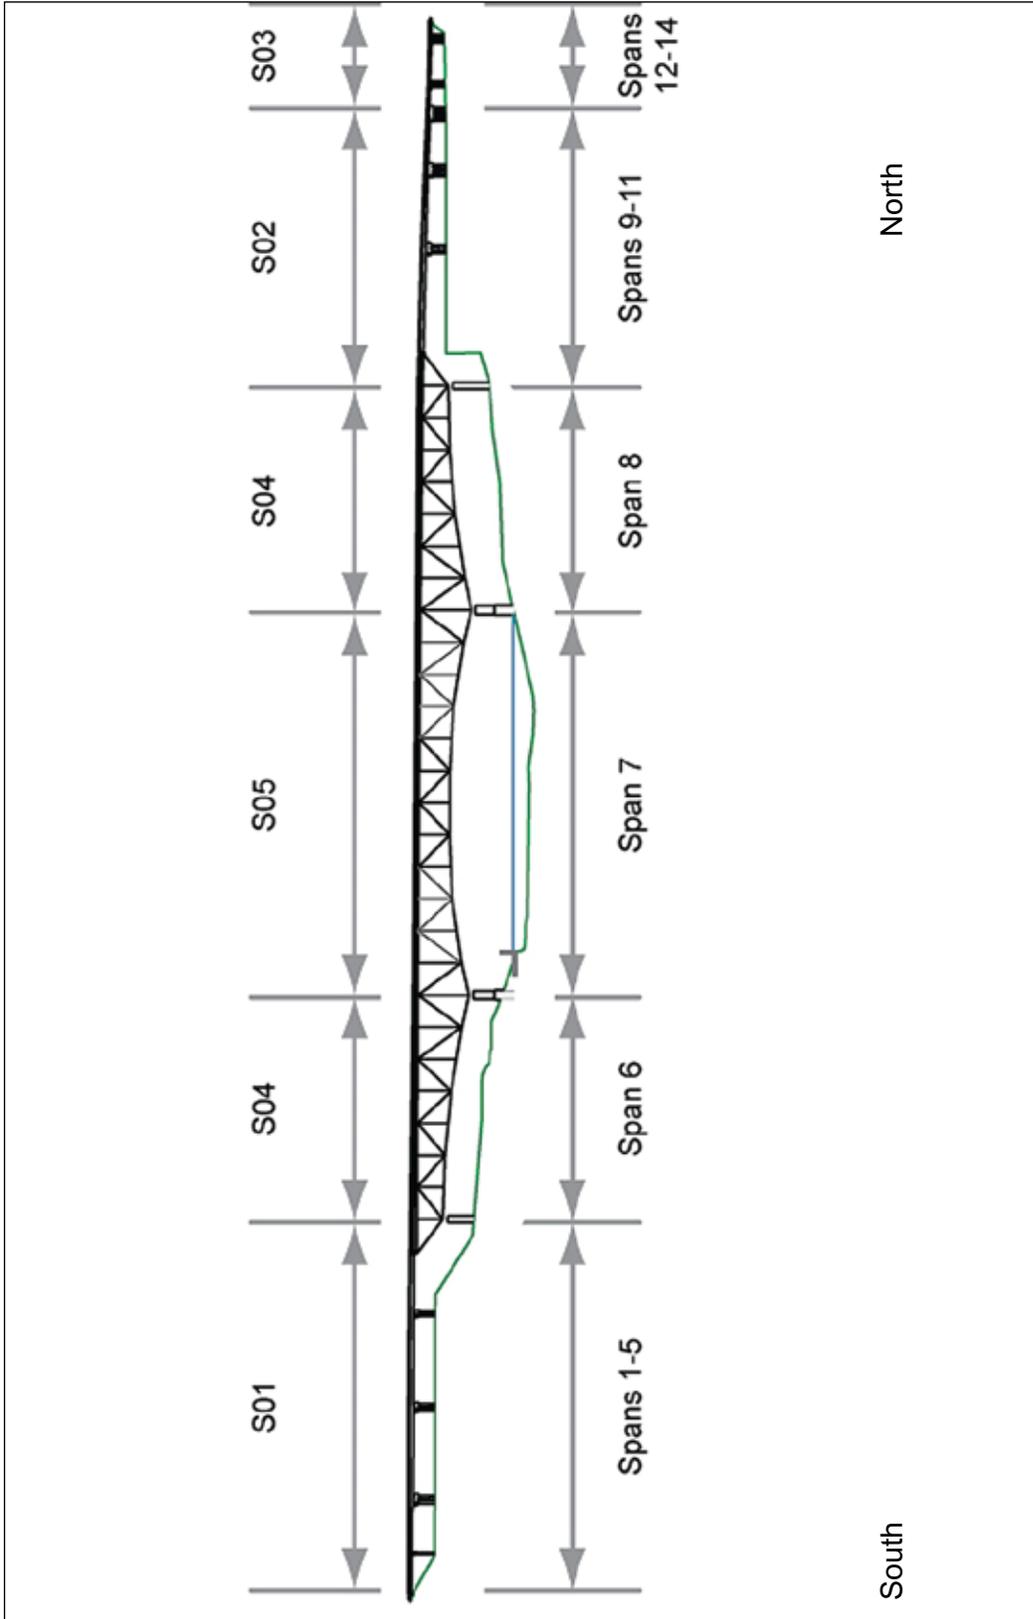
The 1995 load rating was based on a BARS analysis that calculated the inventory and operating ratings for three critical sections of the bridge: S01, representing the south approach spans (spans 1-5); S02, representing the north approach spans (spans 9-11); and S03, representing the far north approach spans (spans 12-14). (See figure 18.) The dead load used in the rating analysis was 358 pounds per linear foot for critical sections S01 and S02 and 47 pounds per linear foot for critical section S03.

Figure 18. Critical bridge sections used for 1995 load rating, approach spans designated S01, S02, and S03. (Source: Adapted from Mn/DOT graphic)
