*Transportation Pooled Fund Project 5(165)*

**DEVELOPMENT OF DESIGN GUIDE FOR THIN AND ULTRA-THIN CONCRETE  
OVERLAYS OF EXISTING ASPHALT PAVEMENTS**

*TASK 1 REPORT:*

**COMPILATION AND REVIEW OF EXISTING  
PERFORMANCE DATA AND INFORMATION**

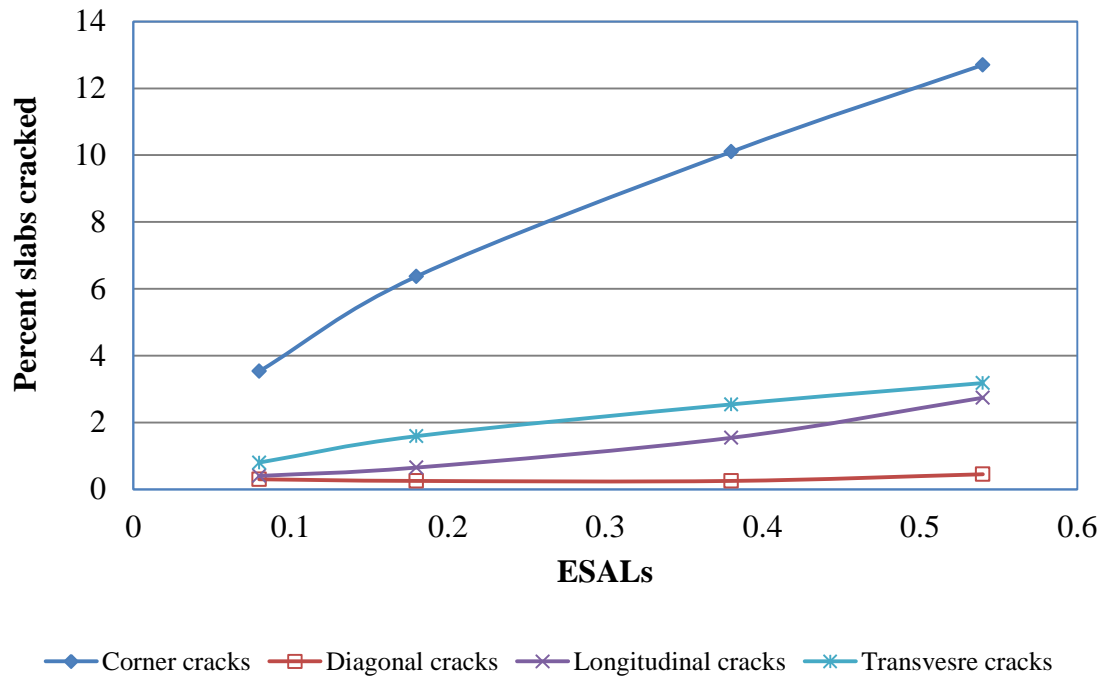
Figure 43: Distresses with respect to ESALs.

**Distress data:** The performance of this intersection indicates a successful application of whitetopping in the distressed areas that exhibit shoving. This intersection did not have any maintenance performed on it until four years after construction, although distresses were observed. Table 33 presents the distress summary of the intersection from 2002 to 2004. Figure 43 presents the trends of the cracks with respect to the ESALs. It may be noted that more than half of the distressed panels appear to be in areas where the concrete inlay was bonded directly to the underlying brick pavers. The debonding rate for this intersection has consistently been five percent for each of the three years surveyed.

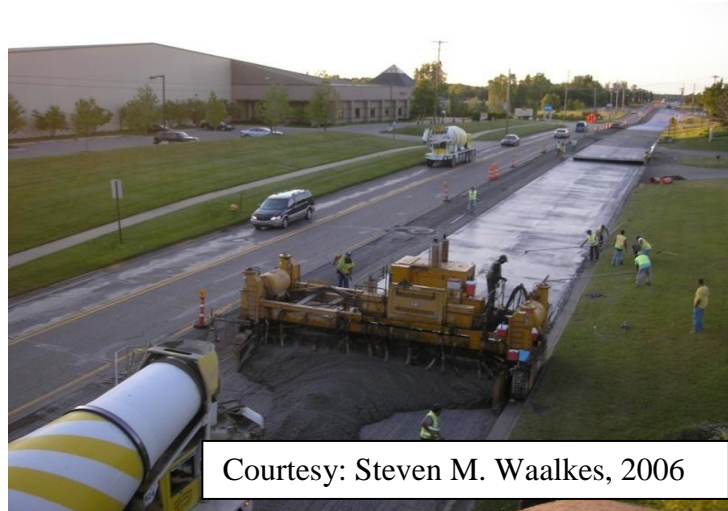
Figure 47: Condition of the original HMA layer at the time of construction.

**Background:** This whitetopping project is 33,000 yd<sup>2</sup>. The original pavement was constructed during the 1960's followed by multiple HMA overlays until 2006 when the pavement was suffering rutting at the intersection approaches and some low severity thermal cracks. There may have been some other isolated distresses, but there was no fatigue cracking. The top layer was also worn and oxidized. Figure 47 shows the HMA layer condition before the construction of the Patterson Avenue project.

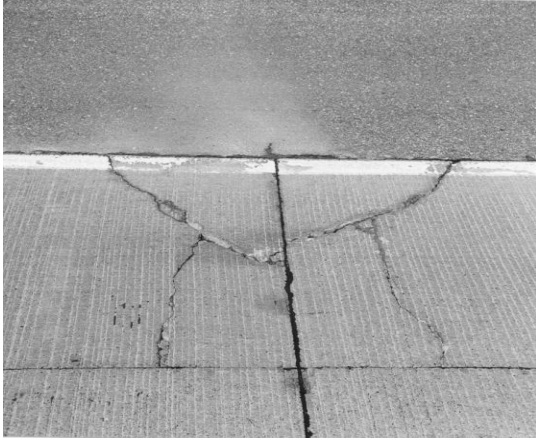
Many of these sections also exhibited transverse cracks but these cracks were typically either reflection cracks or secondary cracks that developed from corner cracks. See Figure 47. Although, there are instances when transverse cracks developed independently of the presents of other cracks, as shown in Figure 49.

a.) Development from corner cracks.    b.) Development independent of other cracking.

Figure 49: Transverse crack development in overlays  $\leq 4$  in.
