Early Performance of Concrete Pavement Overlays in Minnesota

15th Annual TERRA Pavement Conference
February 10, 2011

Tom Burnham, P.E.
Minnesota Department of Transportation

Early PCC Overlay Performance in Minnesota

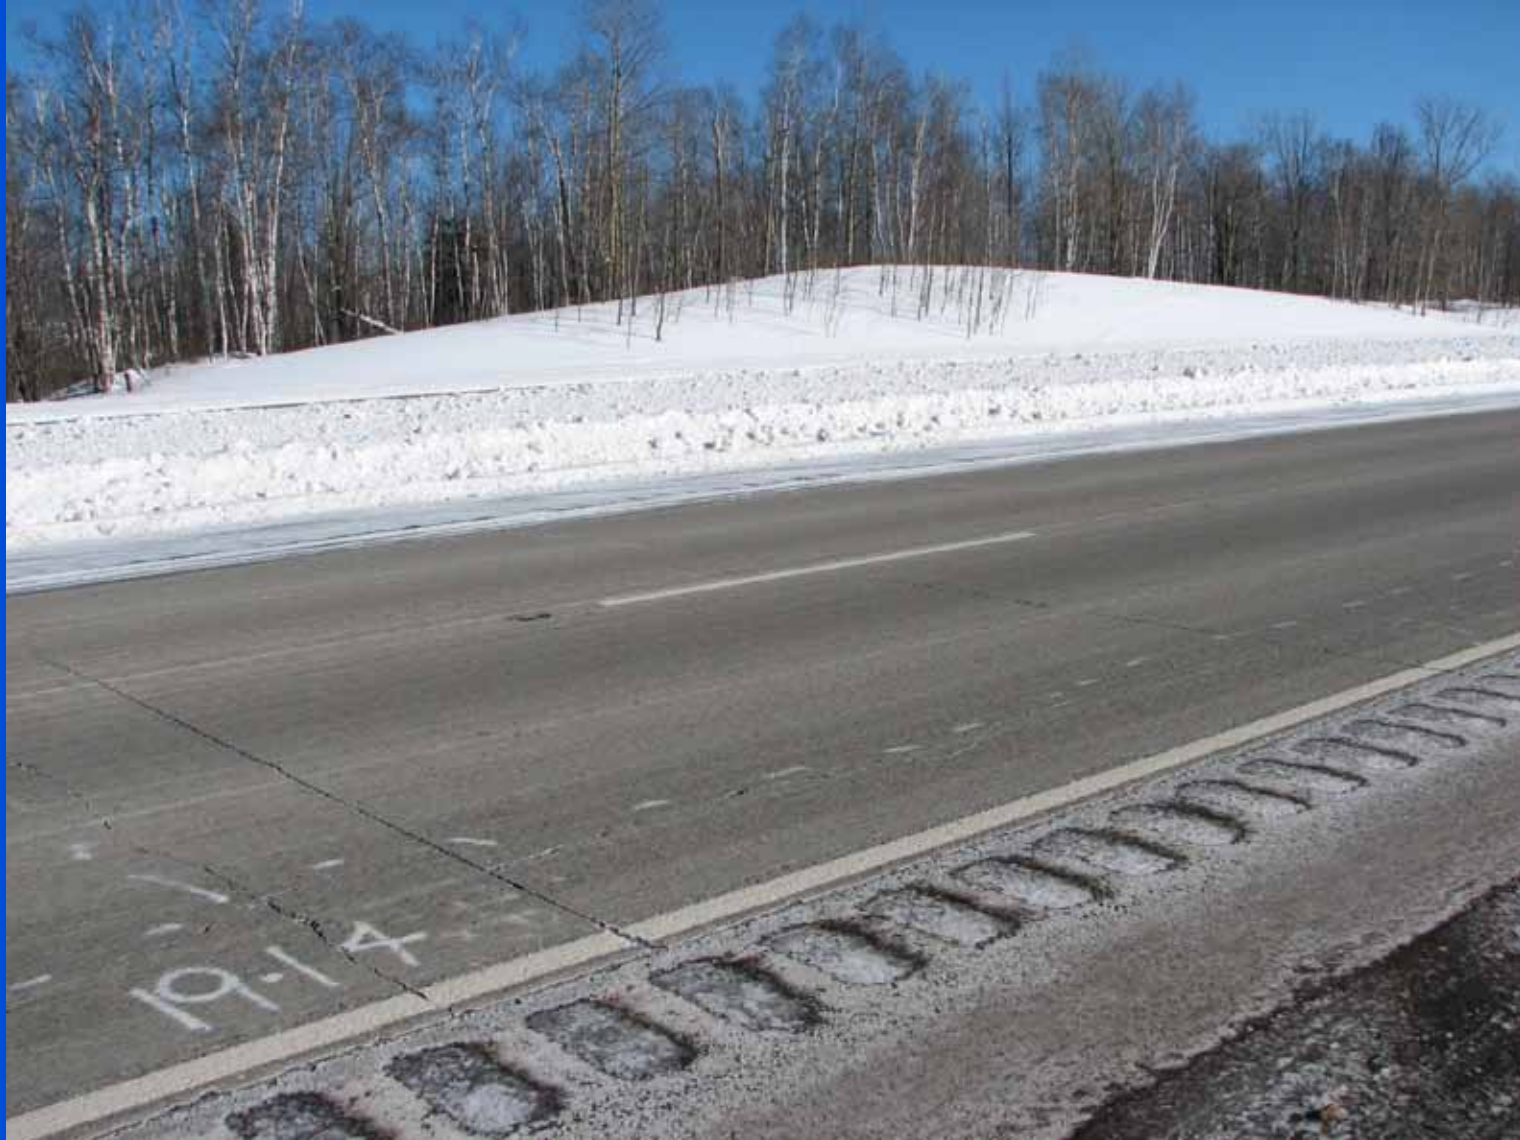
TH 53 Twig Southbound, Thin UBOL

- Early Performance = fair
 - Numerous transverse cracks within 6 months
 - Corner and longitudinal cracks now progressing

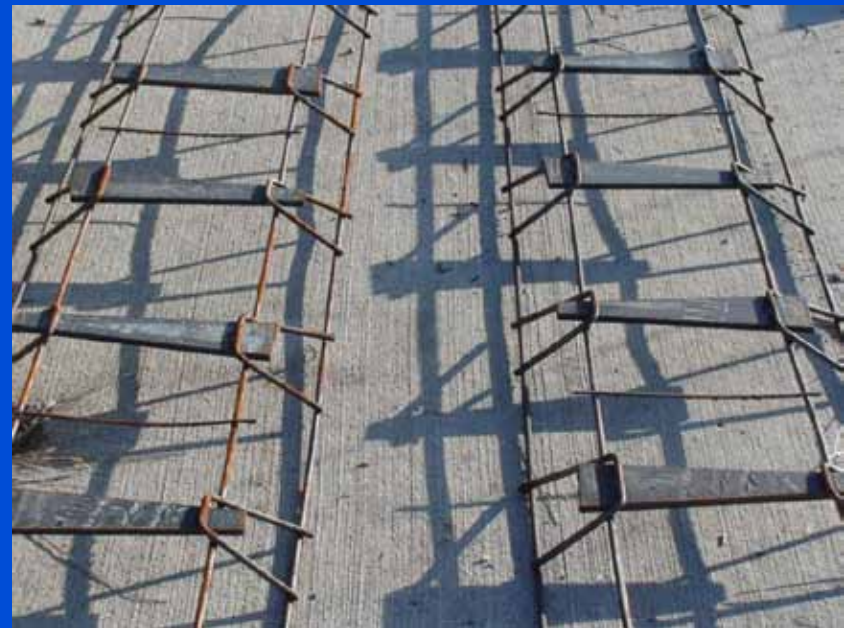
MnROAD Cell 614, Thin Whitetopping

- Design Details:
 - Thickness = 6"
 - 12'L x 6'W panels
 - Remaining HMA thickness = 7"
 - Flat dowels (1' c. to c. spacing)
 - Unsealed joints
 - I-94 traffic

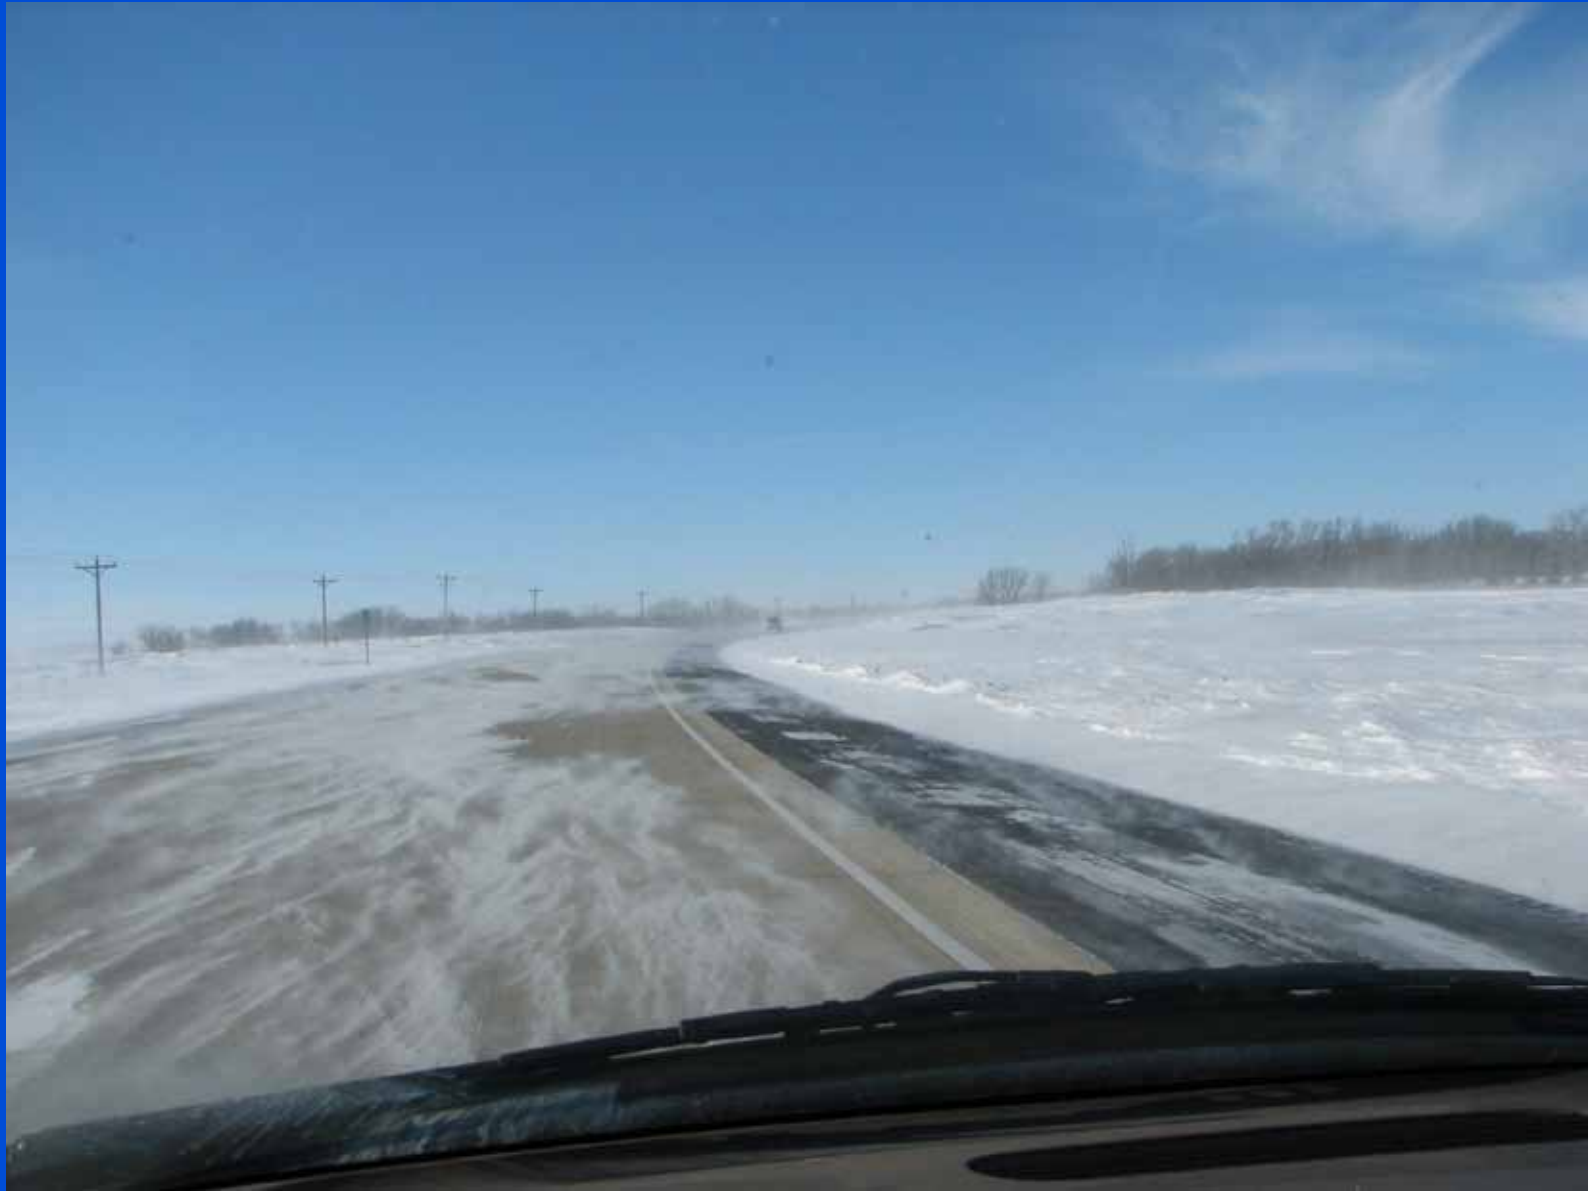
TH23 Marshall, Whitetopping

- Design Details:
 - Constructed 2009/2010
 - 8.3 miles
 - Thickness = 7.5"/8.5"
 - Average milling depth = 3"
 - 15'L x 13/14'W panels
 - 11 dowels across joints
 - Sealed joints
 - Heavy truck traffic
- Early Performance = Very good?
(Could not safely evaluate due to weather conditions)

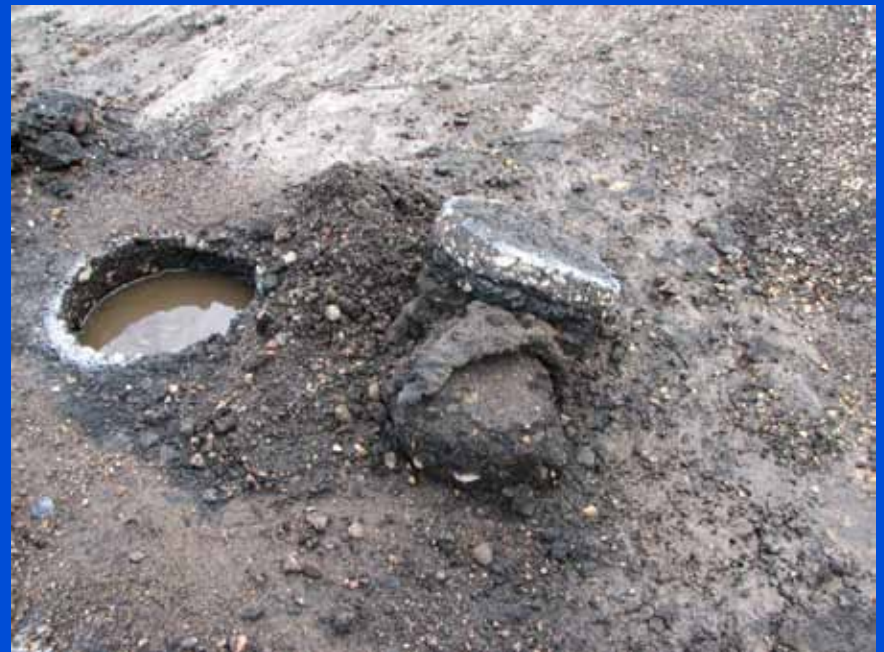
TH 56 West Concord, Thin Whitetopping

- Early Performance: Very Good
 - Some construction issues at joints
