1. Report No. MN/RC 2017-XX	2.	3. Recipients Accession No.	
4. Title and Subtitle Effective Long Lasting Partial Depth Joint Repairs for Challenging Conditions – Installation Summary		5. Report Date May 2018

Report for Effective Long-Lasting PCC Partial Depth Joint Repairs for Challenging Conditions

Installation through 1st Year Performance

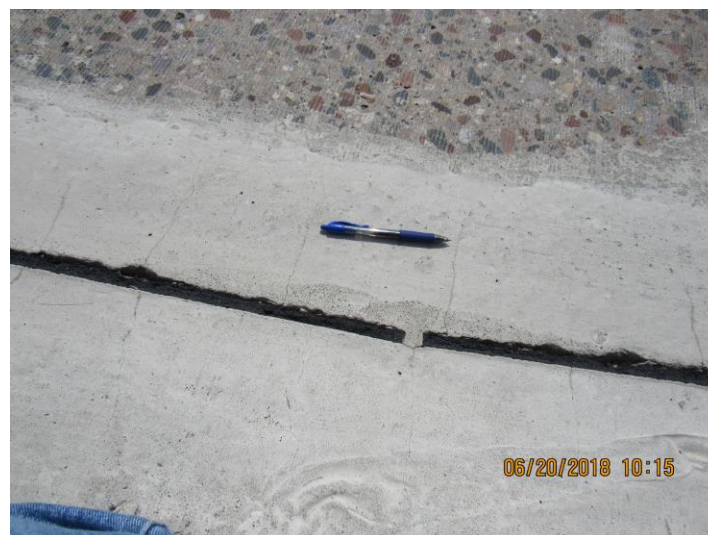
During the first-year review, the patches were exhibiting minor shrinkage cracks but no signs of further distress. The image below shows the general condition of the patches in Cell 94001. Each of the patches within Cell 94001 received a rating of 4.

Figure 5.2 Cell 94001 – General patch condition, minor shrinkage cracks (Rating – 4)

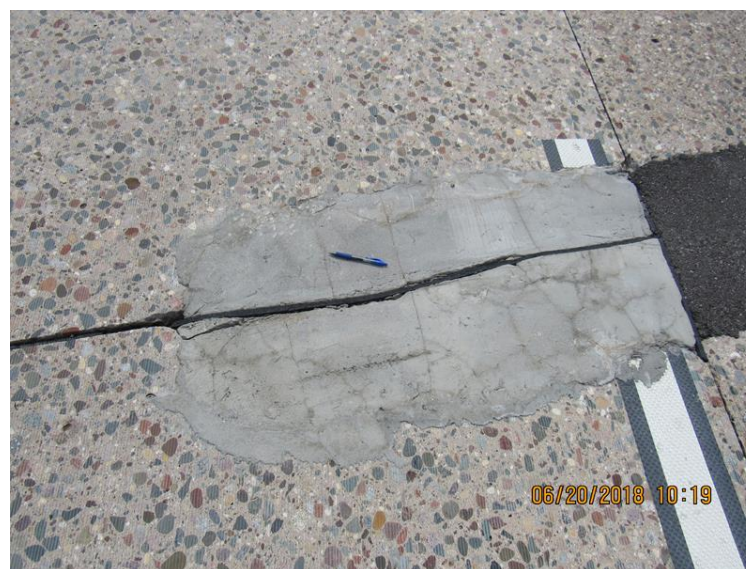
It was noted during the first-year review that the patches had developed some fine linear cracks but were still fully intact. These patches were given a rating of 3. Figure 5.4 shows the general condition of the patches in Cell 94002 (A).

Figure 5.4 Cell 94002 (A) – General patch condition, linear cracks present (Rating – 3)

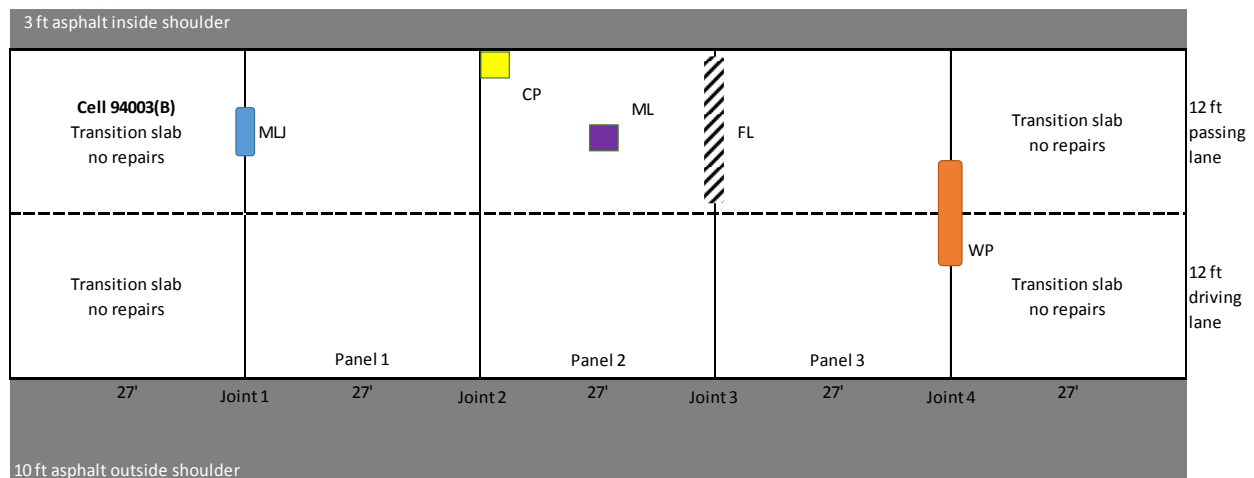
Figure 5.7 Patch Layout for Cell 94003 (B) – Western Material and Design, CE 700 HPC

The passing lane was sand blasted with the exception of the FL and WP repairs. The driving lane for the WP repair was sand blasted. CE 700 HPC is a 3-part system. Before mixing, the material was heated to approximately 70 to 80 degrees Fahrenheit. Part A (liquid polymer, 4 gallons) and Part B (liquid polymer, 4 gallons) are poured into the mixer and mixed for approximately 3 minutes. Then Part C (aggregate, 12 50-pound bags) was added. The supplier utilized their own mixer which was a “screw” type mixer. The mixer attached to the front of a skid steer and was used to mix as well as place the concrete in the patches. The material is finished with traditional concrete tools. Aggregate was broadcast onto the surface for added slip resistance. Cardboard was used to re-establish joints. The patches were not pre-wetted and were not cured.

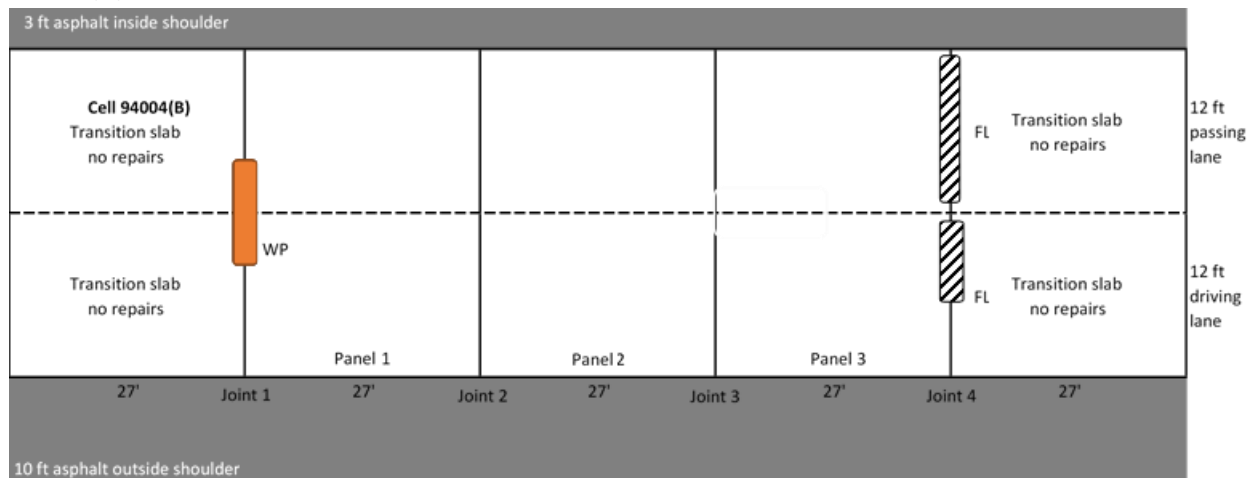
Figure 5.9 Patch Layout for Cell 94004 (B) – Crafc0, HP Concrete Cold Patch

The patches in Cell 94004 (B) did not show any signs of distress and no photographs were taken during the first-year review. The patches were rated 4.

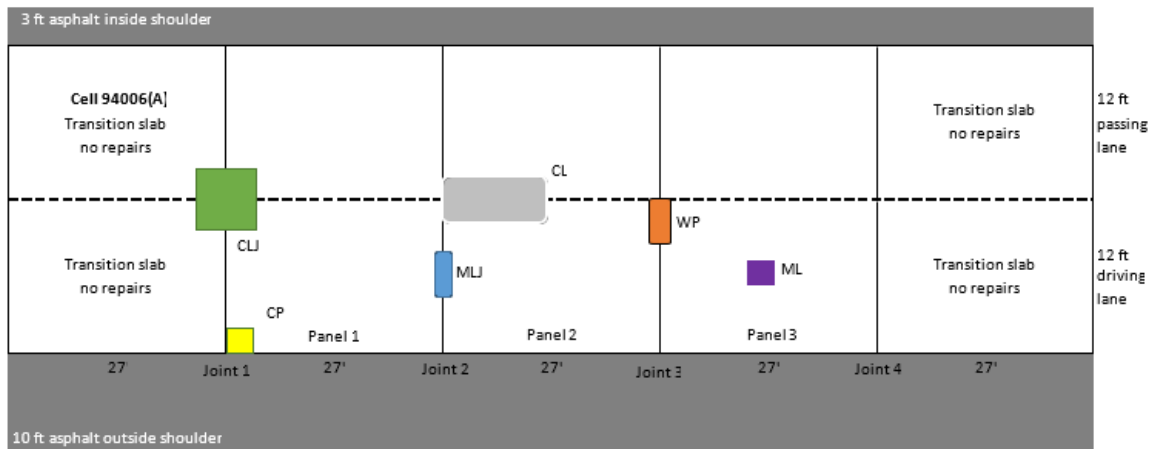
Figure 5.11 Patch Layout for Cell 94006 (A) – Five Star Products, Rapid Surface Repair Easy Mix

The driving lane WP and ML patches had about 50 percent of the patch material missing during the first-year review and were repaired with the Crafc HP Concrete Cold Patch material. These patches were given a rating of 1. The other patches were in generally good condition, with some shrinkage cracks present. However, it was clear to see that the material had set before finishing could be completed. Figure 5.12 shows the general condition of the patches in Cell 94006 (A), which were given a rating of 4.

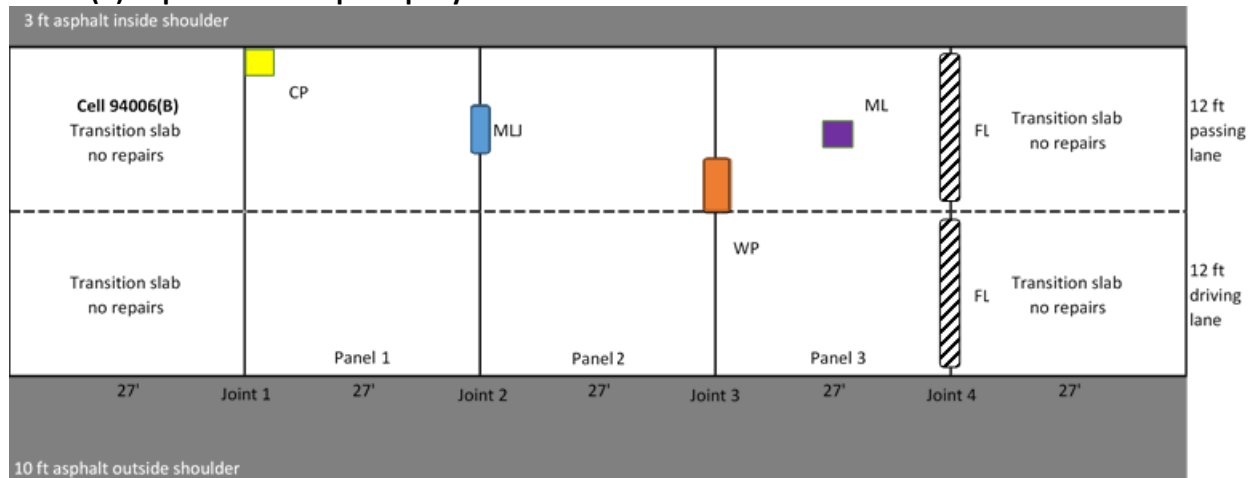
Figure 5.13 Patch Layout for Cell 94006 (B) – Five Star Products, Rapid Surface Repair Epoxy Mix

The passing lane MLJ and driving lane FL patches had over 50 percent of the patches repaired with HMA or the Crafco HP Concrete Cold Patch material. These patches have a rating of 1. The remaining patches were in generally good condition, with some minor linear cracks and debonding developing along the edges. These patches were given a rating of 3.

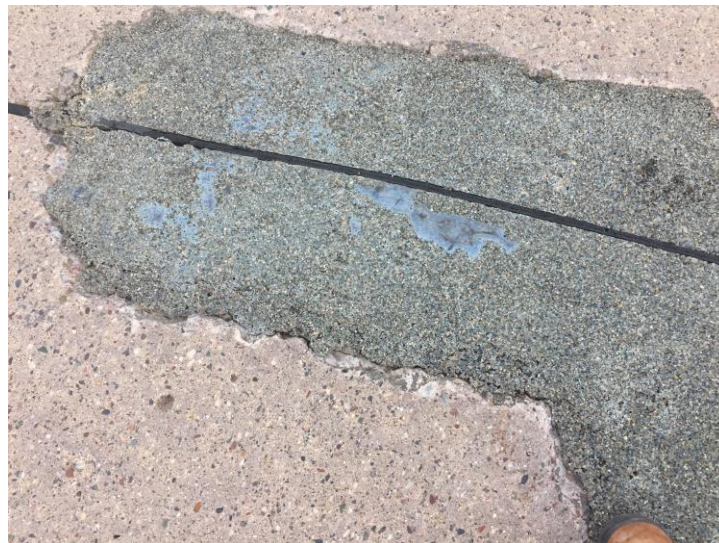
Figure 5.14 Cell 94006 (B) – General patch condition, minor cracks and debonding (Rating – 3)

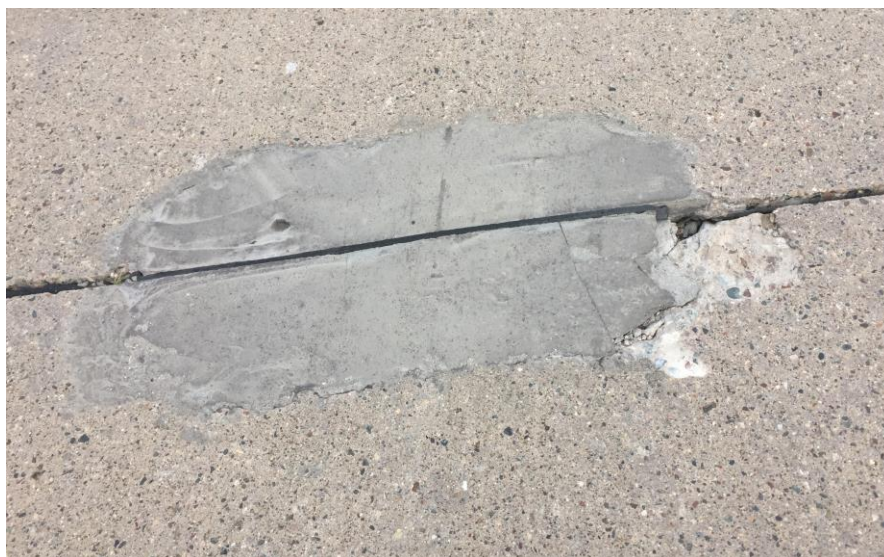
During the first-year review, the patches in cell 94007 generally showed some debonding and missing material along the edges of the patches. The patches with missing material included the passing lane FL, MLJ and WP, and were given a rating of 2. The other patches each got a rating of 3.

Figure 5.16 Cell 94007 – General condition, minor cracks and missing material (Rating – 2)

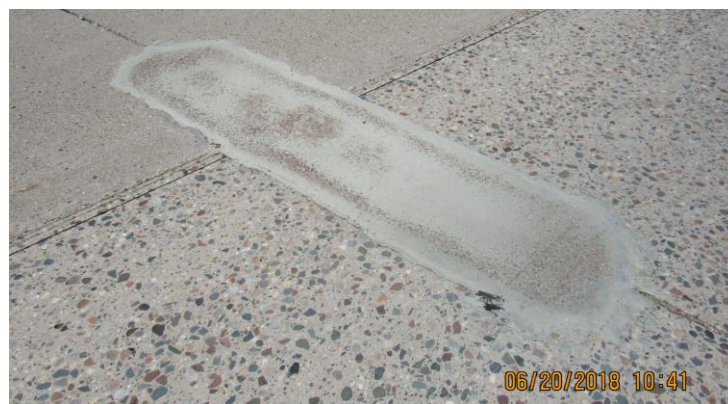
The patches were exhibiting no signs of distress during the first-year review and were rated 4.

Figure 5.24 Cell 94010 – General patch condition (Rating – 4)

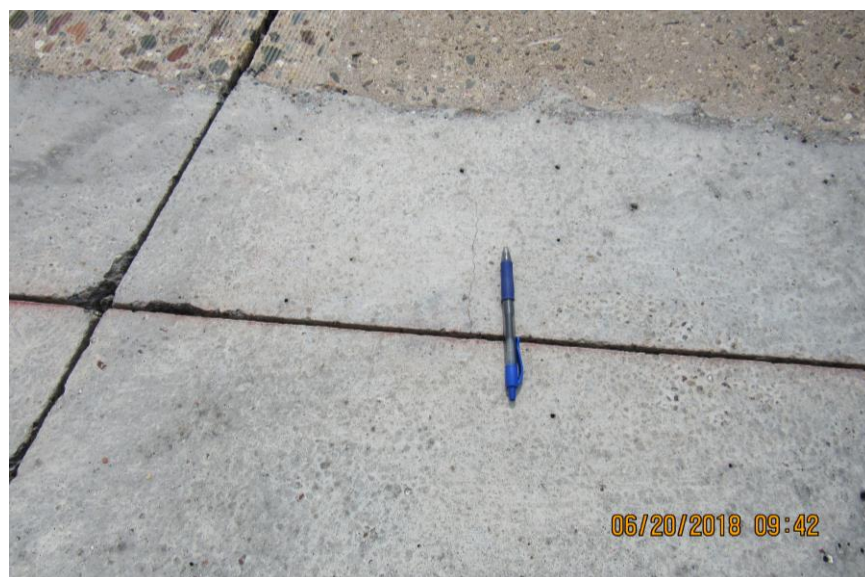
The patches were generally not exhibiting any signs of distress during the first-year review. Some patches developed shrinkage cracks. All of the patches in Cell 94011 were rated as 4.

Figure 5.26 Cell 94011 – General patch condition (Rating – 4)

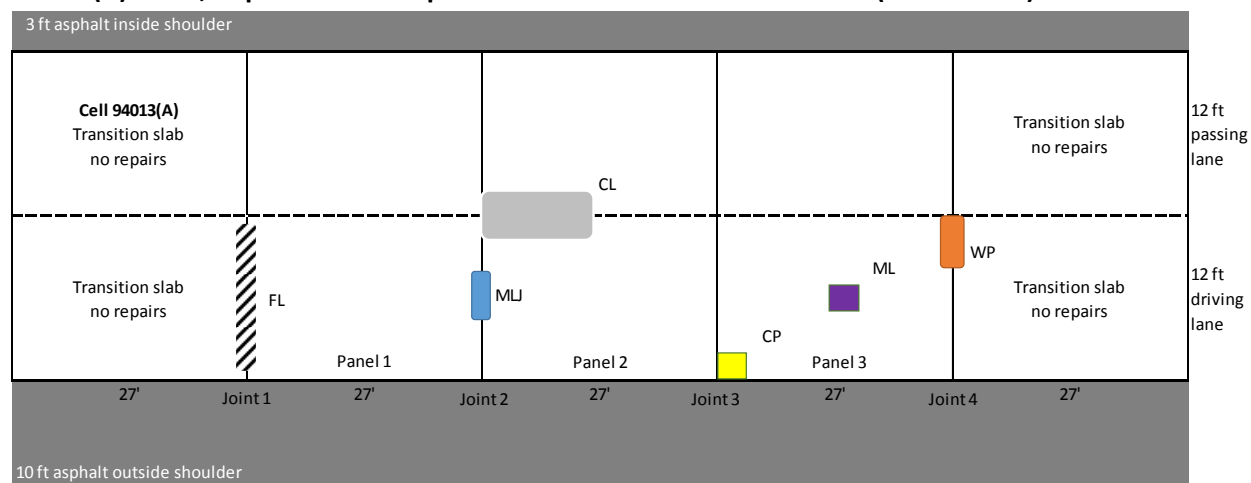
Figure 5.29 Patch Layout for Cell 94013 (A) – CTS, Rapid Set DOT Repair Mix and Helix 5-25-Standard BA (Zinc Coated) Fibers

During the first-year review, some of the patches had developed shrinkage cracks and the driving lane WP had a crack along the edge of the patch. Most of the patches were rated 4, but the WP was rated 3.

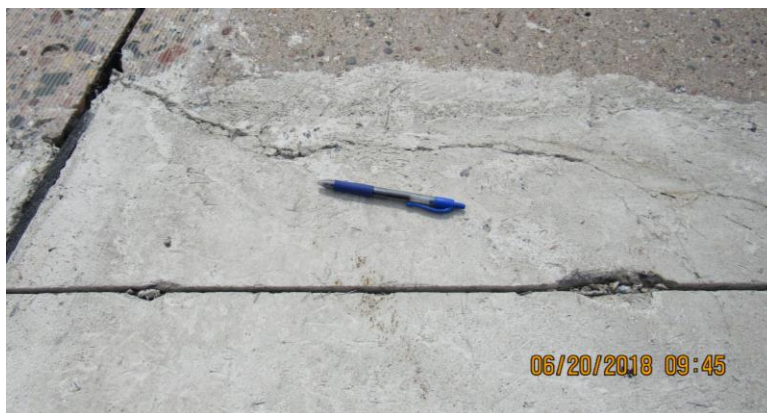
Figure 5.30 Cell 94013 (A) – WP patch, cracking along edge (Rating – 3)

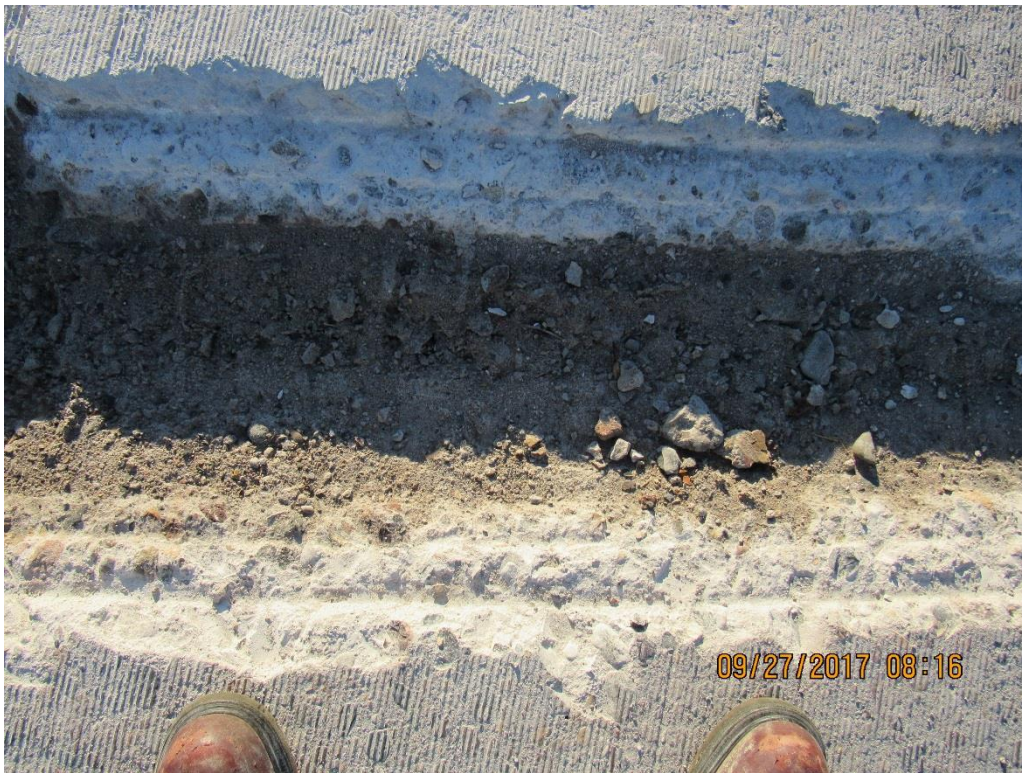
Photograph: Milled Patch

Subject: General patch condition after milling

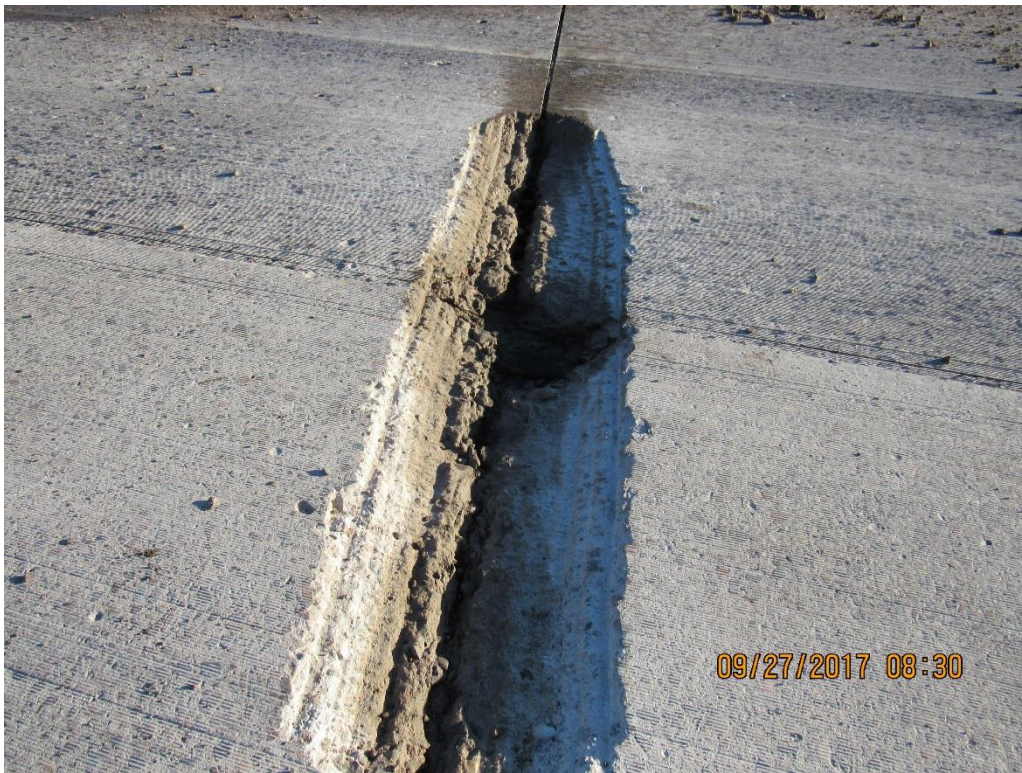
Photograph: Air Blasted Patch

Subject: General patch condition after air blasting

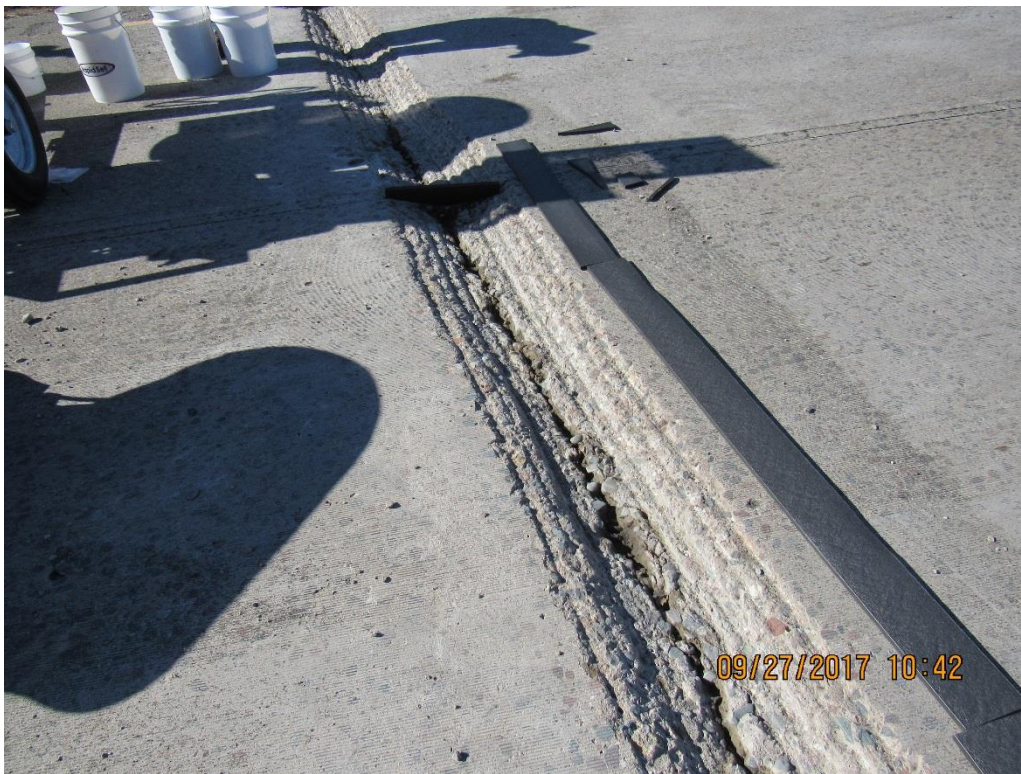
Photograph: Sand Blasted Patch

Subject: General patch condition after sand blasting

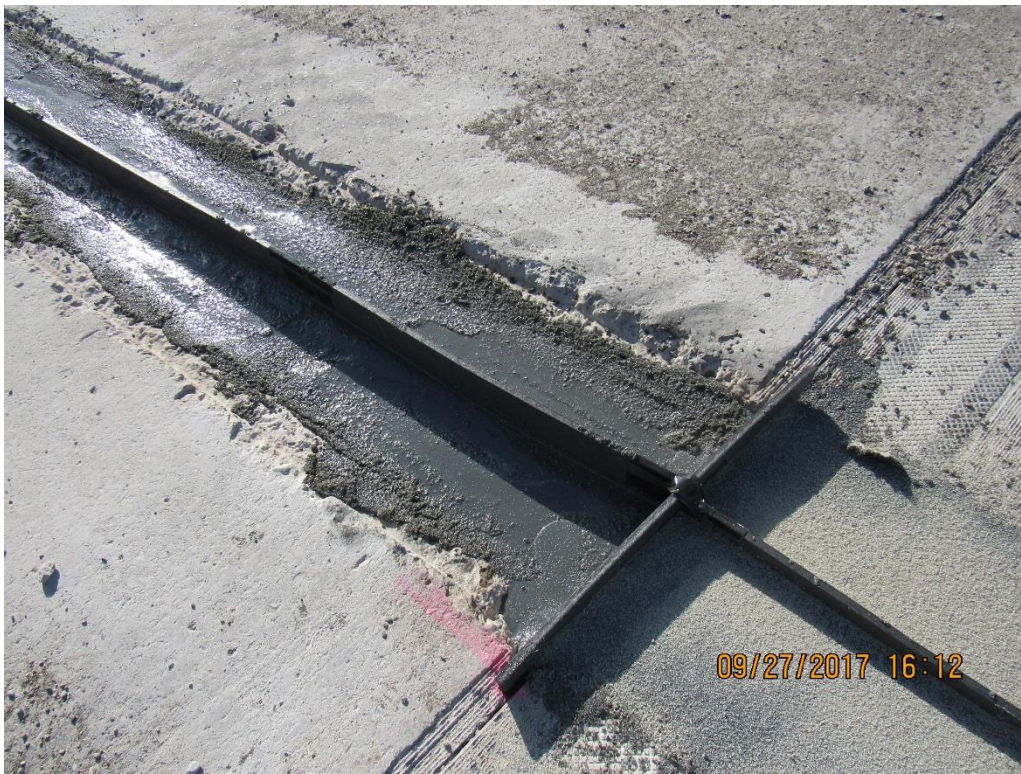
Photograph: 94005 Willamette Valley Company, FastPatch

Subject: Final product (right side has aggregate broad cast)

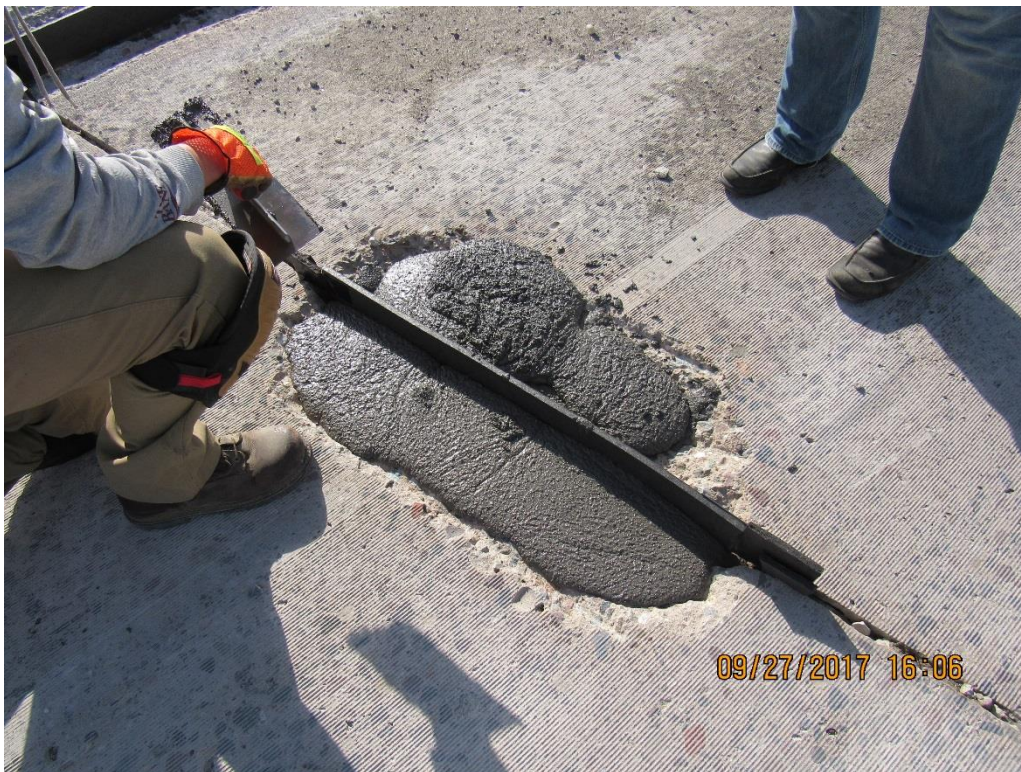
Photograph: 94006 (A) Five Star, Rapid Surface Repair Easy Mix

Subject: First lift had set up

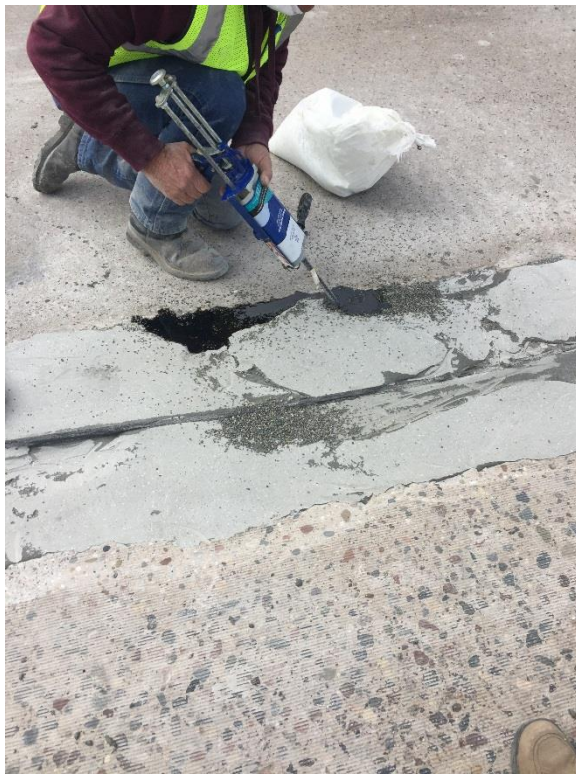
Photograph: 94006 (B) Five Star, Rapid Surface Repair Epoxy Fix

Subject: Small application of previous patch

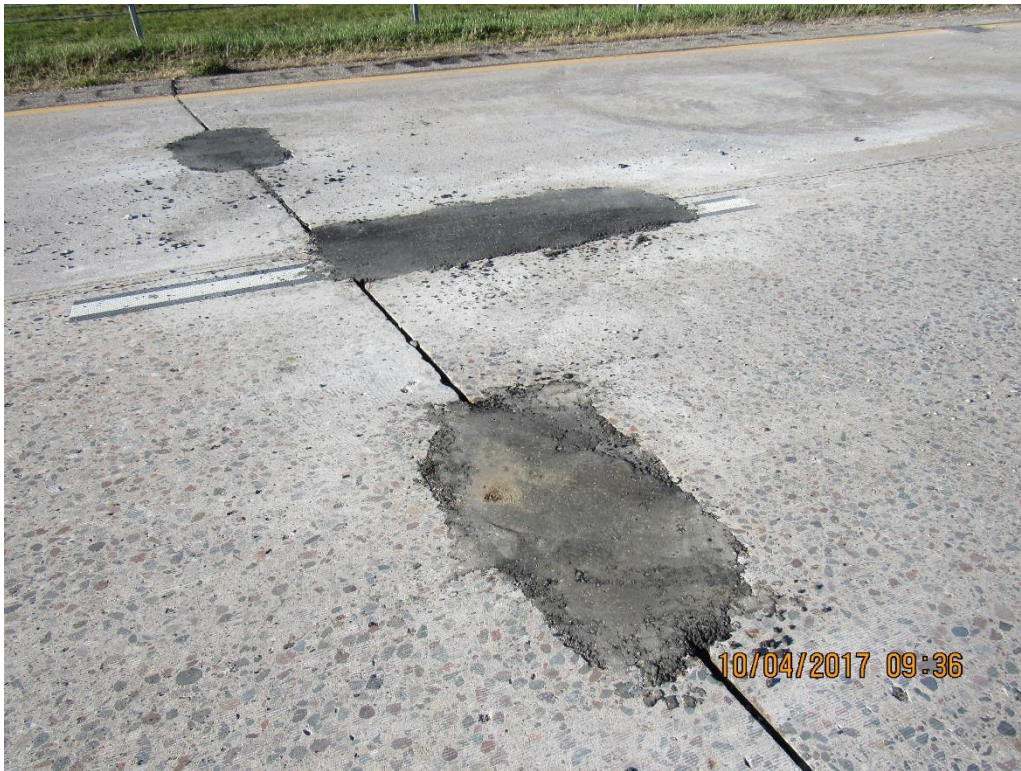
Photograph: 94008 (B) Aqua Patch Road Materials, Aqua Patch

Subject: Patch Material the day after placement

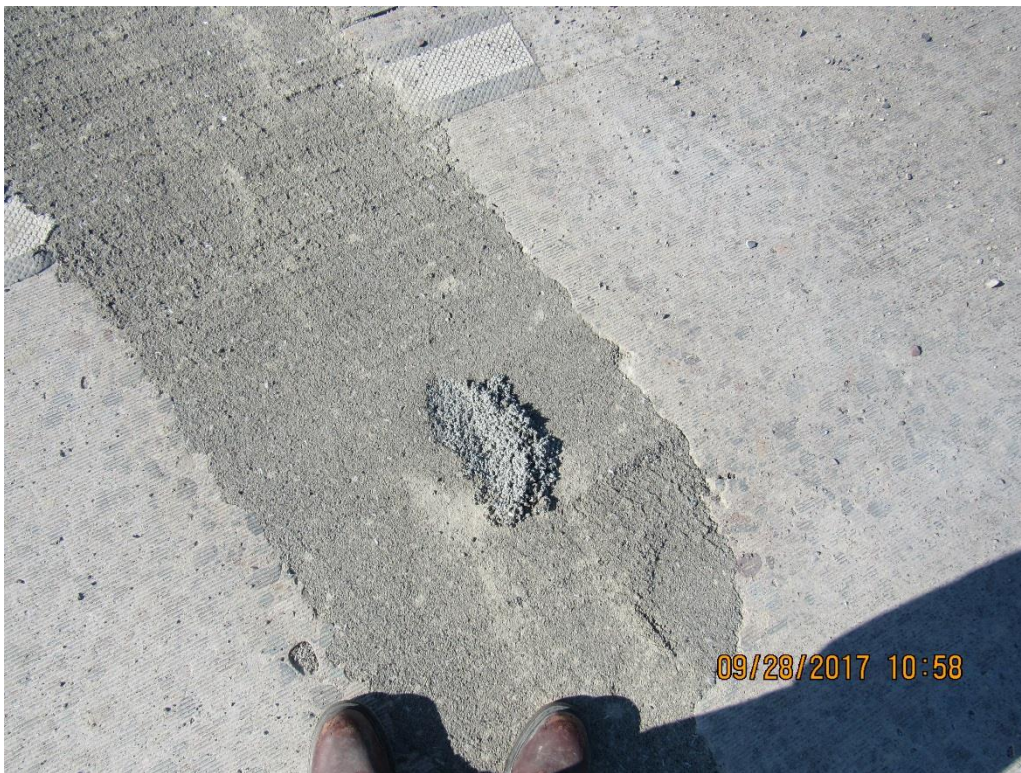
Photograph: 94009 Crafco HP Concrete Cold Patch

Subject: Patch material the day after placement (no traffic)

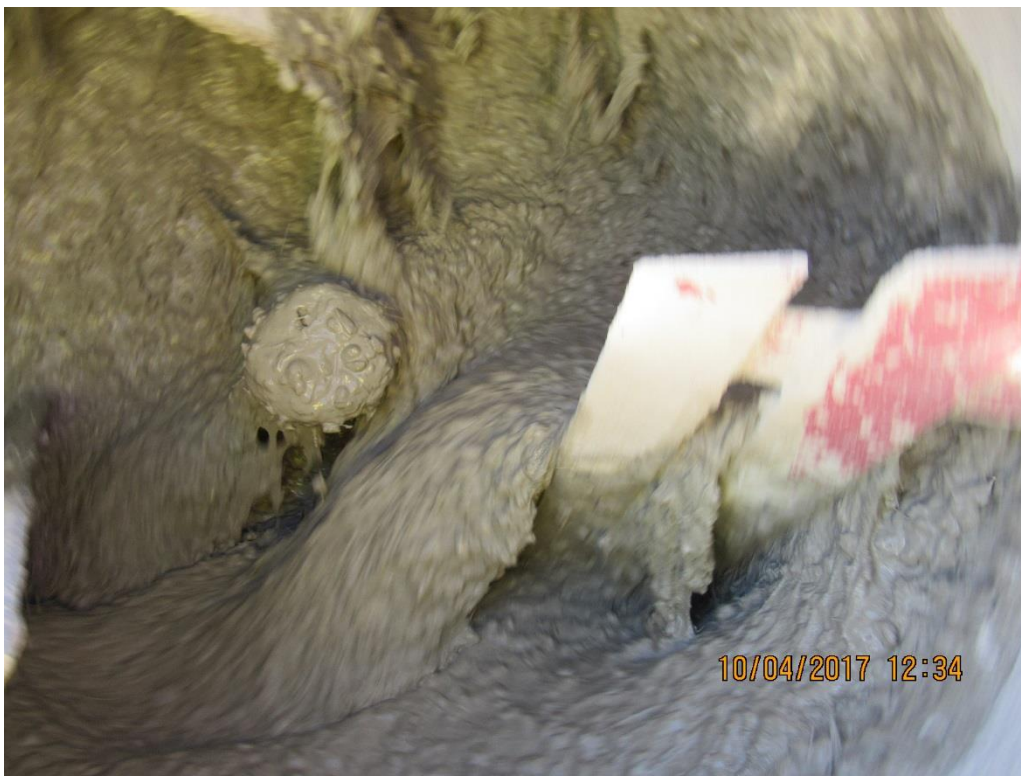
Photograph: 94013 CTS, Rapid Set and Helix Fiber

Subject: Fibers and aggregate mixing

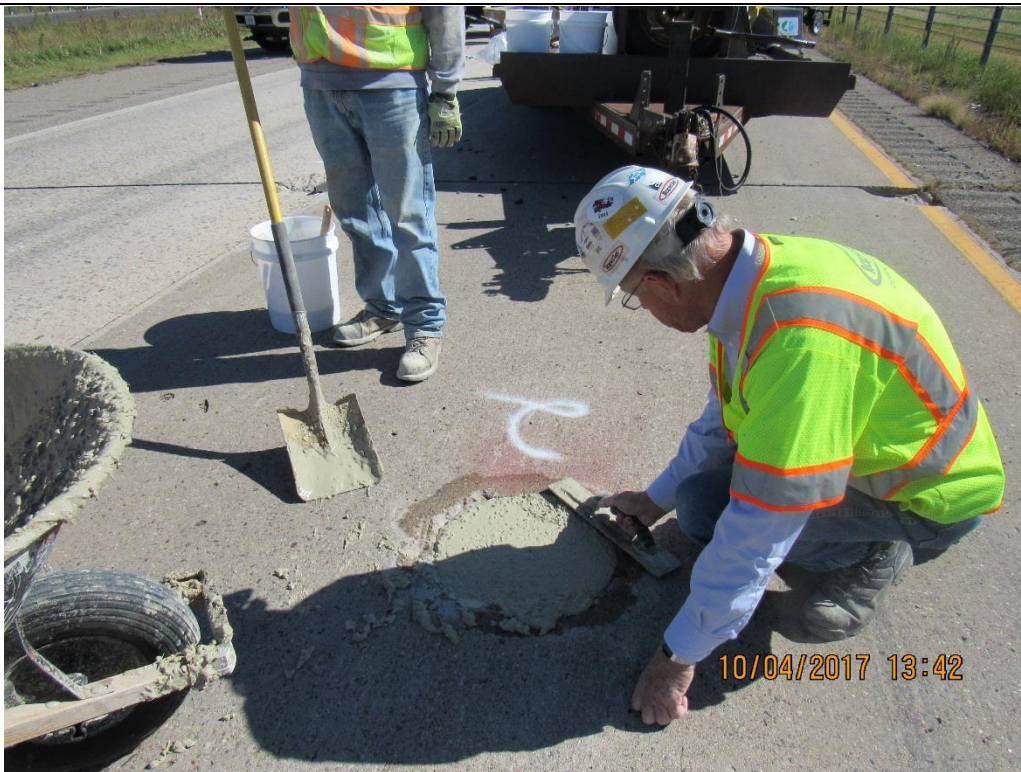
Photograph: 94013 CTS, Rapid Set and Helix Fiber

Subject: Mixing of bagged product, aggregate, and fibers

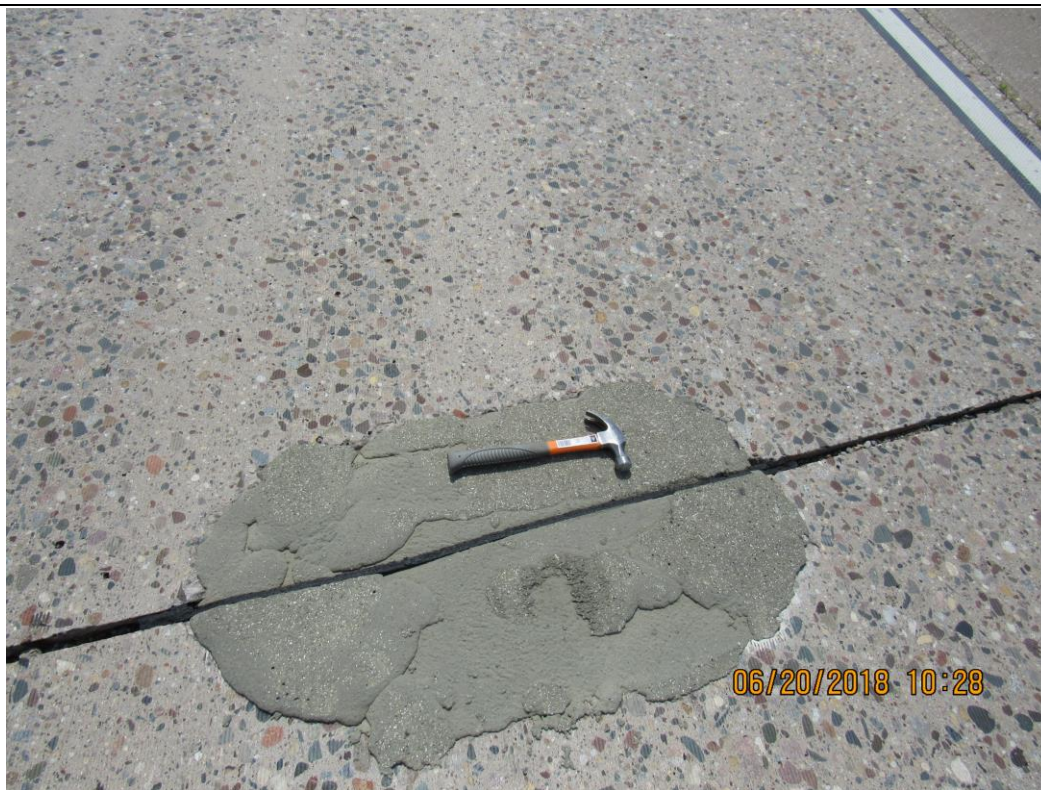
Cell/Patch:	94002 (A)/WP – driving lane	Material: SpecChem, RepCon 928
Date:	6/20/2018	
Condition:	Linear Cracks	
Rating:	3

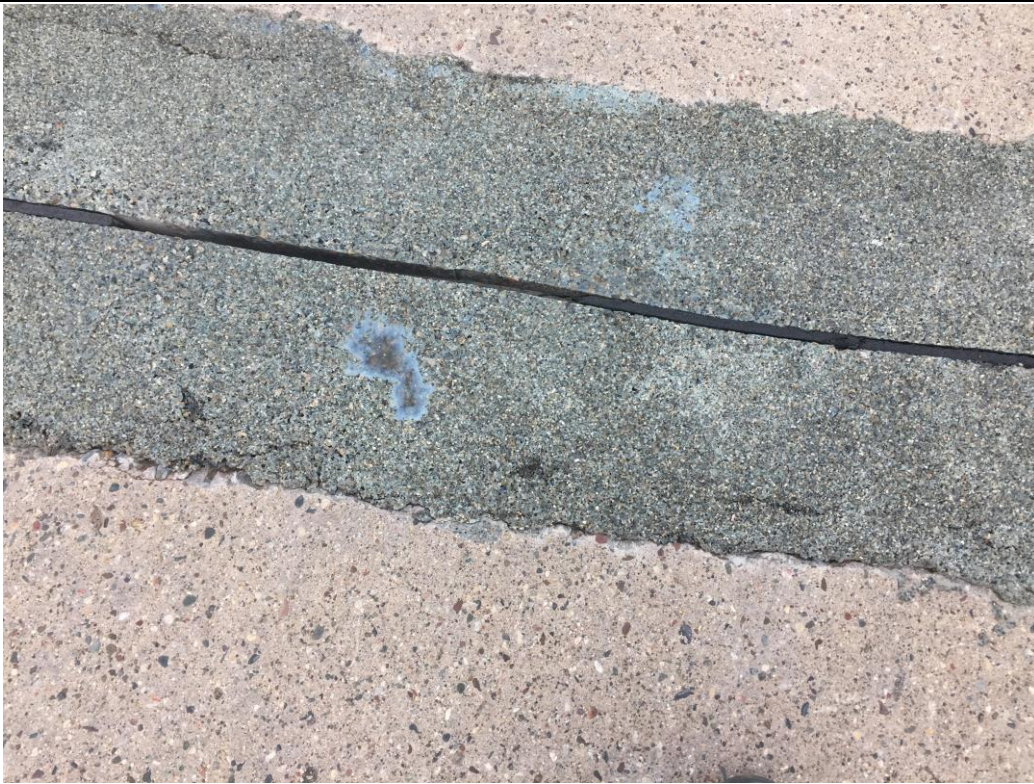
Cell/Patch:	94006 (B)/FL – driving lane	Material: Rapid Surface Repair Epoxy Fix
Date:	9/15/2018	
Condition:	Most of patch has been repaired.	
Rating:	1

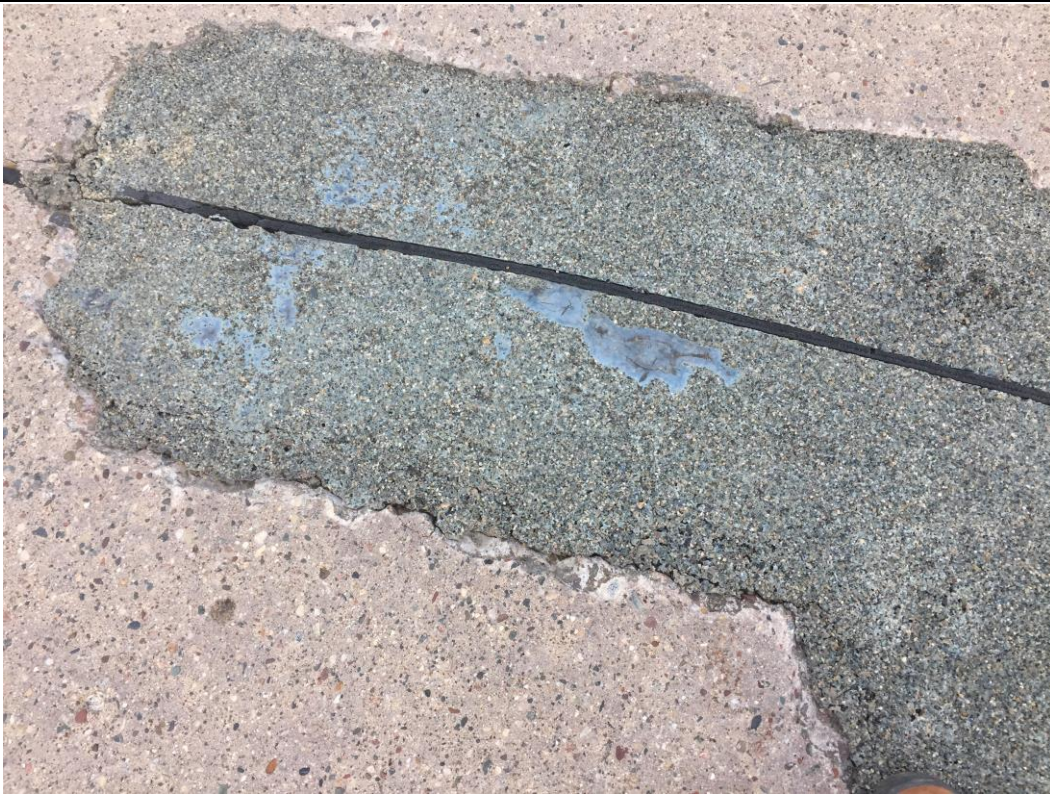
Cell/Patch:	94006 (B)/MLJ – passing lane	Material: Rapid Surface Repair Epoxy Fix
Date:	9/15/2018	
Condition:	50% of the patch is gone, needs repair	
Rating:	1

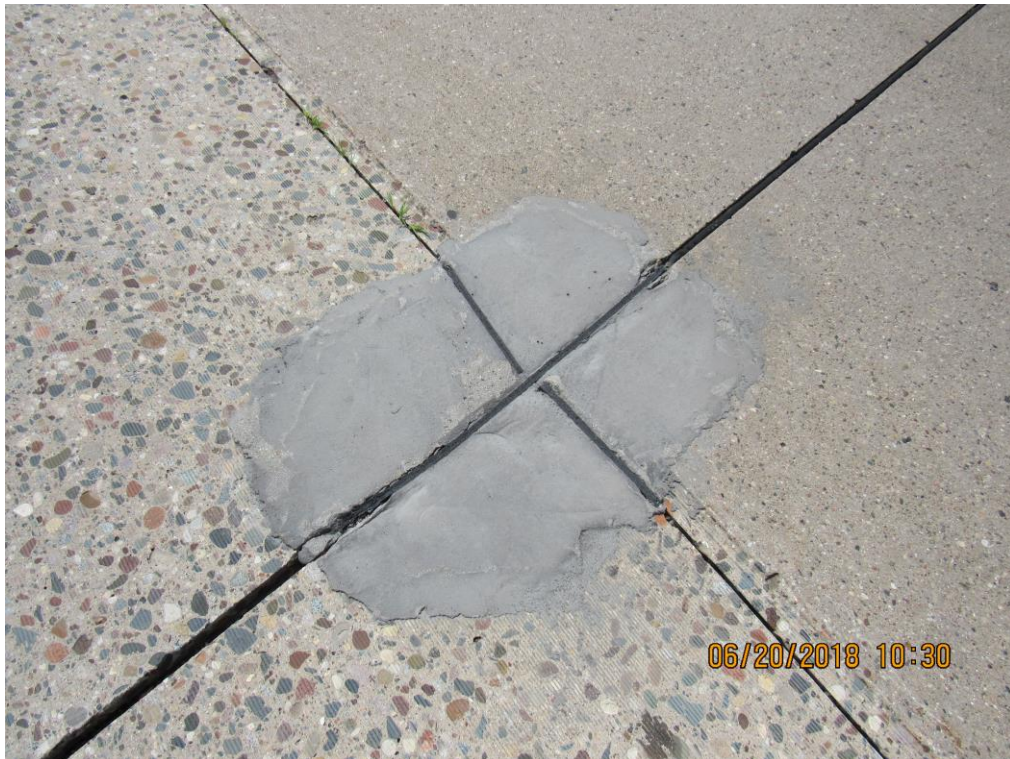
Cell/Patch: 94006 (B)/WP
 Date: 9/15/2018
 Condition: No distress
 Rating: 4

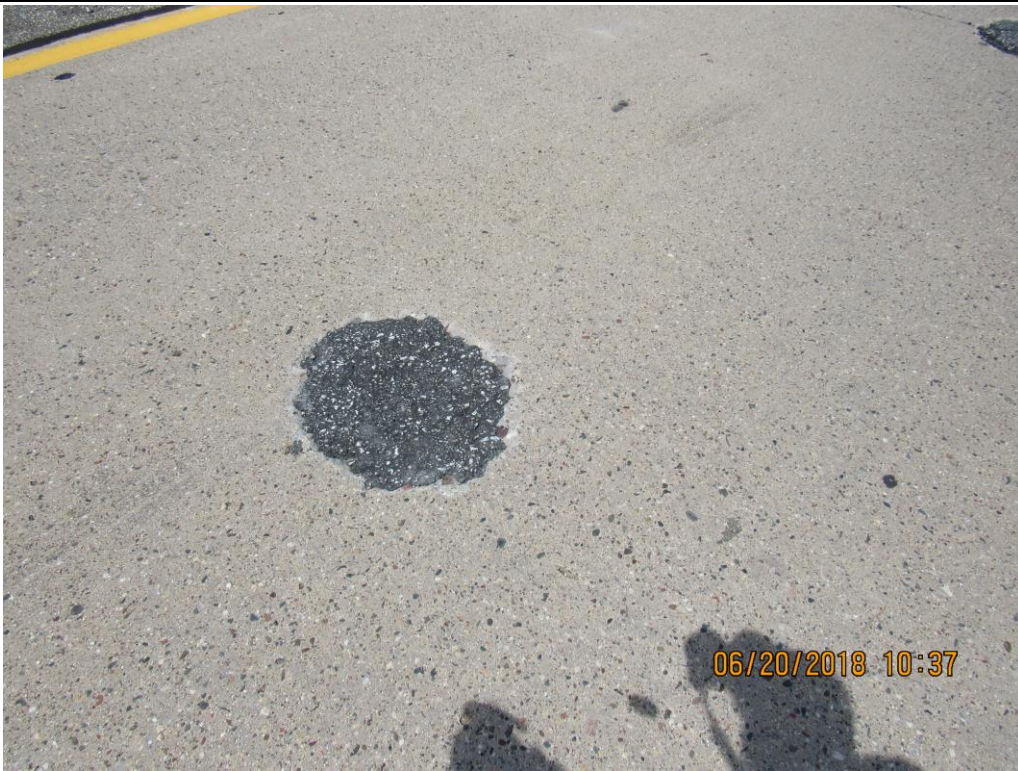
Cell/Patch:	94007/WP	Material: TCC Materials, ProSpec
Date:	9/15/2018	Concrete Patching Mix
Condition:	Less than 50% of patch repaired	
Rating:	2

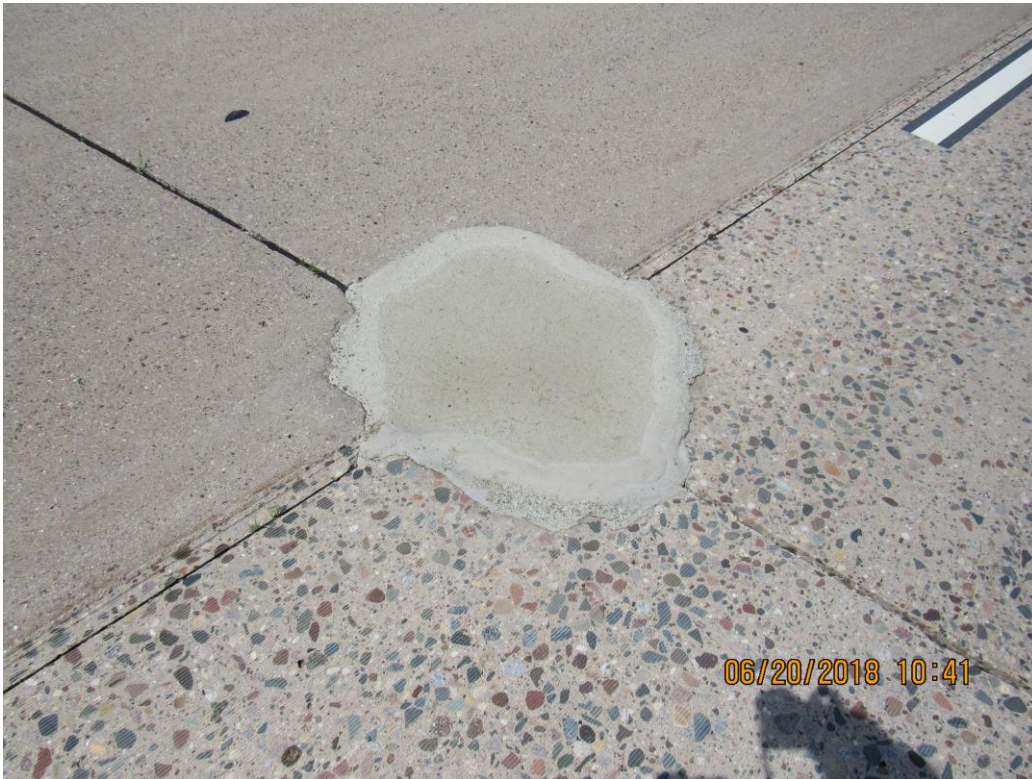
Cell/Patch:	94009/FL – both lanes	Material: Crafc0, HP Concrete Cold Patch
Date:	9/15/2018	
Condition:	No distress, layer of material added to driving lane FL due to depression	
Rating:	4

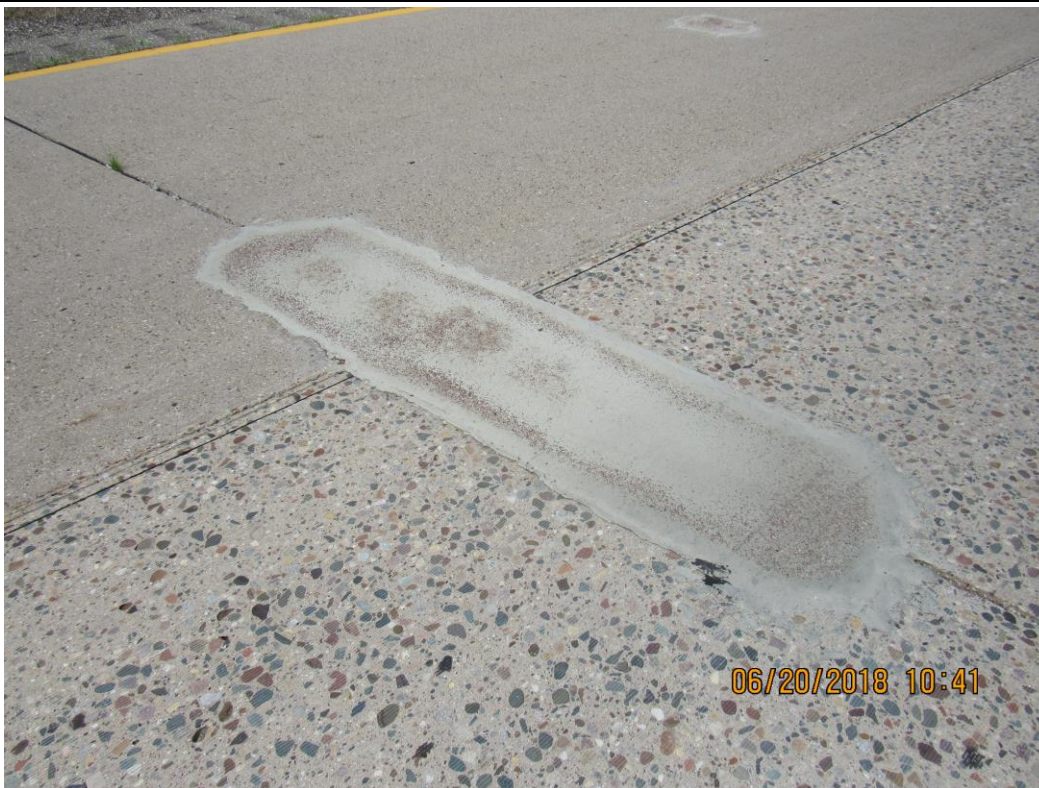
Cell/Patch:	94010/CLJ	Material: Crafc0, Techrete-TBR
Date:	6/20/2018	
Condition:	No distress	
Rating:	4

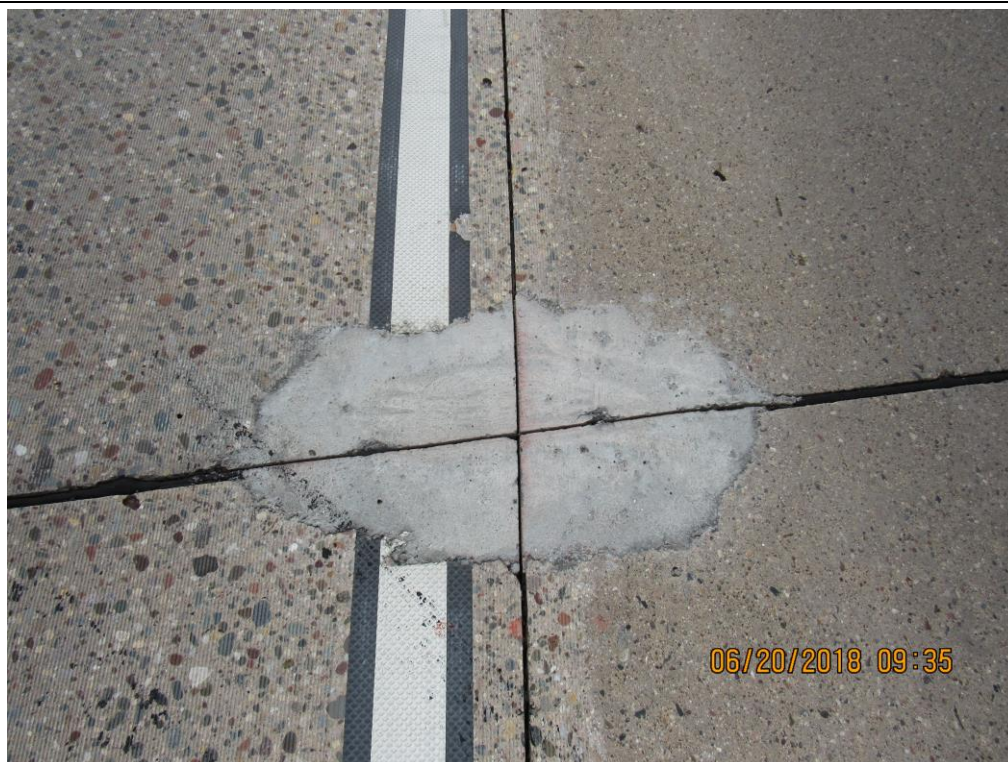
Cell/Patch: 94010/WP
 Date: 6/20/2018
 Condition: No distress
 Rating: 4

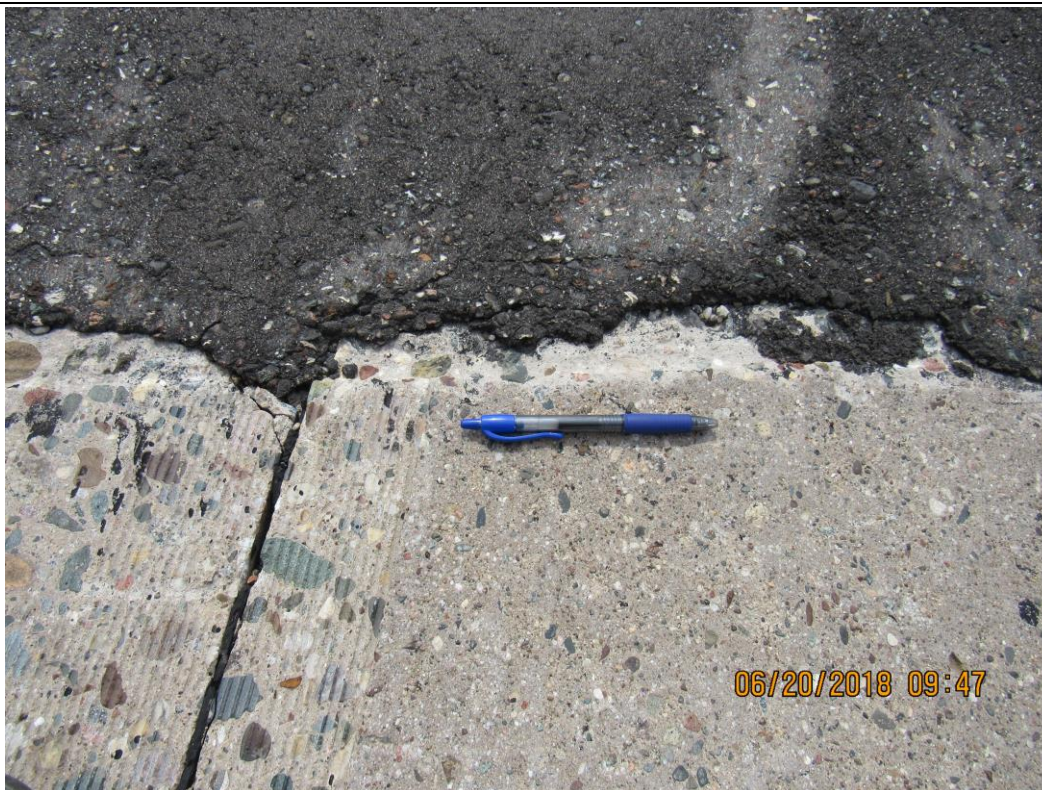
Cell/Patch:	94013 (B)/CLJ	Material: CTS, Rapid Set DOT Repair Mix
Date:	6/20/2018	and Helix 5-25-SS BA (Stainless Steel)
Condition:	Crack near edge of patch	Fibers
Rating:	3

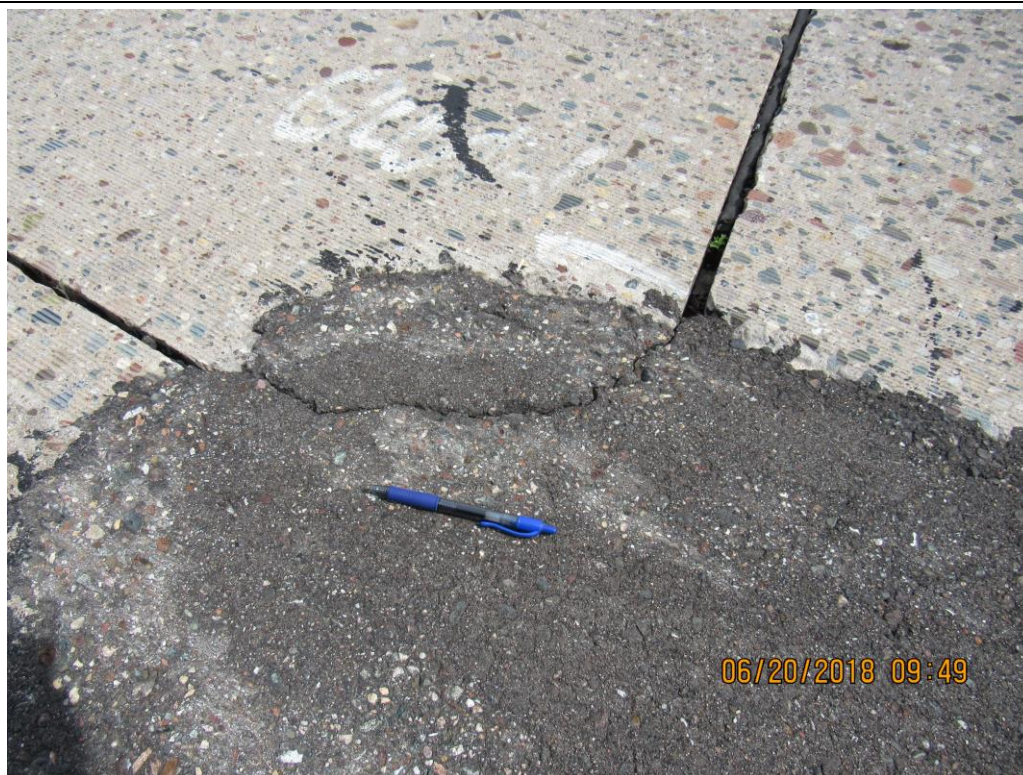
Cell/Patch: 94014/WP

Condition: Edge cracks and some missing material at edges

Rating: NA/Not failed
