MnDOT Contract, No. 1003325, Work Order No. 56

NRRA Long-term Research Project

Performance Benefits of Fiber-reinforced Thin Concrete Pavement and Overlays

Task-2: Second Year Annual Cell Performance Report (2018-2019)

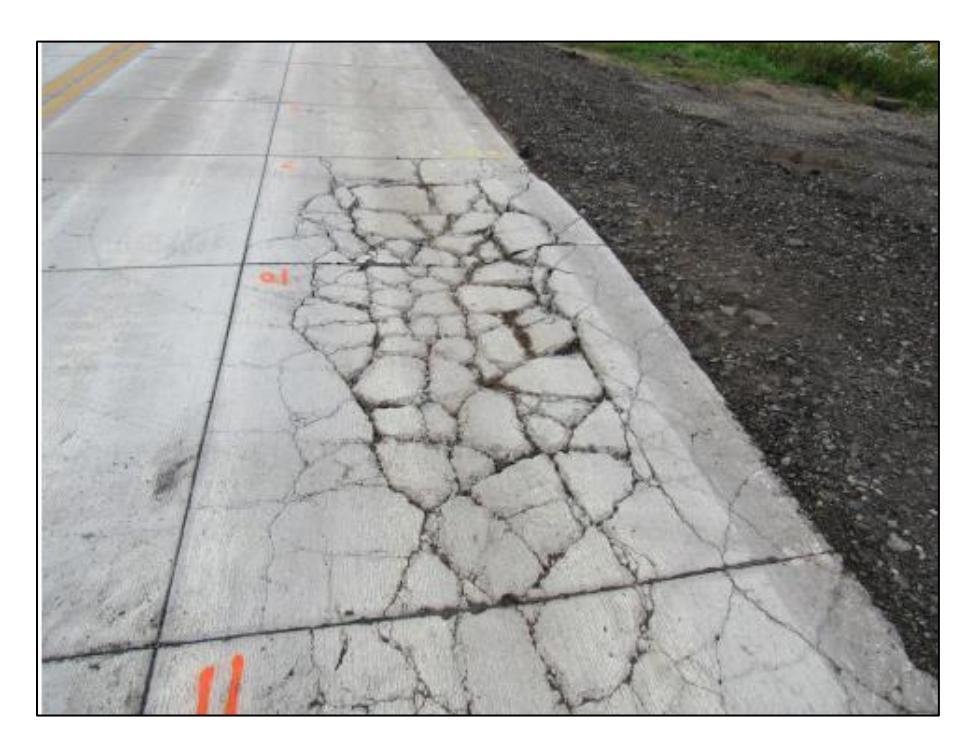
Cell 139 was constructed with a three-inch-thick (ultra-thin) concrete pavement on an unstabilized gravel base at the MnROAD low-volume test track. The size of the slabs of this cell was 6ft x 6ft and the number of the total slabs is 180. Cell 139 was inadvertently exposed to early loads from construction trucks that were using the crossover segment to access other cells under construction, which resulted in many early-age cracks. Figure 2-2 shows a picture of a couple of such early-age cracks in this cell. These types of cracks continued to develop, propagate throughout the first year of service, and eventually, many slabs of this cell were shattered by the end of the summer of 2018. Besides that, there was a considerable amount of depression along the outer wheel path at some locations; this distress looked similar to rutting that occurs in asphalt pavement. Figure 2-3 and Figure 2-4 show photographs of the abovementioned distresses. While the slab thickness limitation (only 3-inch thick) of this cell and early-age loading were the main reasons for the initiation of the distresses of Cell 139, a relatively weak base layer and some drainage issues were believed to have aggravated the distresses of this cell.

Figure 2-3. Shattered slabs in Cell 139.

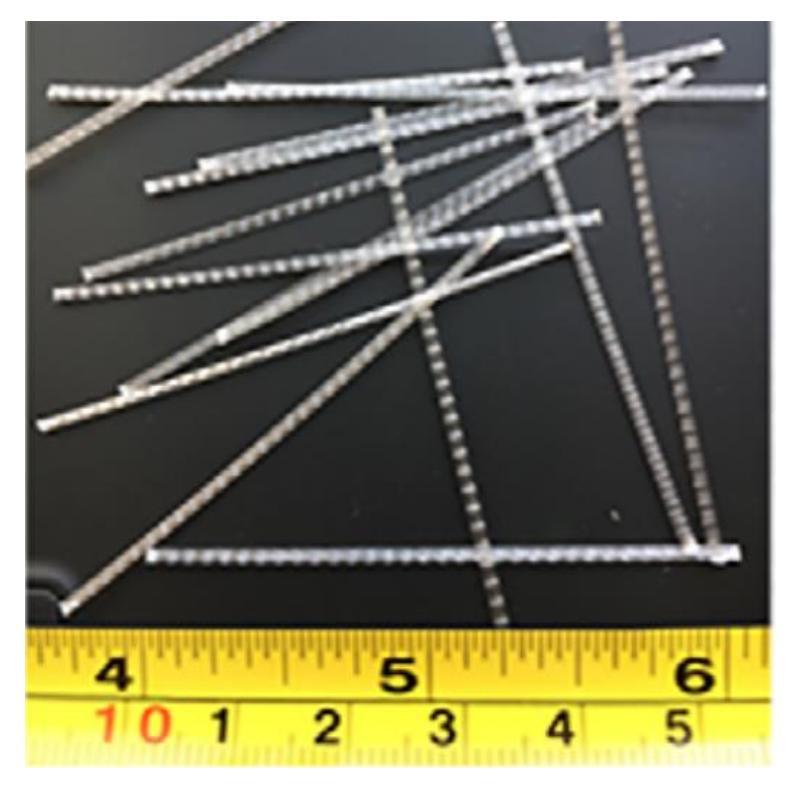
(2.6a) Fibers used in new slabs of Cell 139.

As many as 14 of the 44 slabs in the inside lane were replaced on September 27, 2018. Figure 2-5 shows a few ph collected during the removal of broken slabs and the construction of the replacement slabs. The replacement slabs are now 4-inch thick, with eight of them containing fiber reinforced concrete and the other six constructed with plain concrete. The fibers used in the replacement slabs are different and laterally stiffer than that used in 2017, as shown in Figure 2-6a. The dosage of the fiber was 5.5 lb/cy, which corresponds to a 30% residual strength ratio. Figure 2-6b shows the ASTM C1609 test results for the two numbers of beam samples prepared at the site during the construction of replacement slabs in Cell 139. The replaced slabs are performing well; no cracks have been found visible in a recent photographic survey conducted in October 2019.

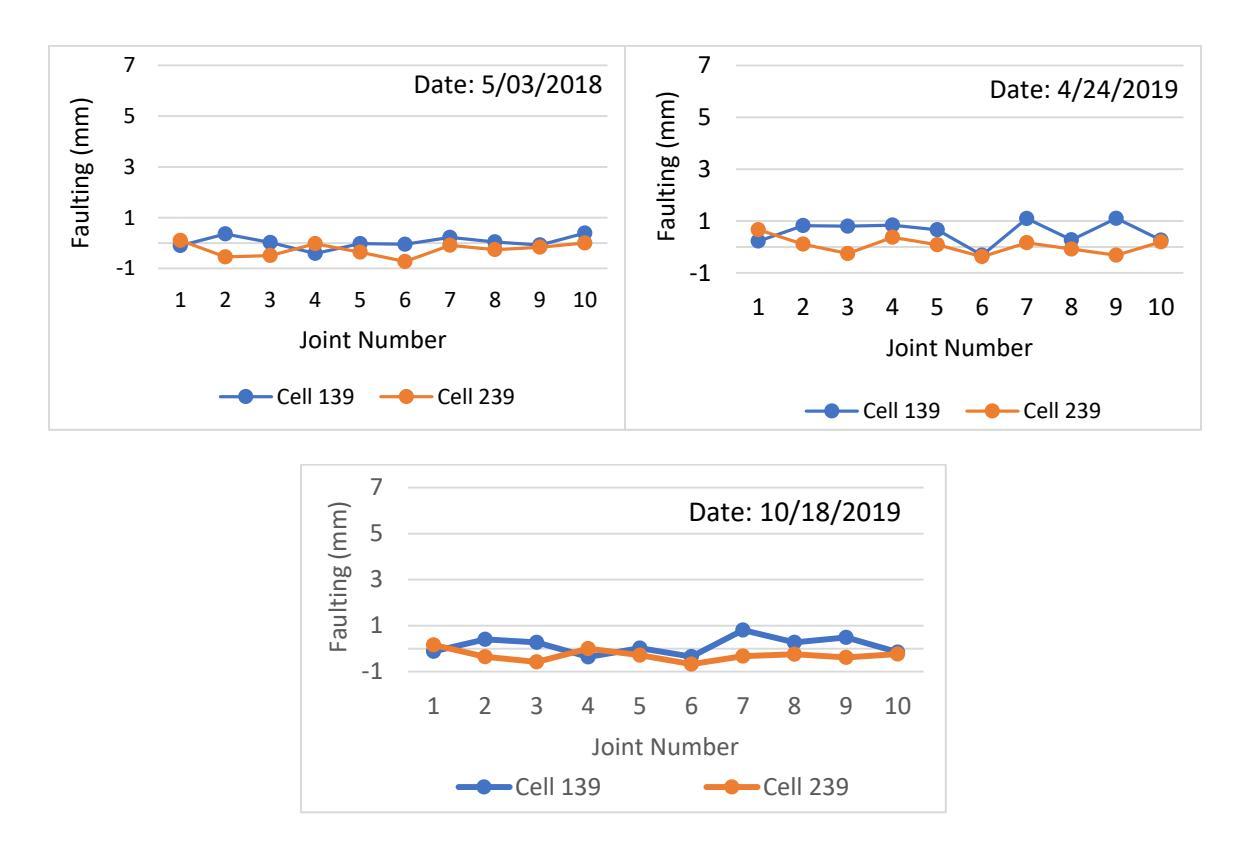
Figure 2-23 shows the faulting measured at various transverse joints of Cells 139 and 239. It should be noted that the surface texture depth is usually around 1 mm on average; therefore, any faulting readings below 1 mm may not be indicating any notable faulting. As previously mentioned, Cell 139 had experienced depression along the wheel path, so, it may not also be appropriate to compare the faulting results between Cells 139 and 239.

Figure 2-23. Faulting summary of Cells 139 and 239 at three different dates until October 18, 2019.

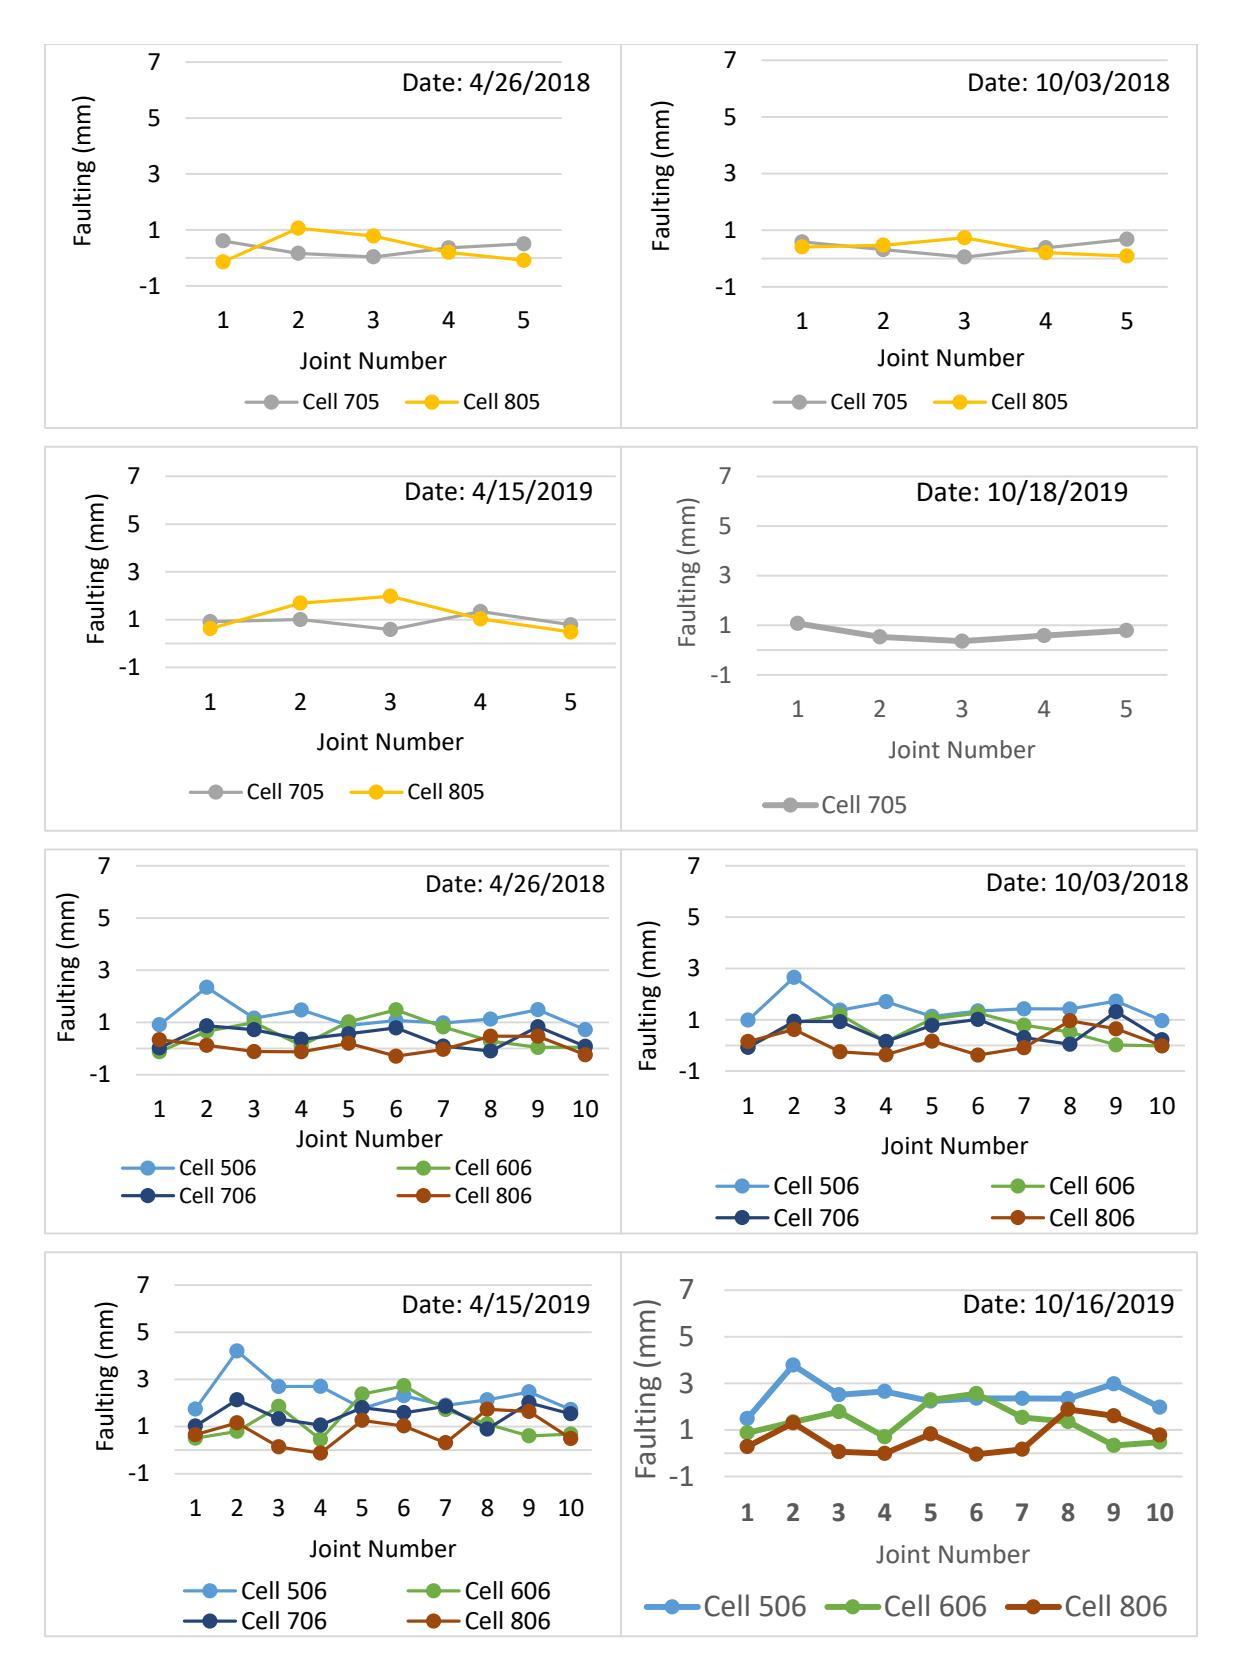
Figure 2-24 shows the faulting for Cells 705 and 805 until October 2019. Both Cells 705 and 805 had shown mostly positive faulting. One noticeable observation was that the faulting at Joint number-2 and-4 of Cell 705 was higher in April 2019 than what was measured in October 2019. Even though the faulting values in these cells were around 1 to 2 mm, Cell 805 experienced a slightly higher amount of faulting. It may happen that the narrower and lighter slabs in Cell 805 compared to Cell 705 move relatively more under the wheel load.

Figure 2-24 also shows the faulting measured in Cells 506, 606, 706 and 806 until October 2019. Cell 506, which was constructed with plain concrete, experienced the highest faulting (up to 4.2 mm) among the four cells. Figure 2-25 shows a photograph of noticeable faulting in Cell 506 (note that there is a sunken corner crack in the leave slab which exaggerates the faulting in the photo). Figure 2-26 shows the trend of average faulting versus fiber dosage. It can be seen that Cell 606, which was 6-inch thick (higher aggregate interlock) and constructed with a fiber dosage of 5 lbs/cy experienced approximately 86% less faulting than Cell 506 until October 2019. Cell 706, with a fiber dosage of 8 lb/cy, also experienced less faulting than Cell 506. Cell 806 which had the highest fiber dosage at 11.7 lbs/cy, experienced significantly lower faulting compared to any other FRC cell.

Figure 2-24. Faulting summary of Cells 705, 805 and 506 through 806 until October 18, 2019.

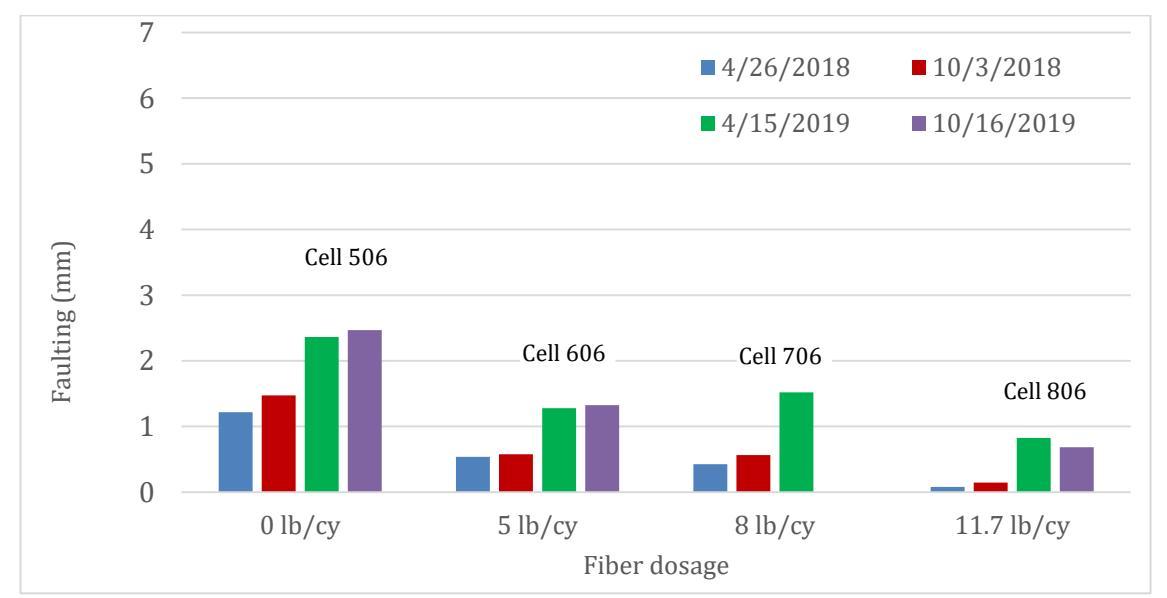
Note: Faulting for each cell is the average of all the faulting readings taken in a cell. Faulting data of Cell 706 for the April 2019 was erroneous, so discarded.

Figure 2-26. Faulting for Cells 506 through 806 with respect to fiber dosage.

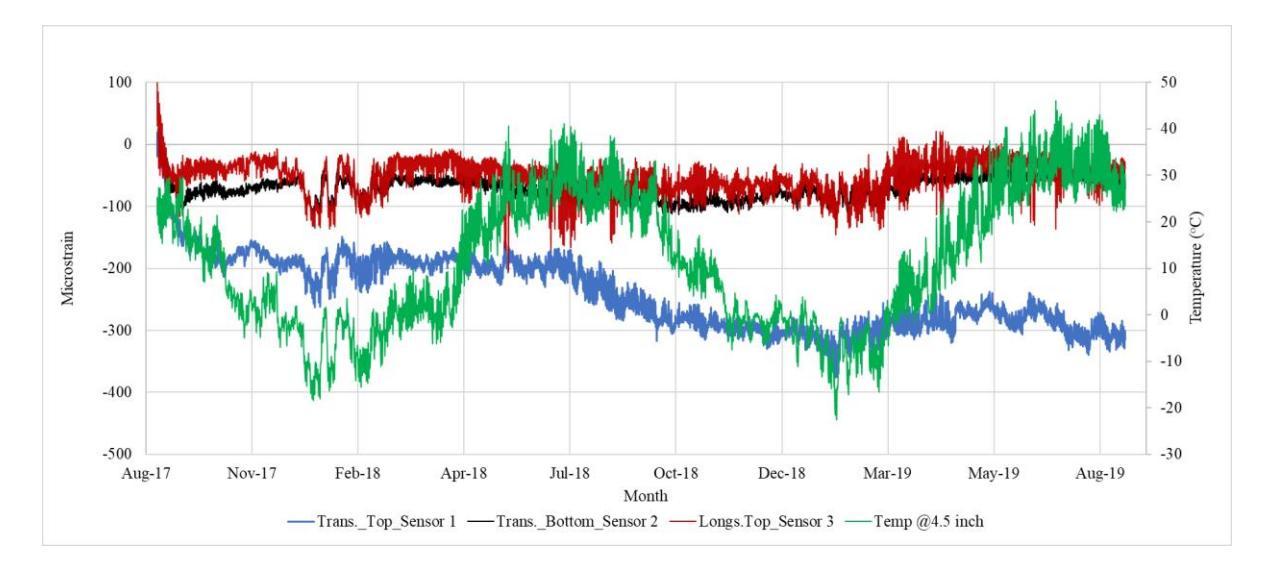
Figure 3-30. Environmental strains and slab temperature for Cell 805, first slab.

Similar to Cell 705, a total of eight vibrating wire sensors were installed in Cell 805. All the sensors were installed at the center of the slabs, both near the top and bottom of the slab, a half-inch inside the concrete. This report included the results of three sensors installed in the first slab. The results of the three sensors in Cell 805 also showed a great correlation with the seasonal temperature variation. Sensor 1, which was placed in the transverse direction, recorded the highest strain, around 300 to 375 microstrain during the winter.

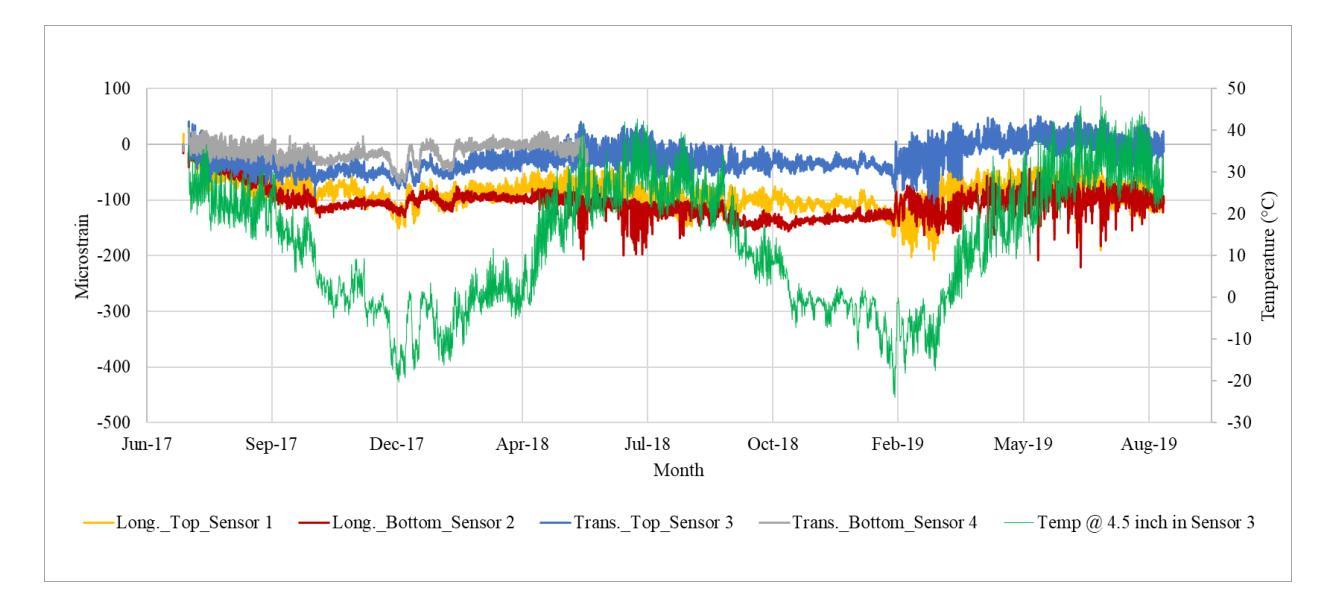
Figure 3-31. Environmental strains and slab temperature for Cell 506.

For these cells, some vibrating wire data for the first couple of weeks were not available. As previously mentioned, the vibrating wire and temperature data for the initial period are used to zero out the subsequent strain values. The vibration wire and temperature data for other cells were thereby studied, and their trends were used to populate the initial strain values for these cells. Figure 3-31through Figure 3-34 show the environmental strains calculated for these cells. Each of these cells has four sensors, two in the transverse direction in one slab and the other two in the longitudinal direction in another slab. The strains measured in all of these cells are relatively low compared to the other four cells discussed above. The strain values have shown a correlation with the slab temperature and values were high during the winter months as anticipated.

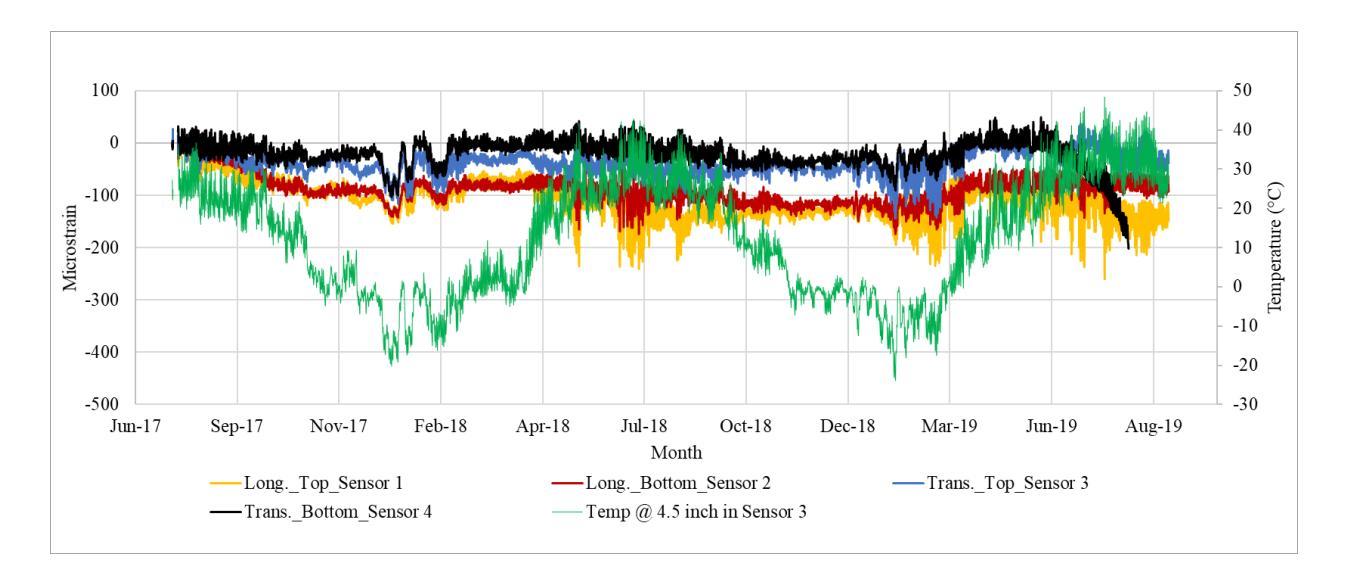
Figure 3-34. Environmental strains and slab temperature for Cell 806.

In summary, it can be stated that the strain recorded by almost all of the sensors were influenced by the seasonal temperature; strains were high during the winter and low in summer. Some sensors also have shown increasing strains with the age of the pavement, probably because of the fatiguing of the slabs and damage accumulation in the overall structure. Strains in ultra-thin (3-and 4-inch thick) concrete pavements were relatively higher than the thin concrete pavements (Cells 506-806), may be because of more curling

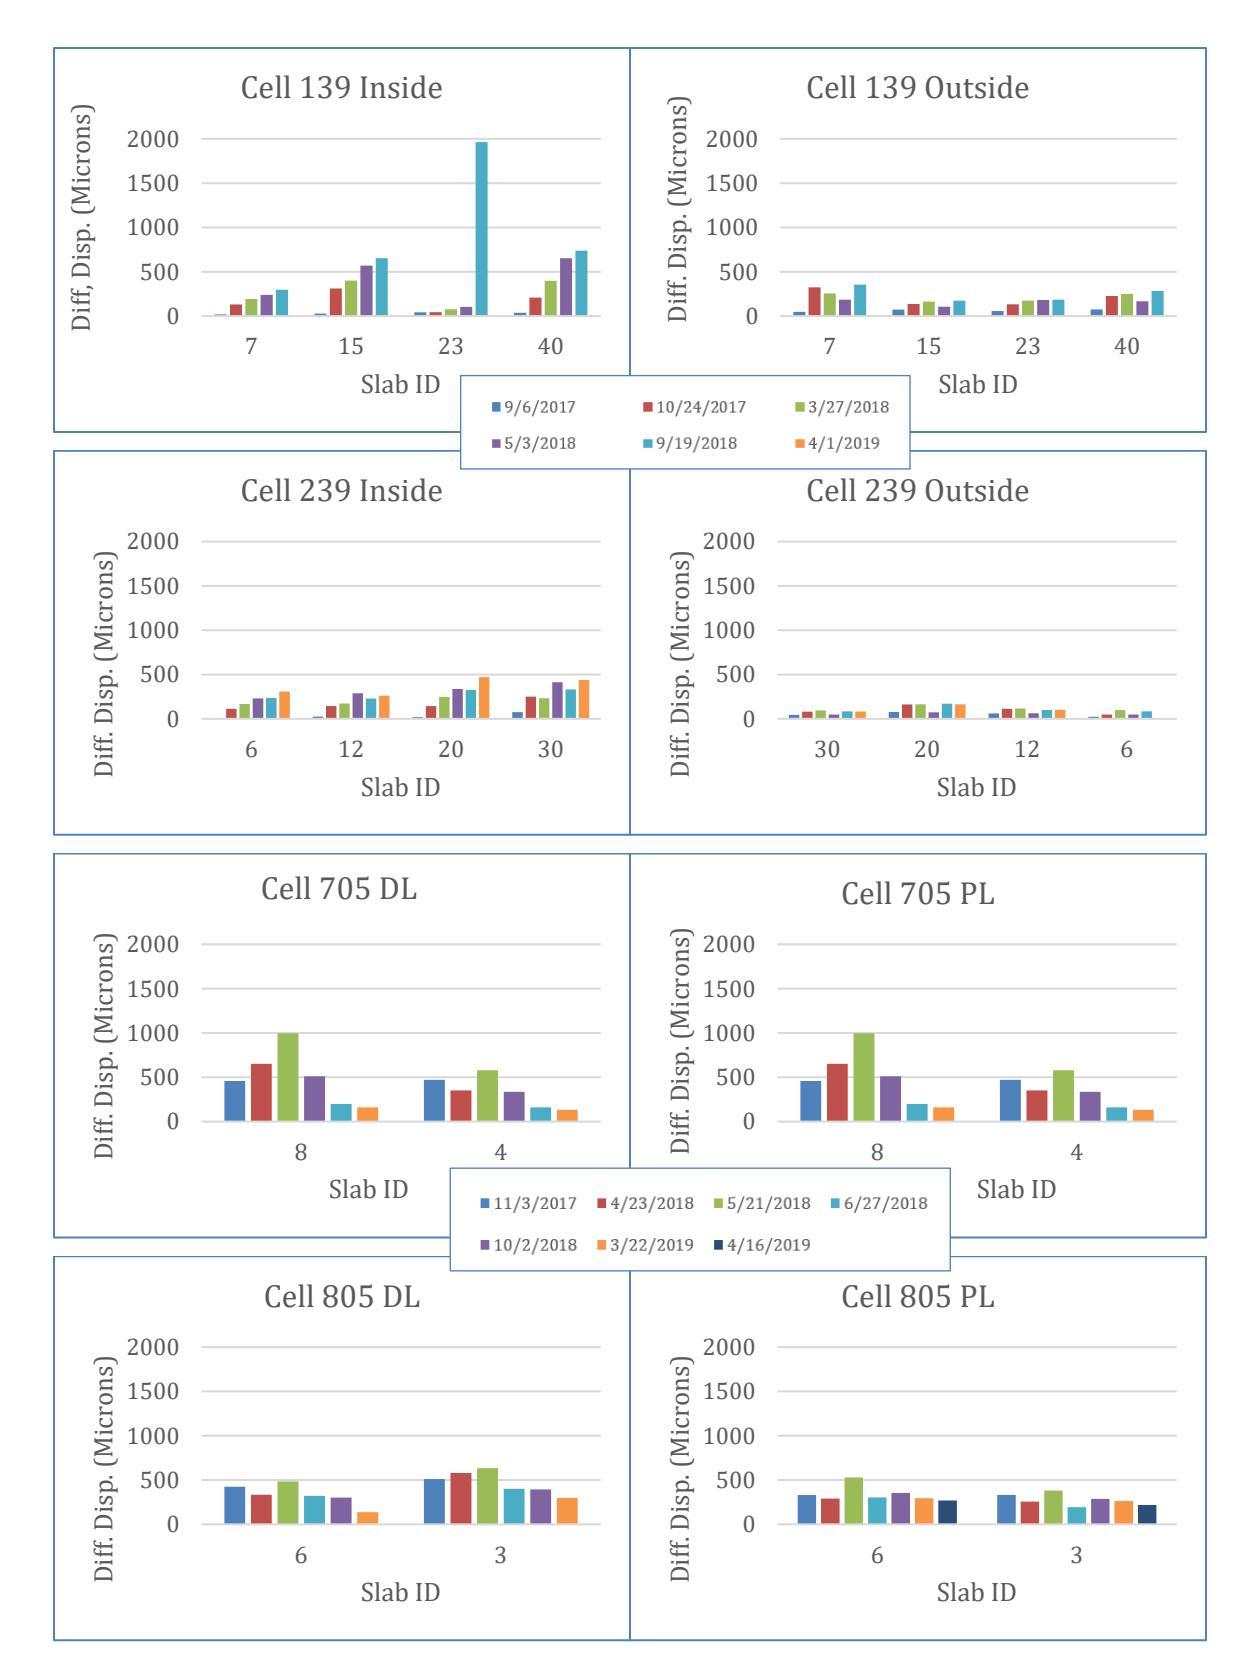
Figure 4-3. Differential displacement of Cells 139, 239, 705 and 805.

Figure 4-3 and Figure 4-4 shows the plots for differential displacements for all the cells. The general trend of the differential displacement is similar to the trends observed for the LTE. The differential displacements for both Cells 139 and 239 continously increased with the traffic load. The FWD test result for the Joint 23 of cell 139 resulted in a very high value of differential displacement.

Cells 705 and 805 both have experienced high differential displacements at the transverse joints; the differential displacements of Cell 705 (~1000 micron) was almost twice of the Cell 805 (~460 microns). Even though the differential displacements was relatively high, the fabric interlayer provided in these cells is expected to limit the faulting. The contribution of fibers in joint performance can also be seen in the differential displacement plots for Cell 506 through 806. Cells 506, 606 and 706 exhibited significantly higher differential displacements than Cell 806.

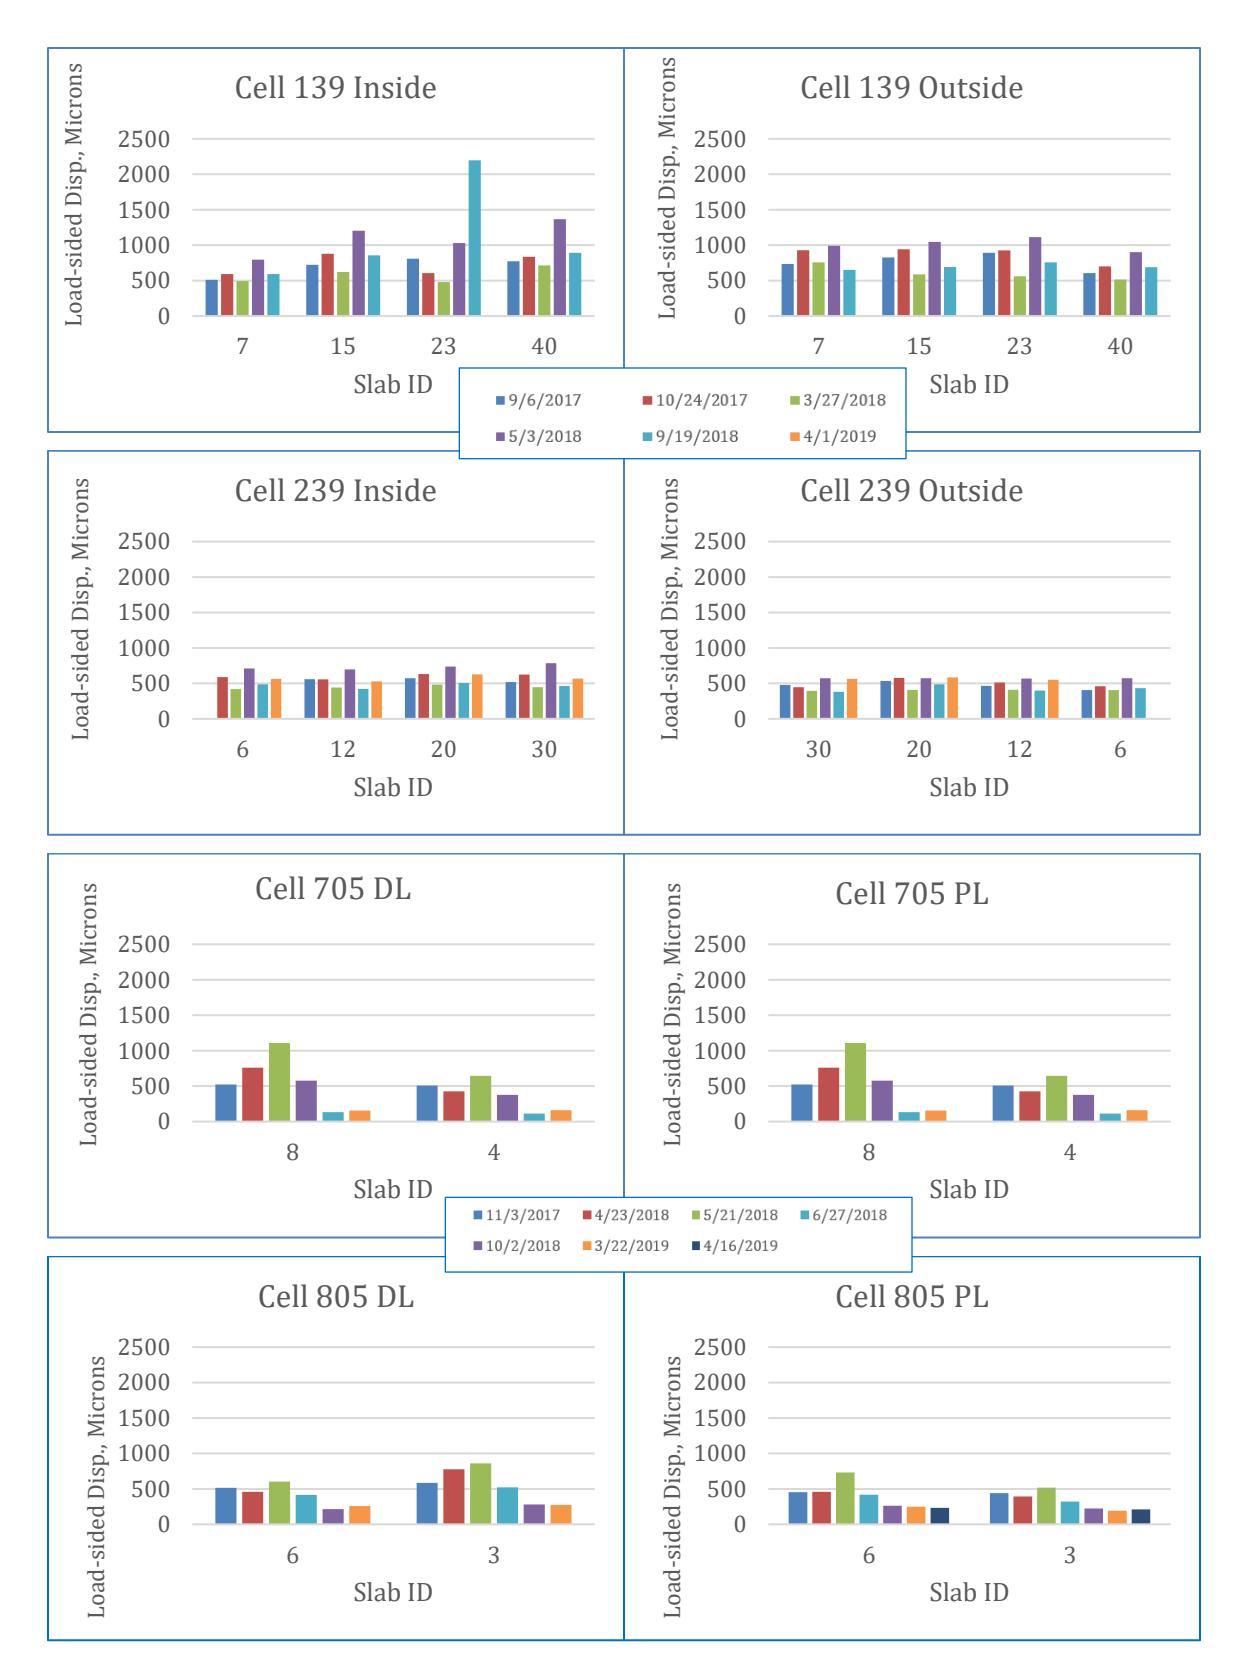
Figure 4-5. Load-sided Displacement of Cells 139, 239, 705 and 805.

Loaded-side displacement is a good indicator of joint performance. Even though the LTEs and differential displacements for the Cells 139 and 239 were somewhat comparable, especially the outside lanes, the Cell 139 had significantly higher loaded-side displacement, as shown in Figure 4-5. This clearly indicates that cell 139 had poorer joint stiffness or weaker support compared to Cell 239.

Similar to LTEs and differential displacements, the loaded-side displacements for the Cells 705 and 805 are a concern. Between these two cells, the Cell 705 had experienced higher, and as much as twice, the loaded-side displacements compared to Cell 805.

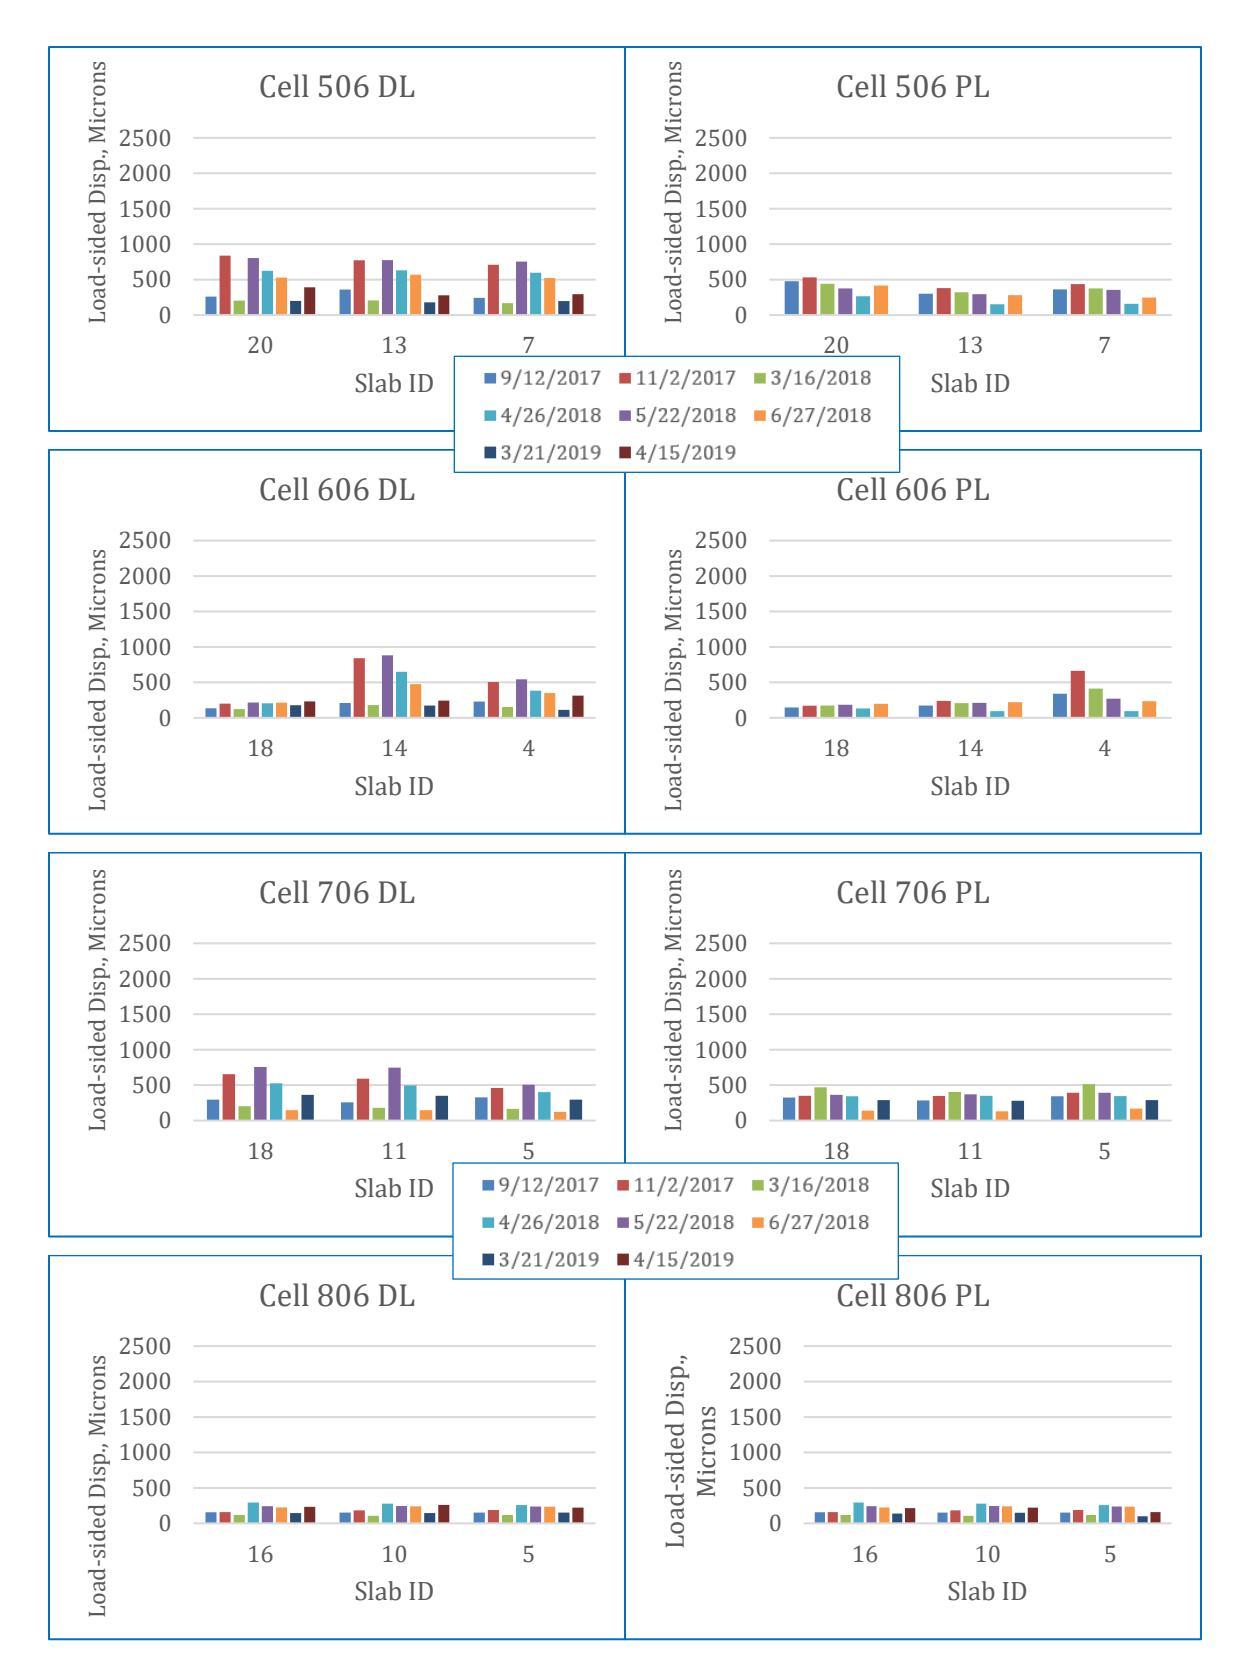
Figure 4-6. Load-sided Displacement of Cells 506, 606, 706 and 806.

The loaded-side displacement of Cells 506 through 806, as shown in Figure 4-6, also showed that the 806 is performing better than the other three cells.

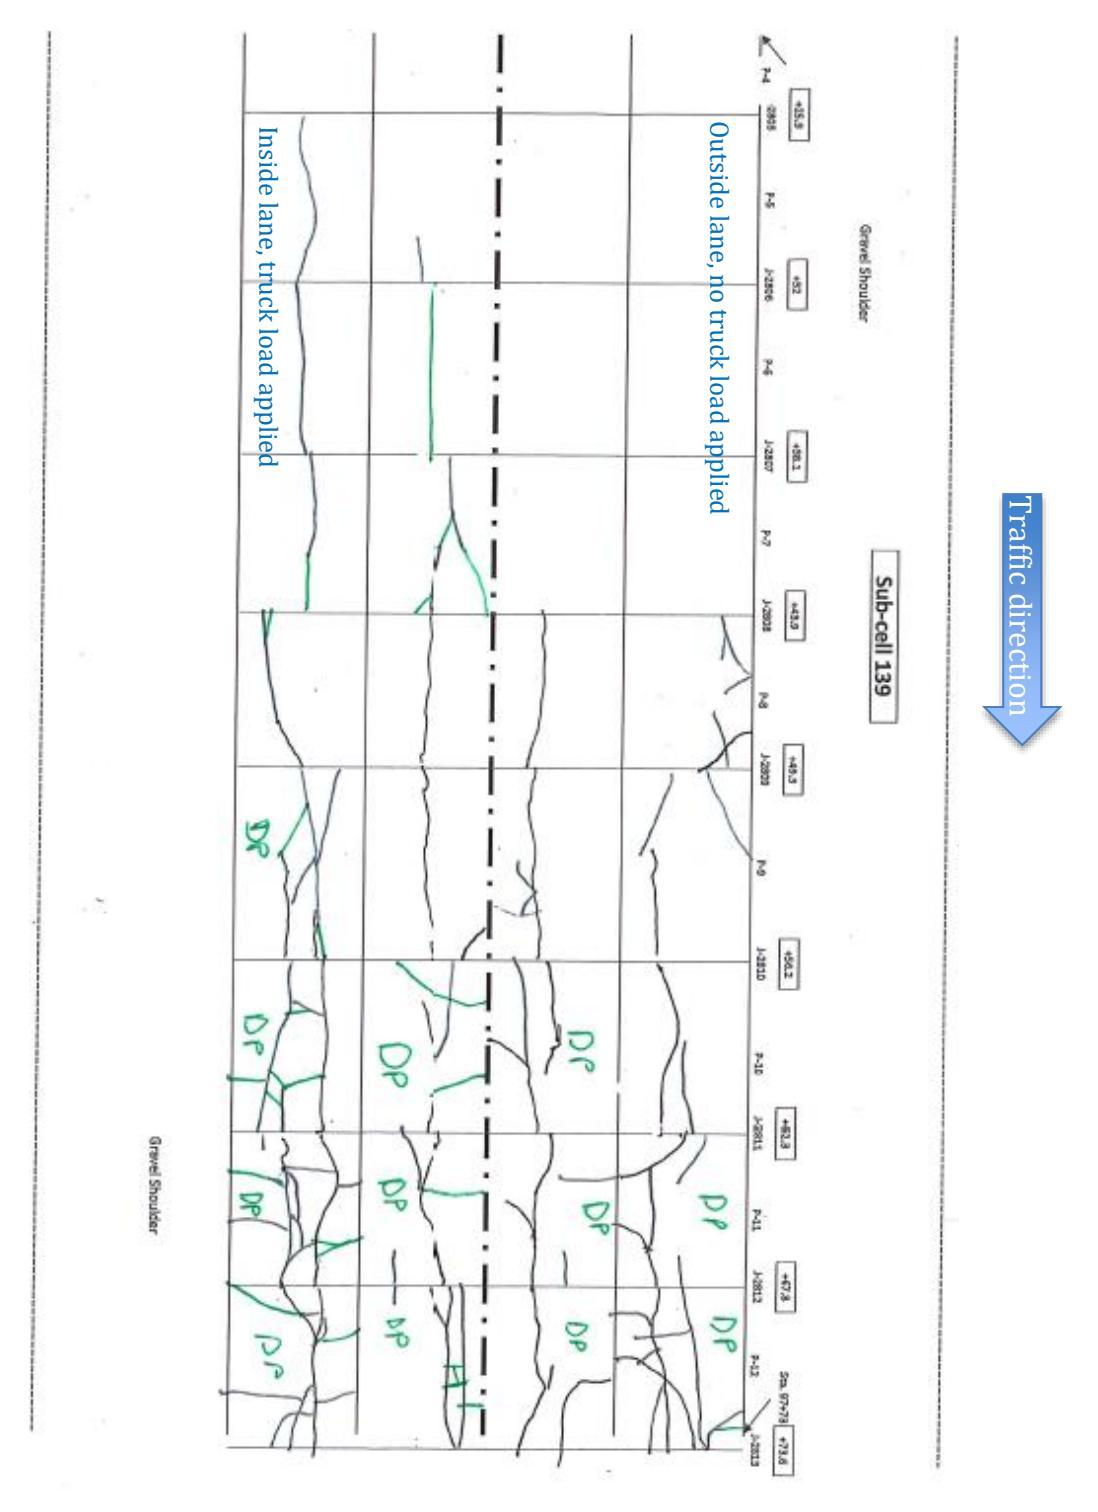
Figure A2: Distress map for Cell 139.. contd.

Cracks until December 2019; cracks colored green were documented on December 4, 2019.

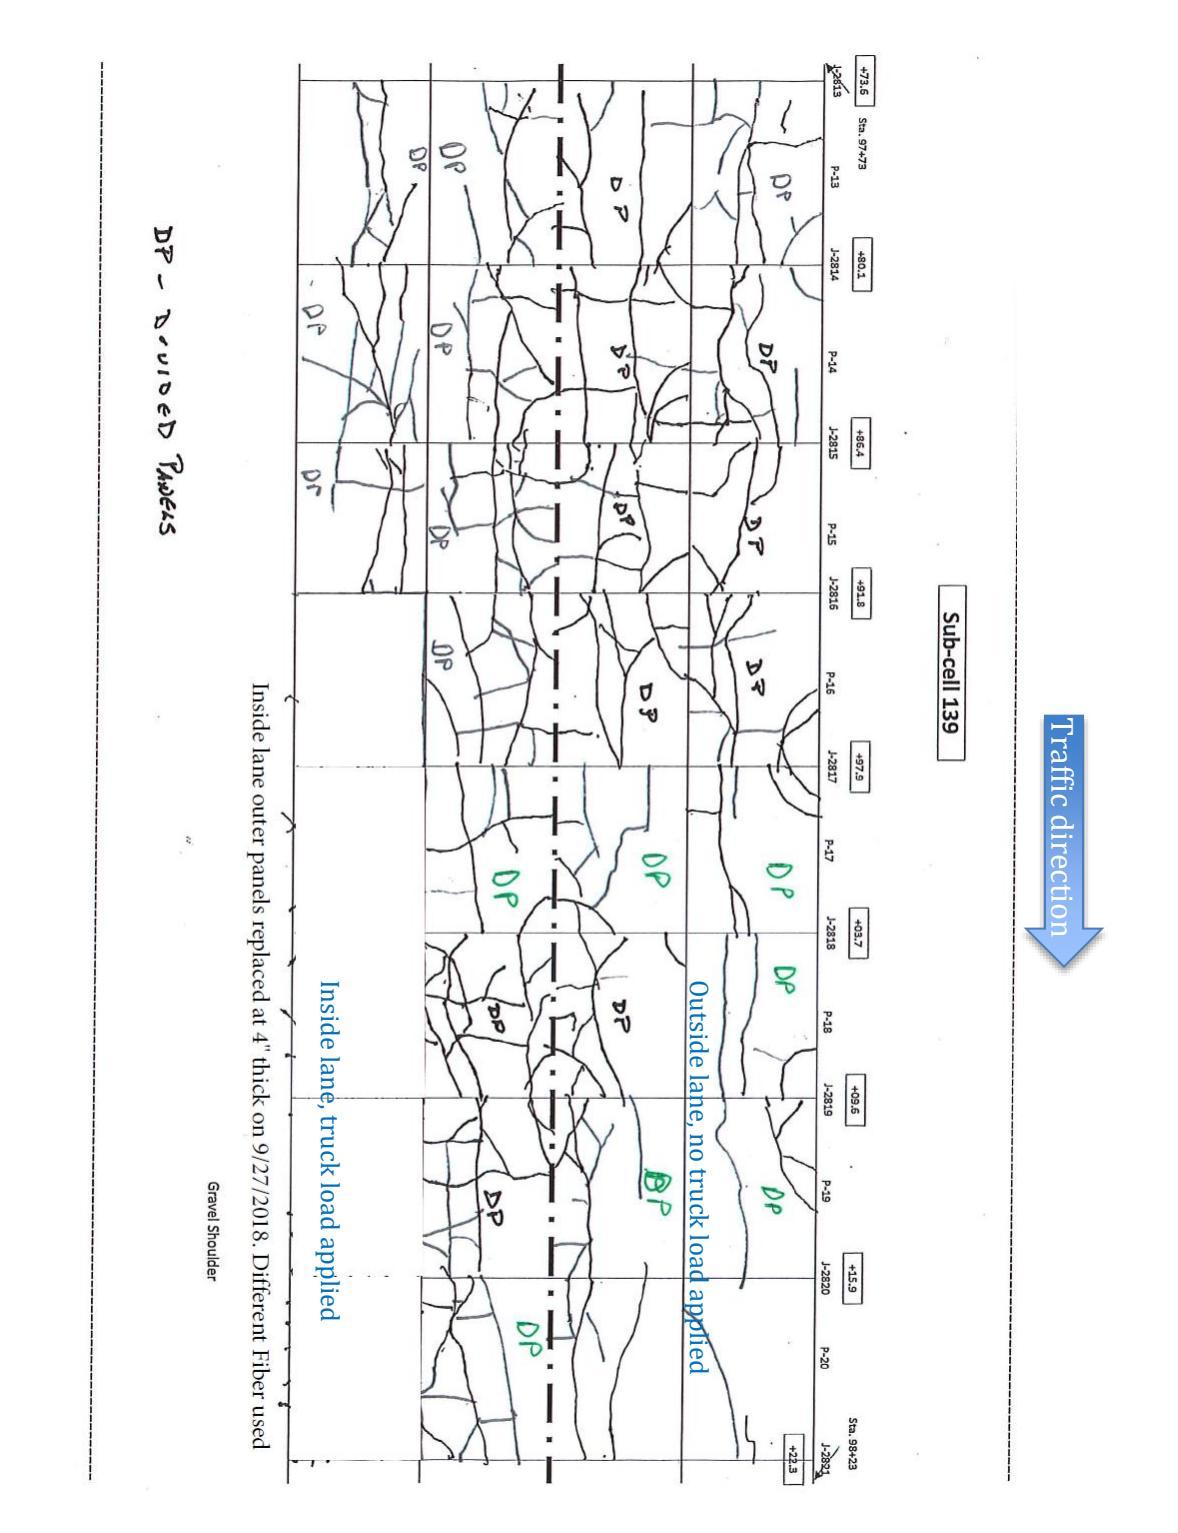
Cracks until December 2019: cracks colored green were documented on December 4, 2019. Figure A3: Distress map for Cell 139.. contd.

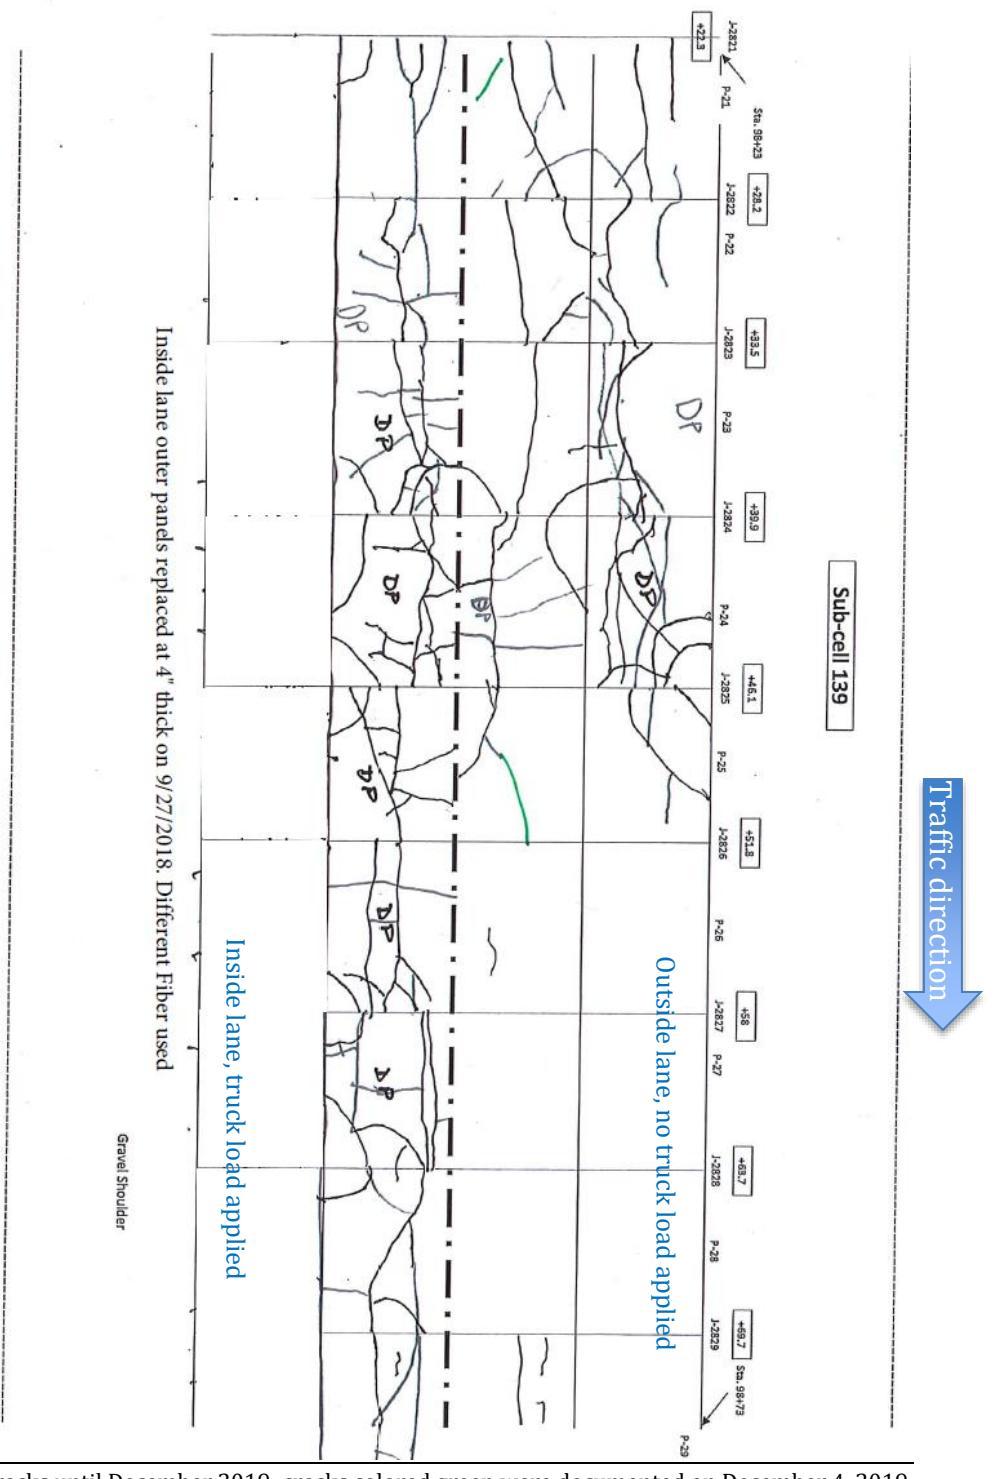
Figure A4: Distress map for Cell 139.. contd.

Cracks until December 2019; cracks colored green were documented on December 4, 2019.

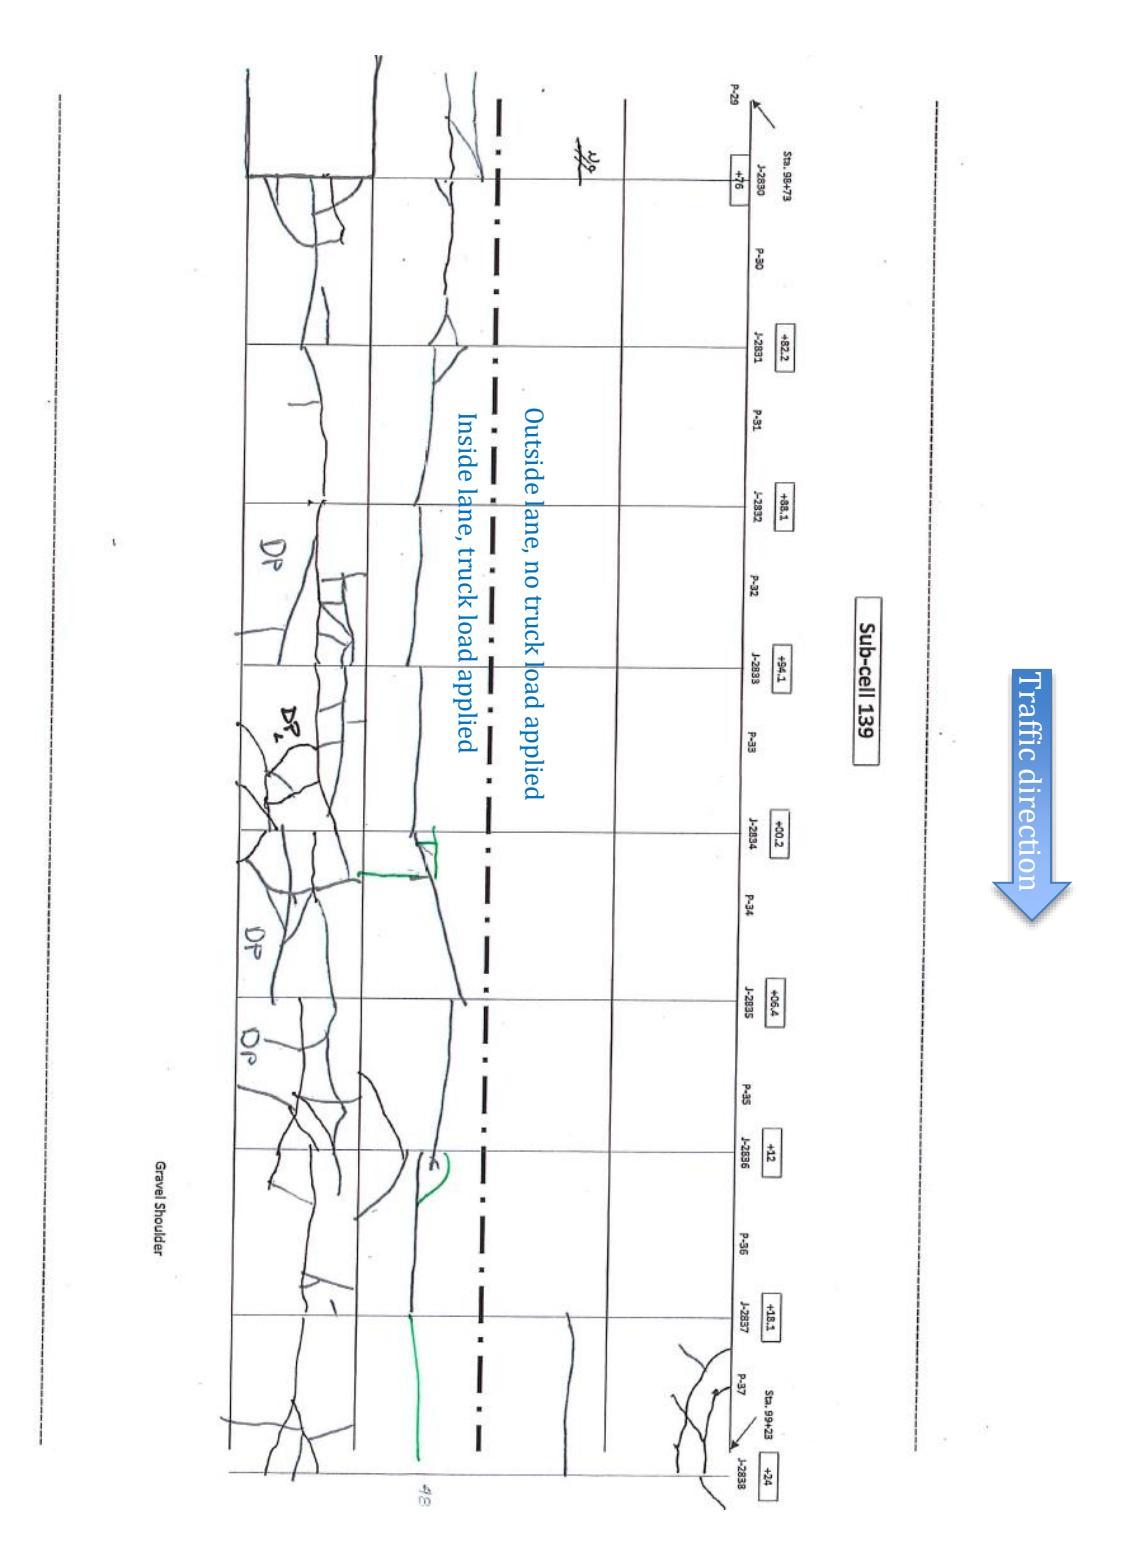
Figure A5: Distress map for Cell 139.. contd.

Cracks until December 2019; cracks colored green were documented on December 4, 2019.
