MnDOT Contract, No. 1003325, Work Order No. 56

NRRA Long-term Research Project

Performance Benefits of Fiber-reinforced Thin Concrete Pavement and Overlays

Task-2: Second Year Annual Cell Performance Report (2018-2019)

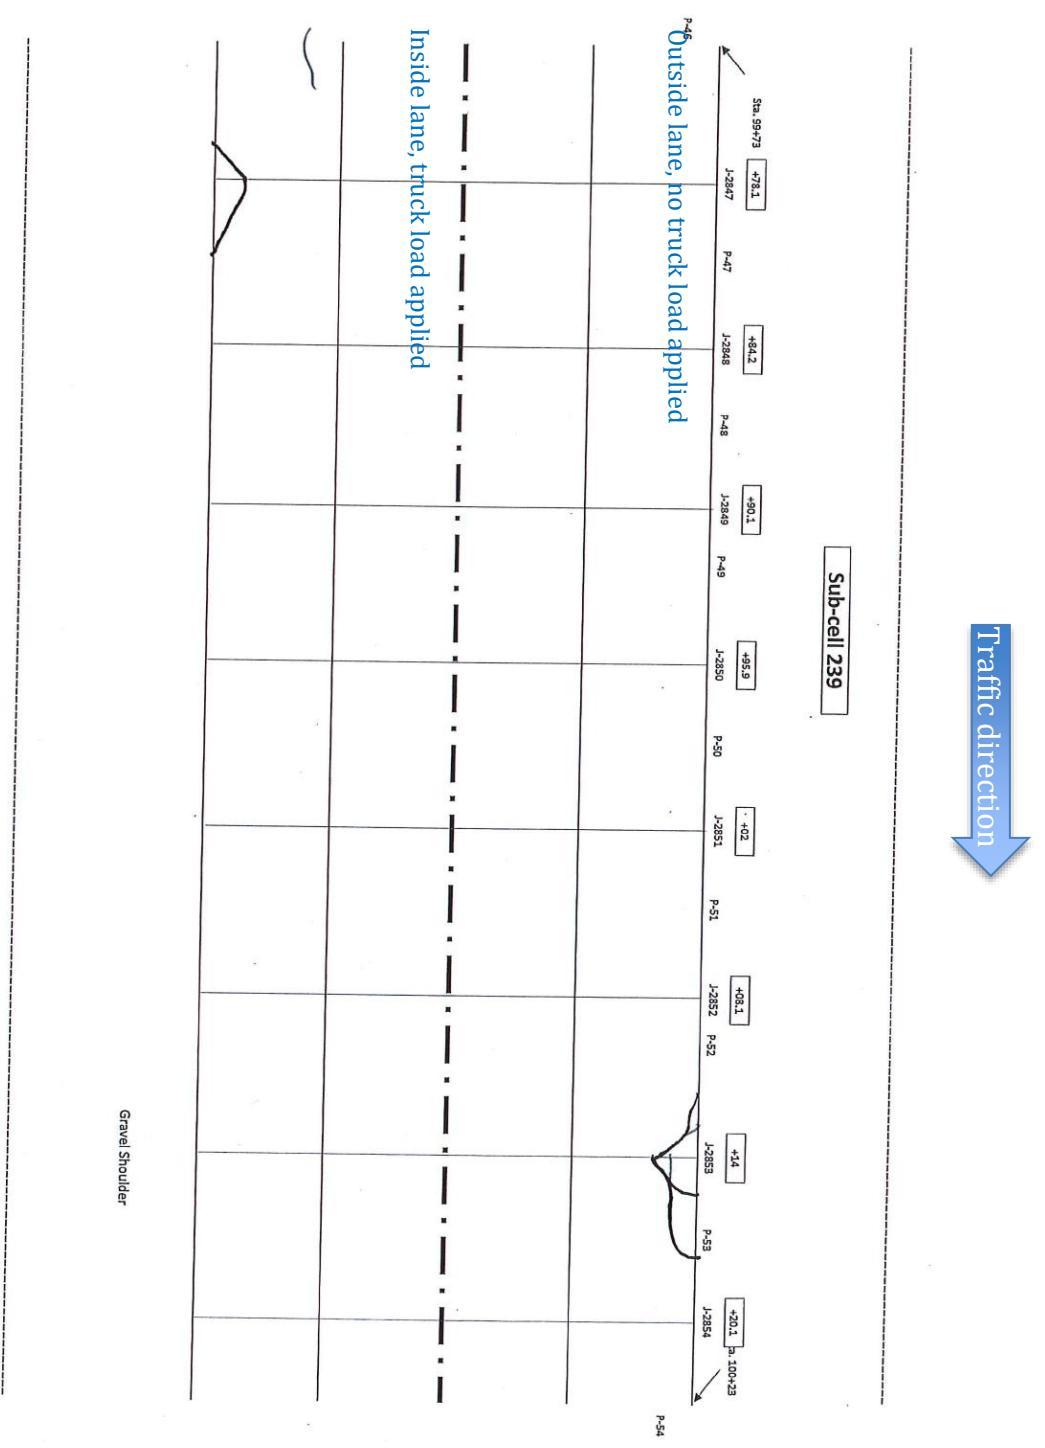
Figure A8: Distress map for Cell 239.

Cracks until December 2019; cracks colored green were documented on December 4, 2019.

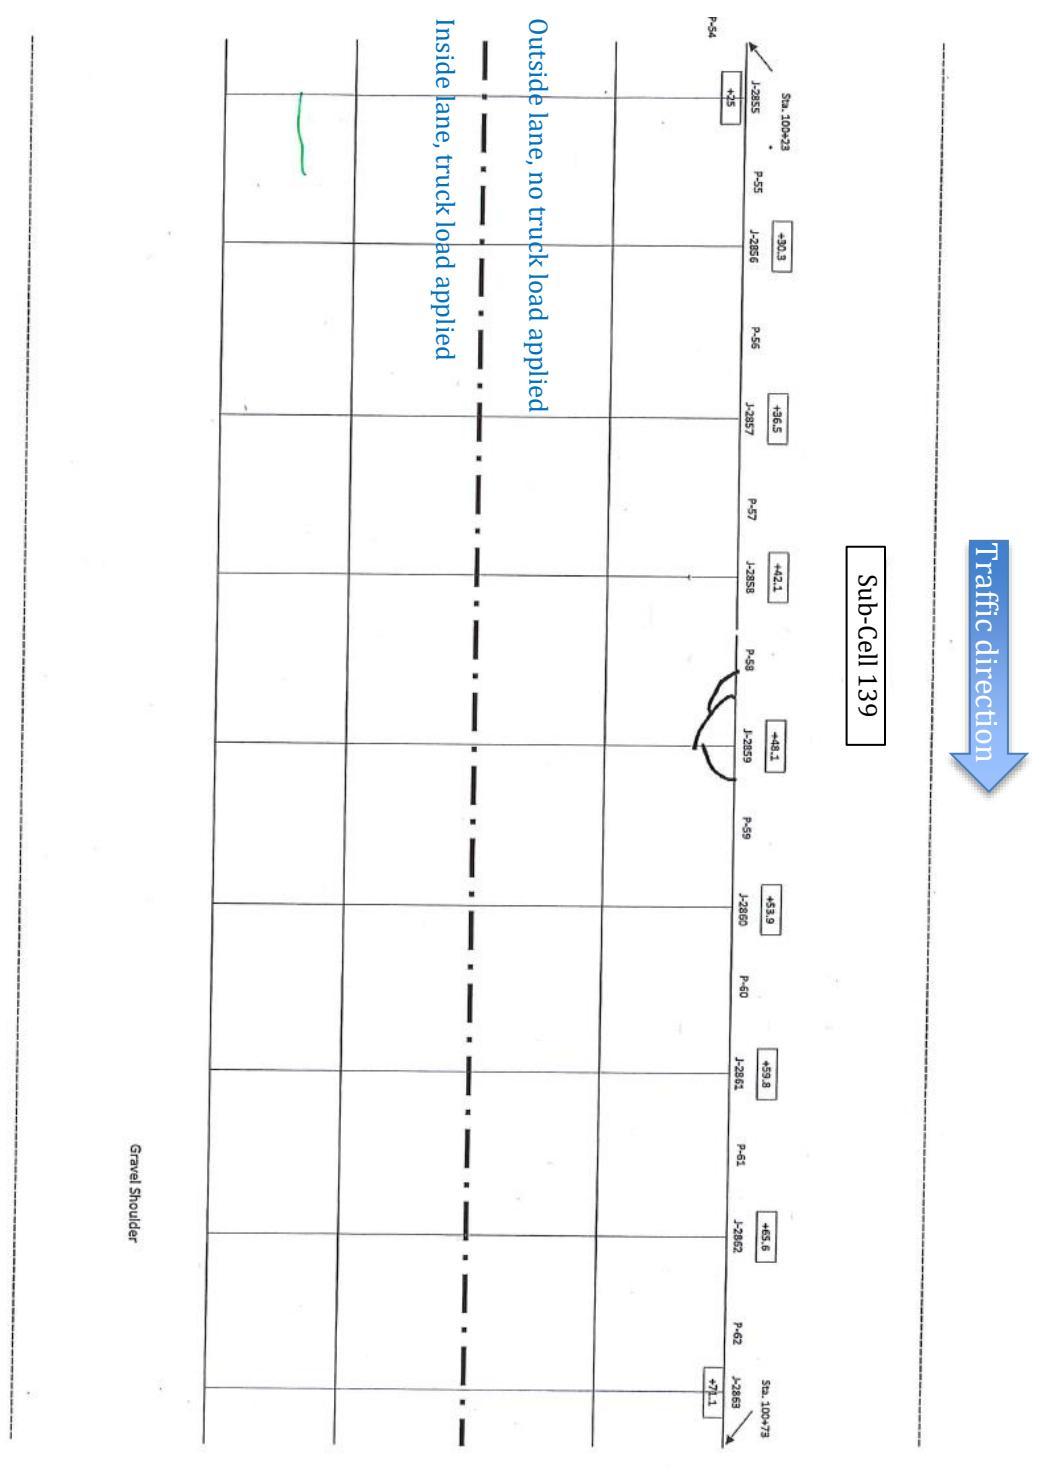
Figure A9: Distress map for Cell 239.. contd.

Cracks until December 2019; cracks colored green were documented on December 4, 2019.

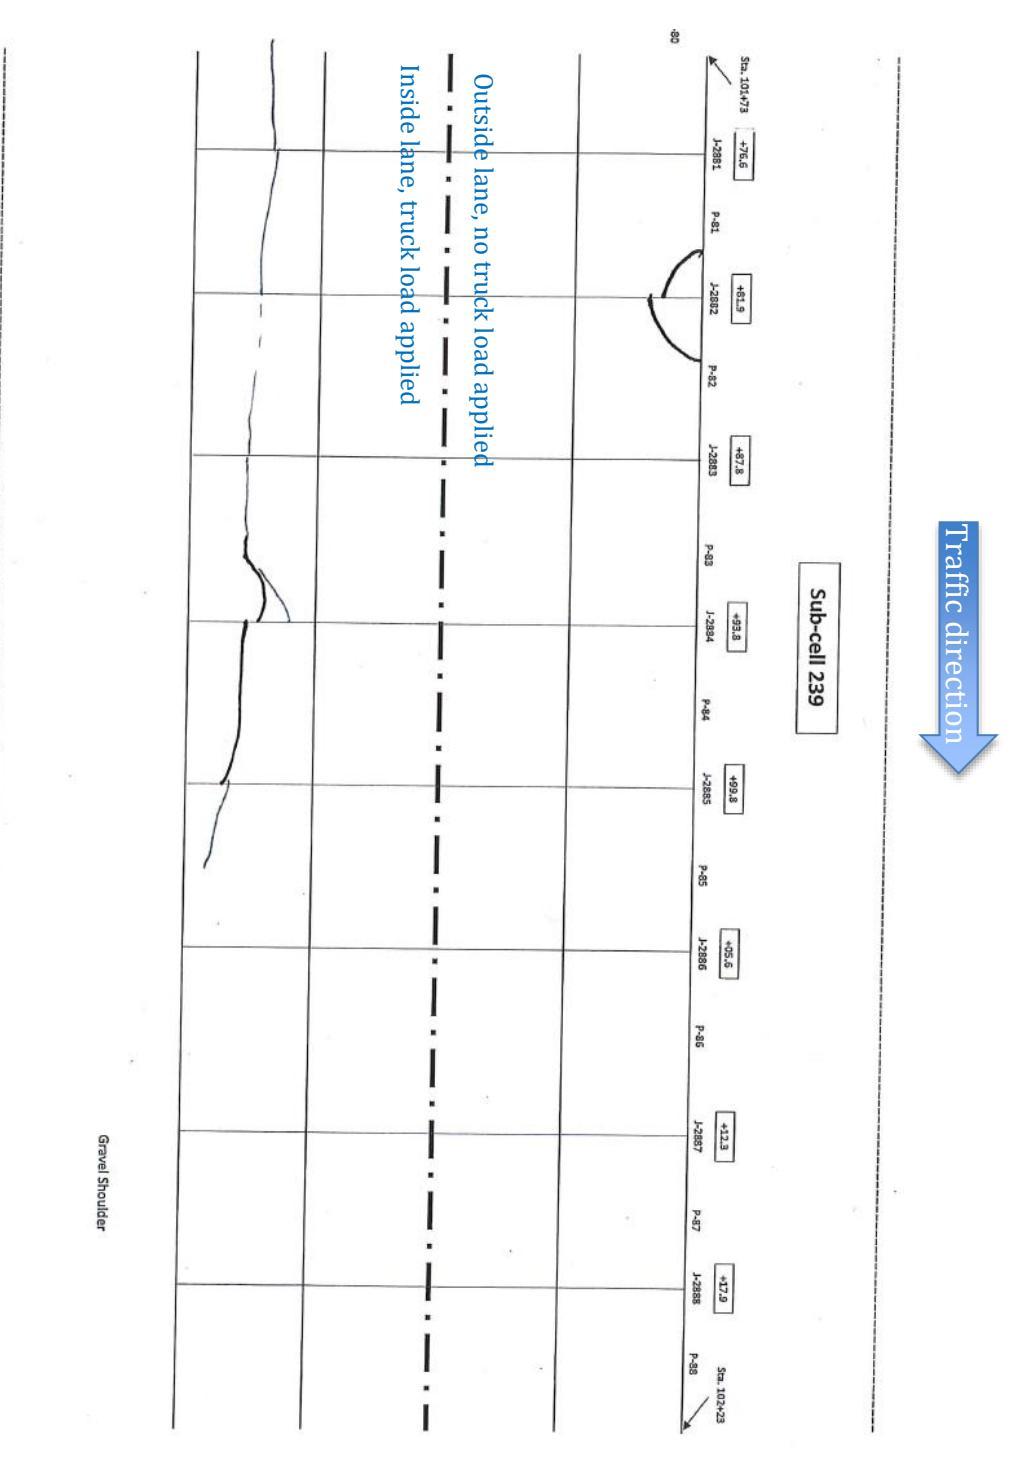
Figure A12: Distress map for Cell 239.. contd.

Cracks until December 2019; cracks colored green were documented on December 4, 2019.

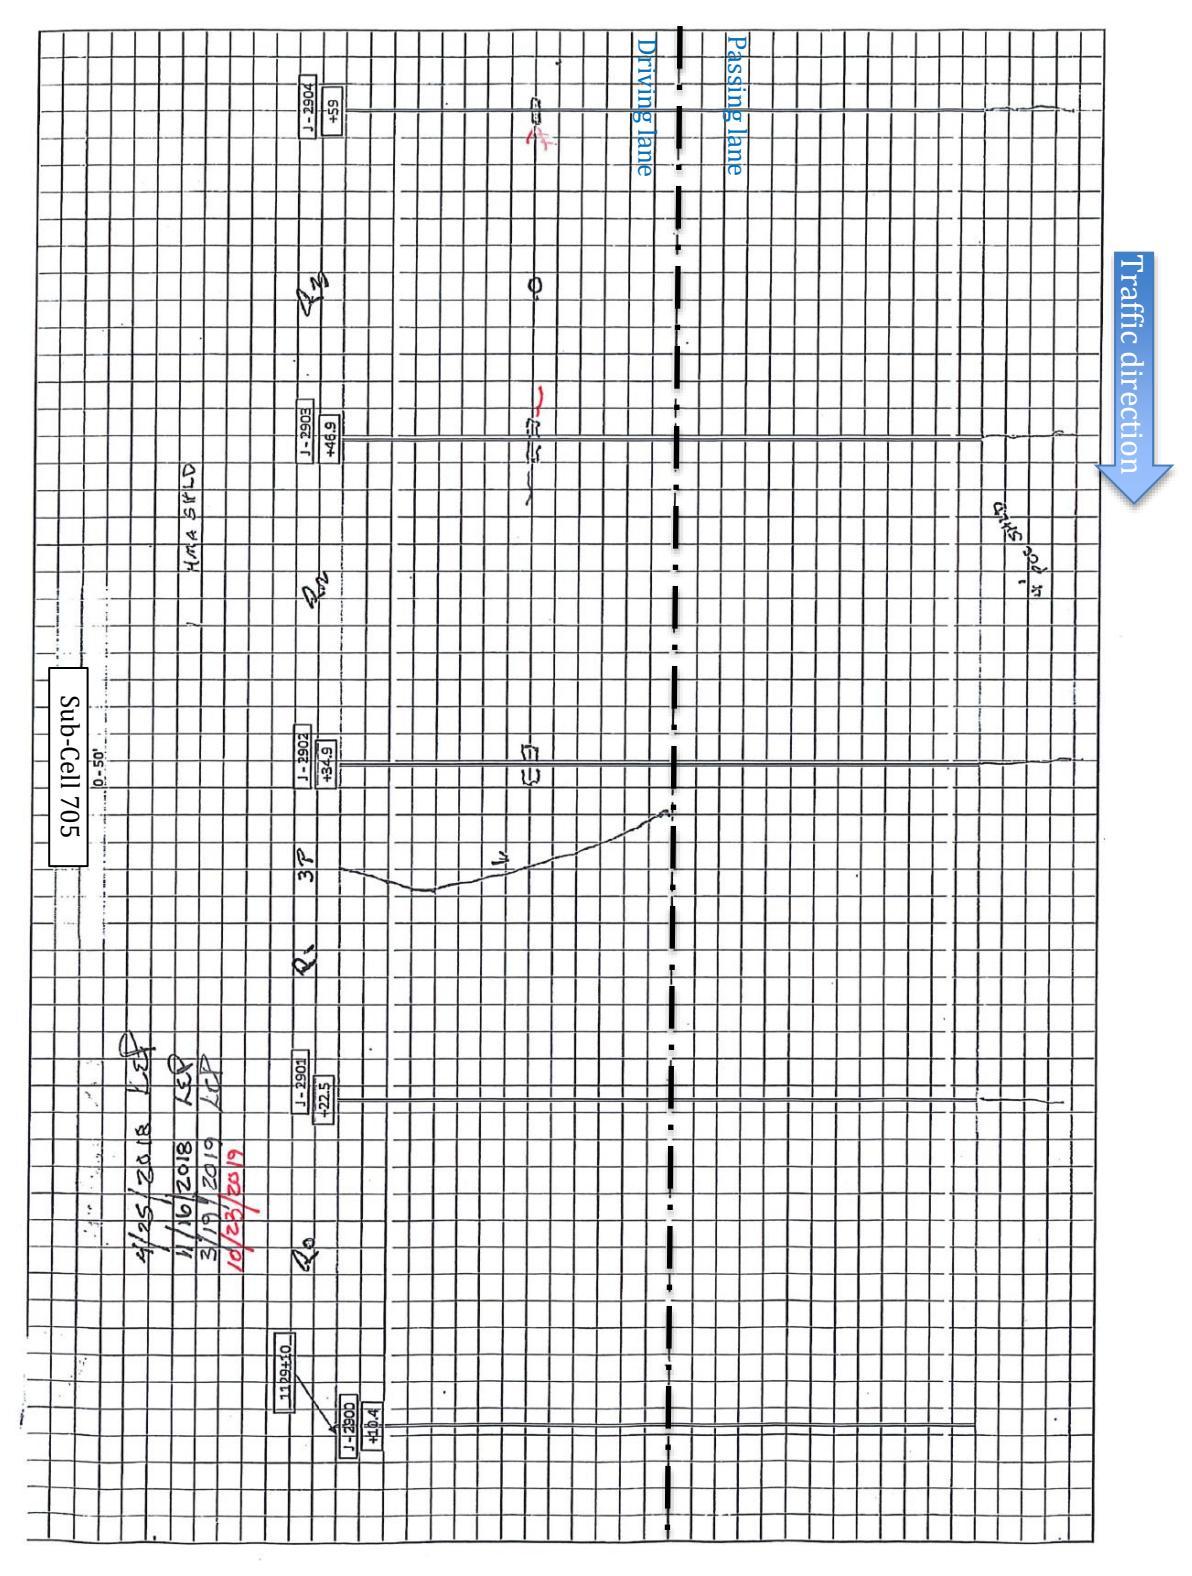
Figure A13: Distress map for Cell 705.

Cracks until October 2019: cracks colored red were documented on October 23, 2019.

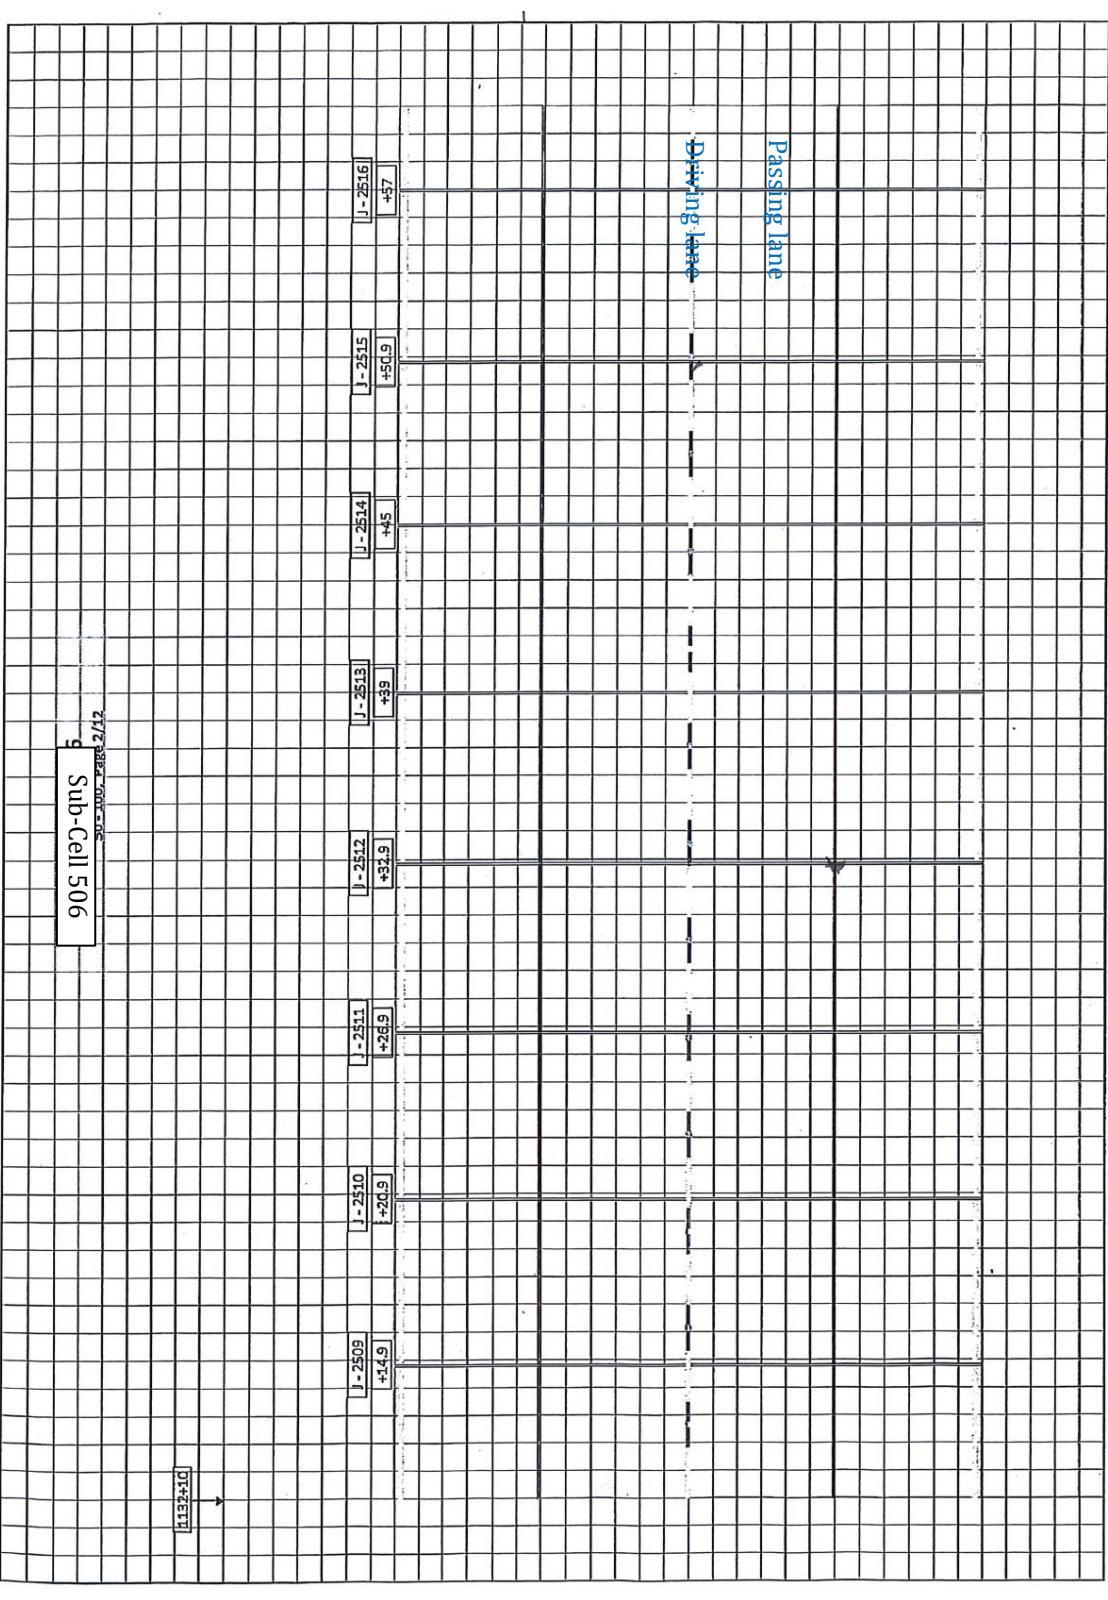
Figure A20: Distress map for Cell 506.. contd.

Cracks until October 2019; cracks colored in red were documented on October 25, 2019.

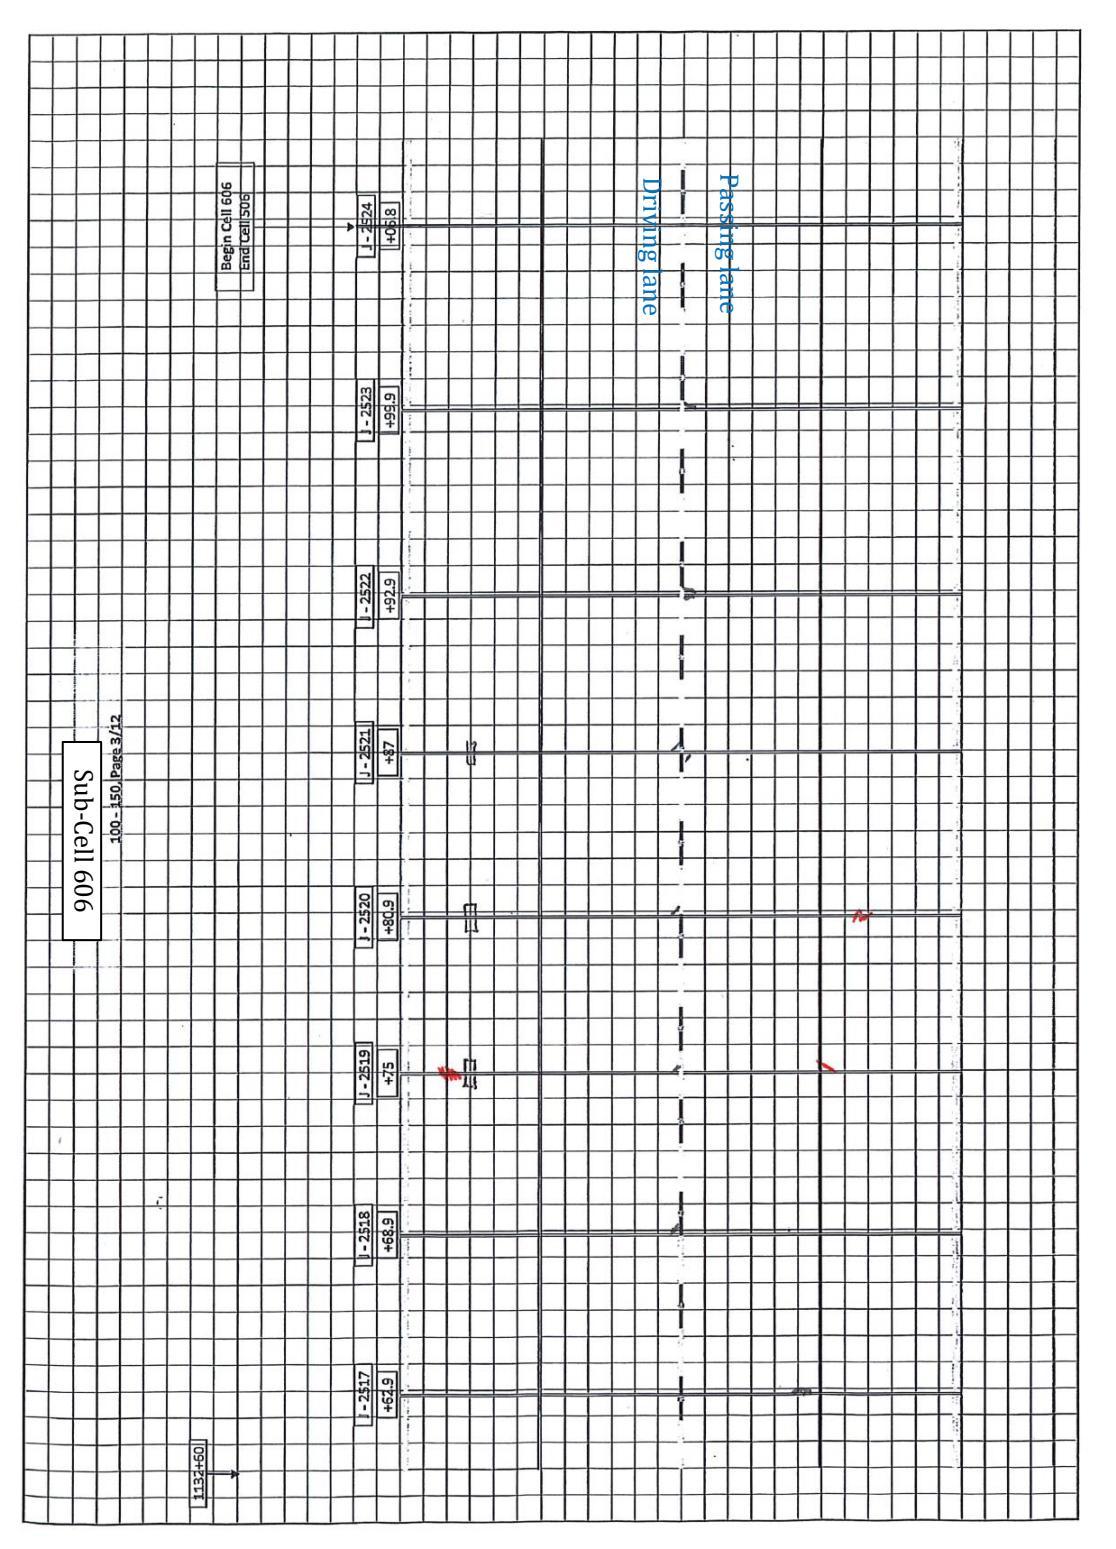
Figure A21: Distress map for Cell 606.

Cracks until October 2019; cracks colored in red were documented on October 25, 2019.

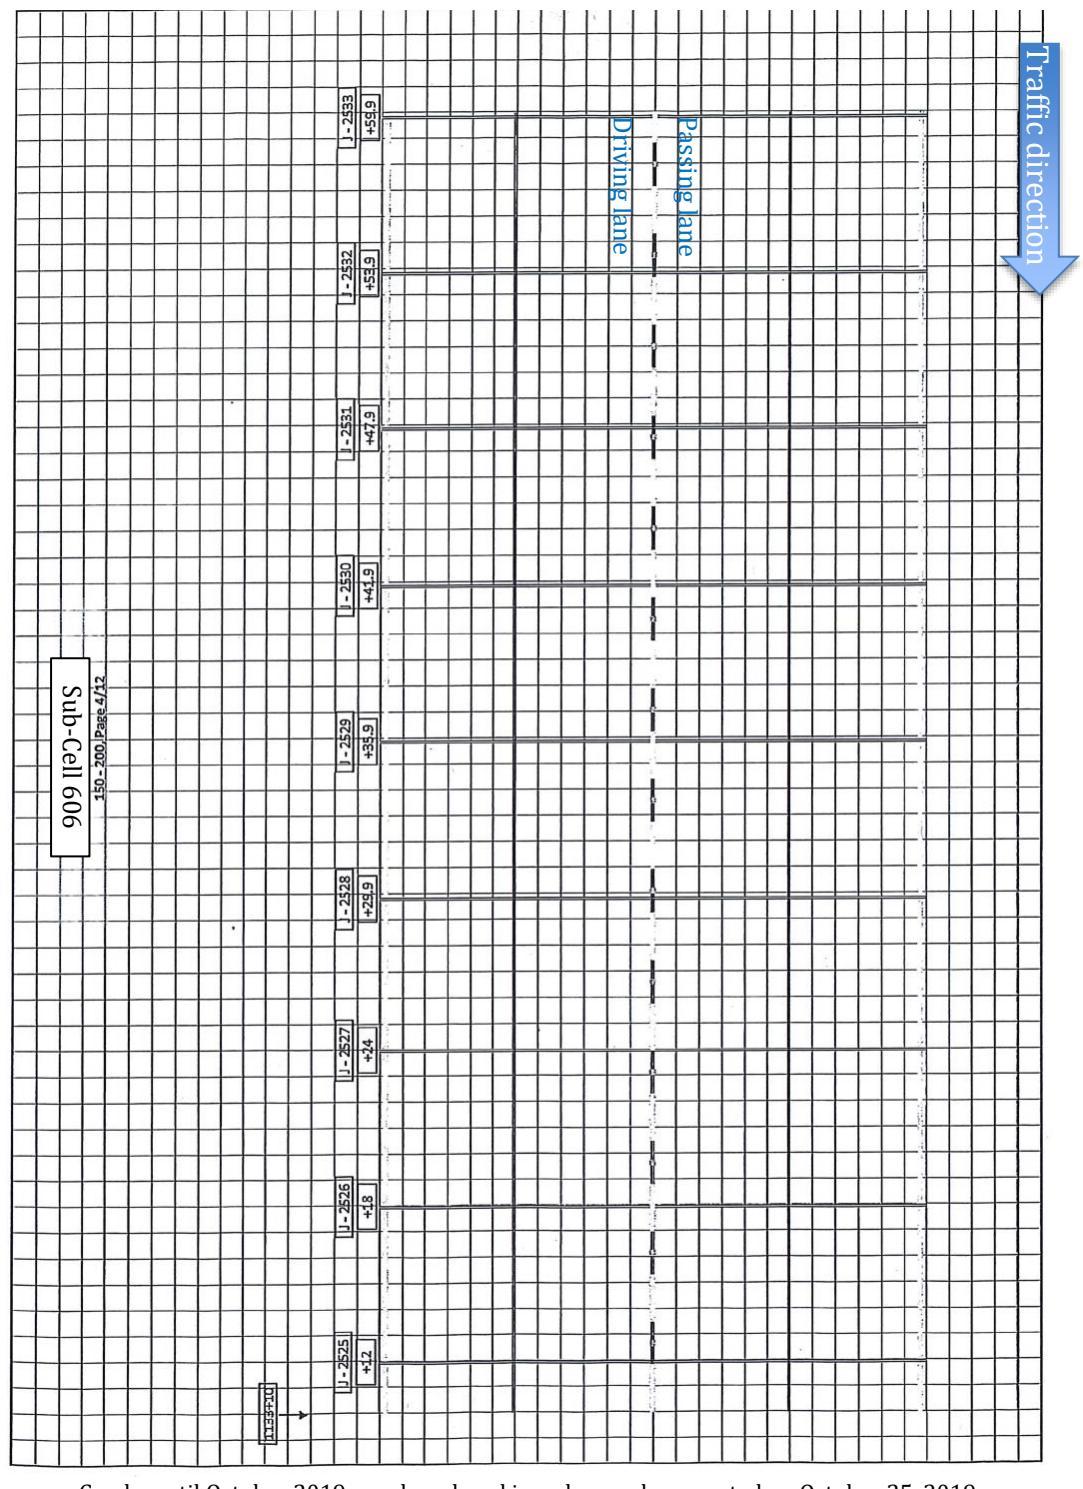
Figure A22: Distress map for Cell 606.. contd.

Cracks until October 2019; cracks colored in red were documented on October 25, 2019.

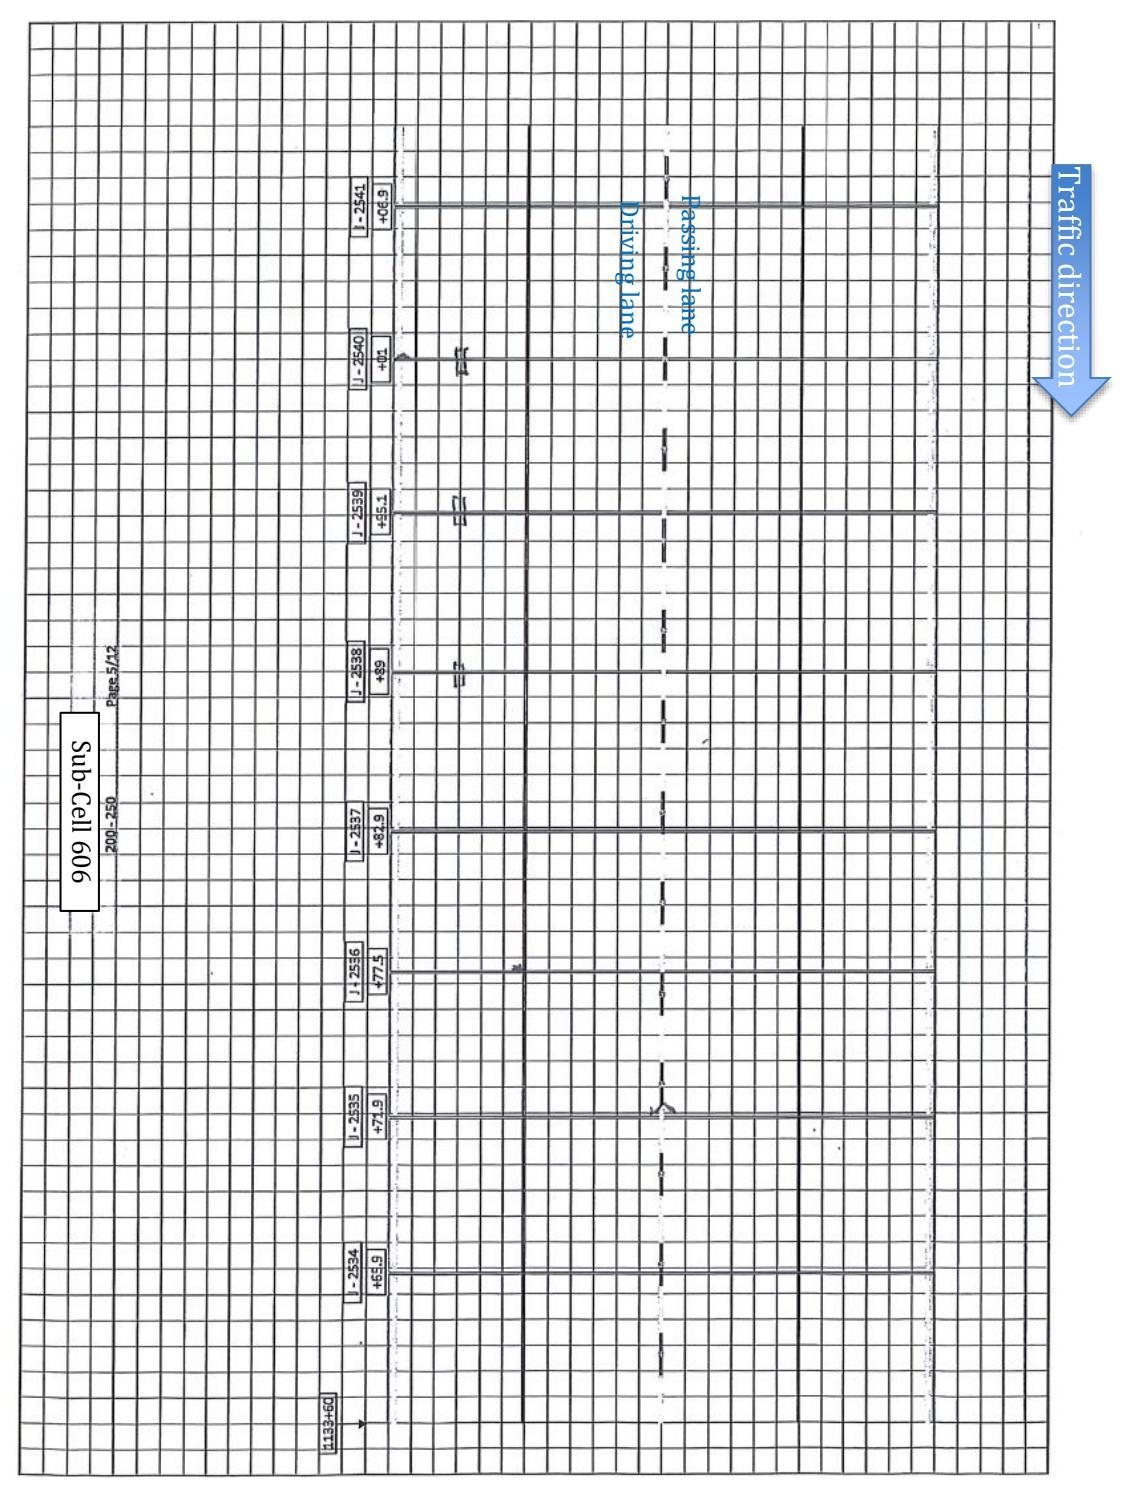
Figure A23: Distress map for Cell 606 .. contd.

Cracks until October 2019; cracks colored in red were documented on October 25, 2019.

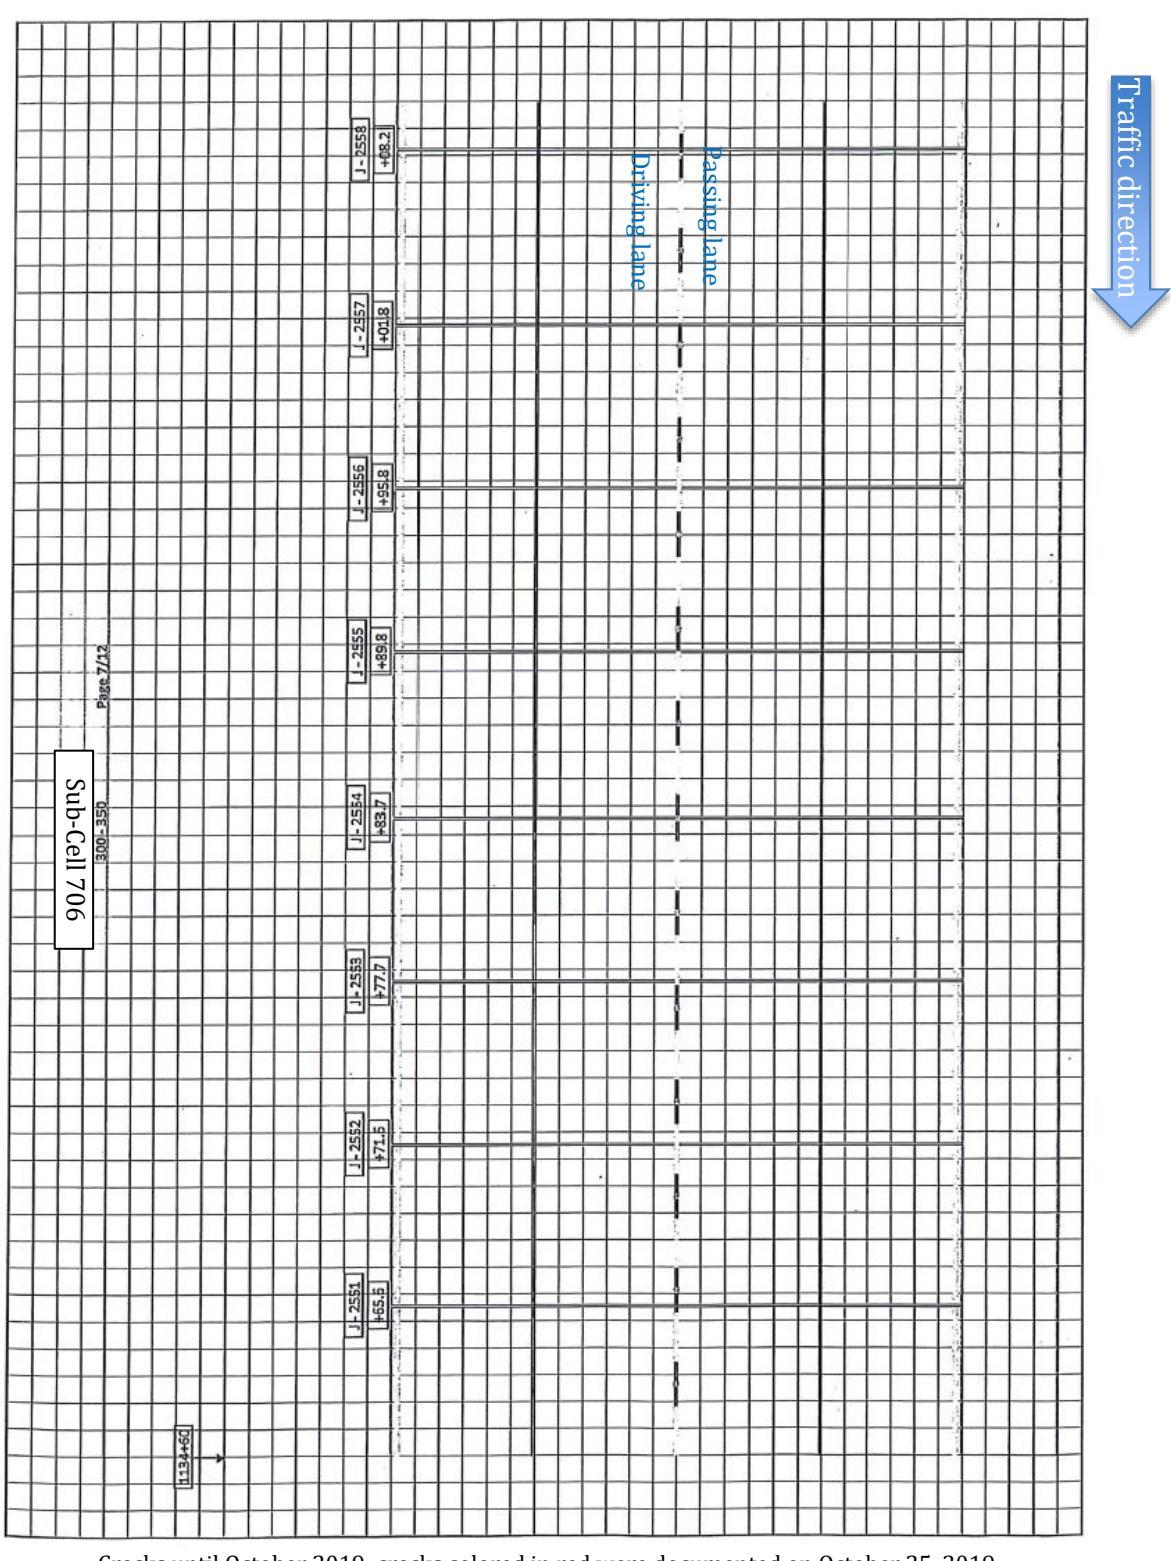
Figure A25: Distress map for Cells 706 .. contd.

Cracks until October 2019; cracks colored in red were documented on October 25, 2019.

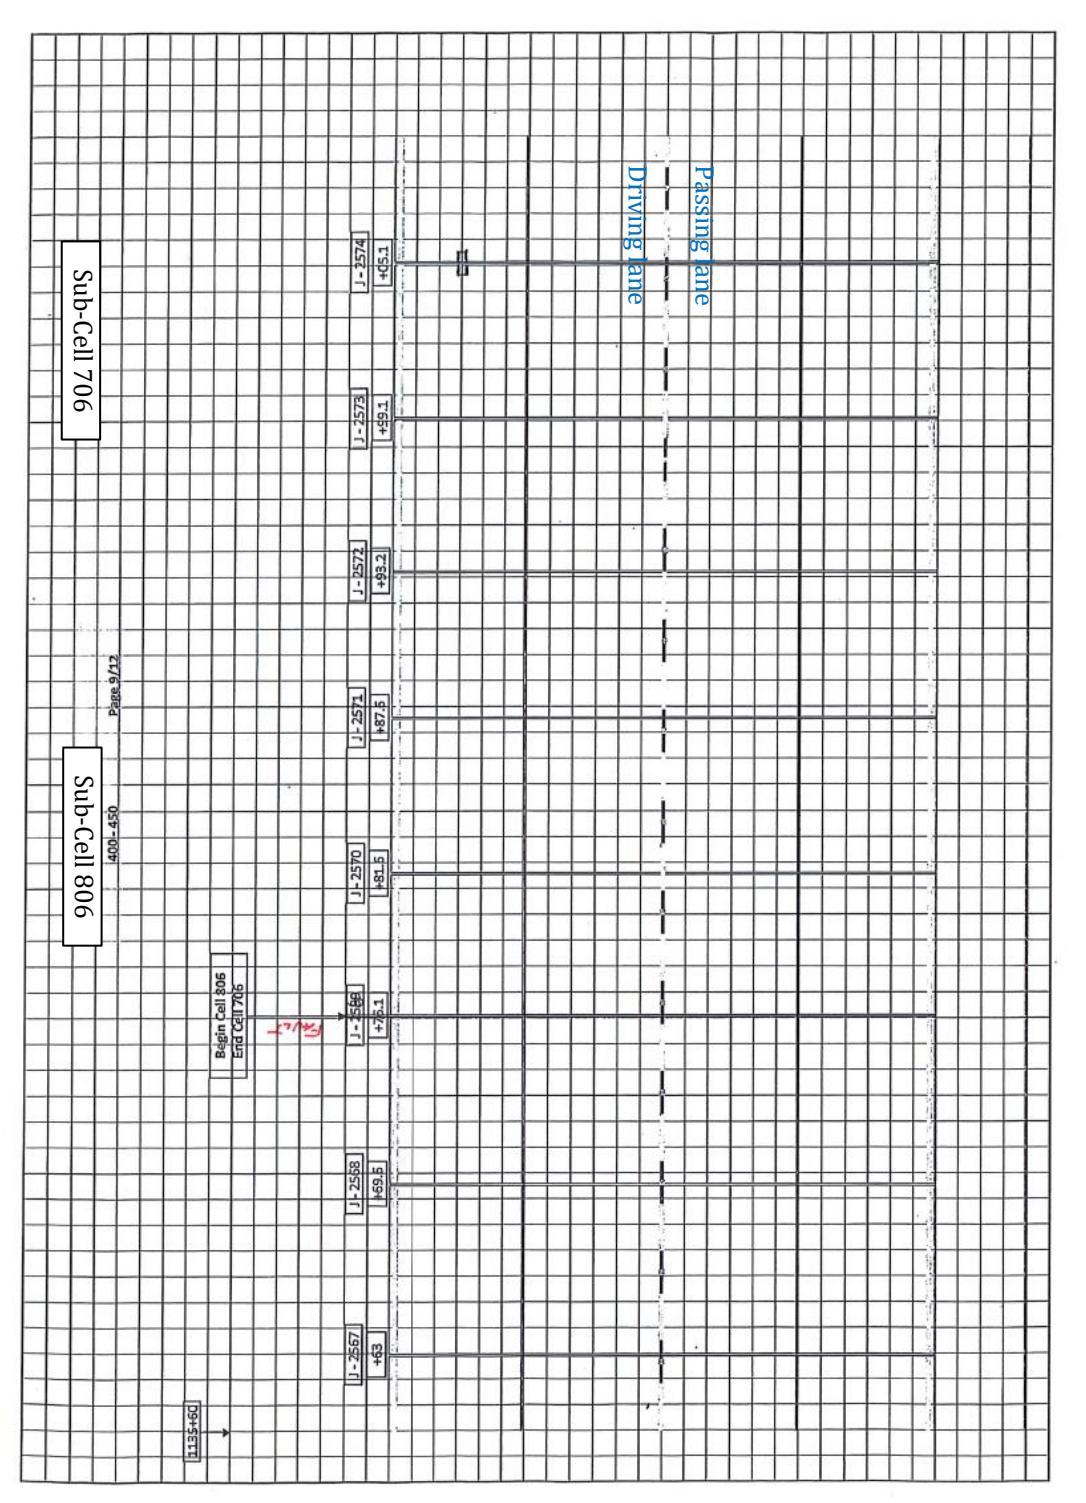
Figure A 27: Distress map for Cells 706 through 806.. contd.

Cracks until October 2019; cracks colored in red were documented on October 25, 2019.

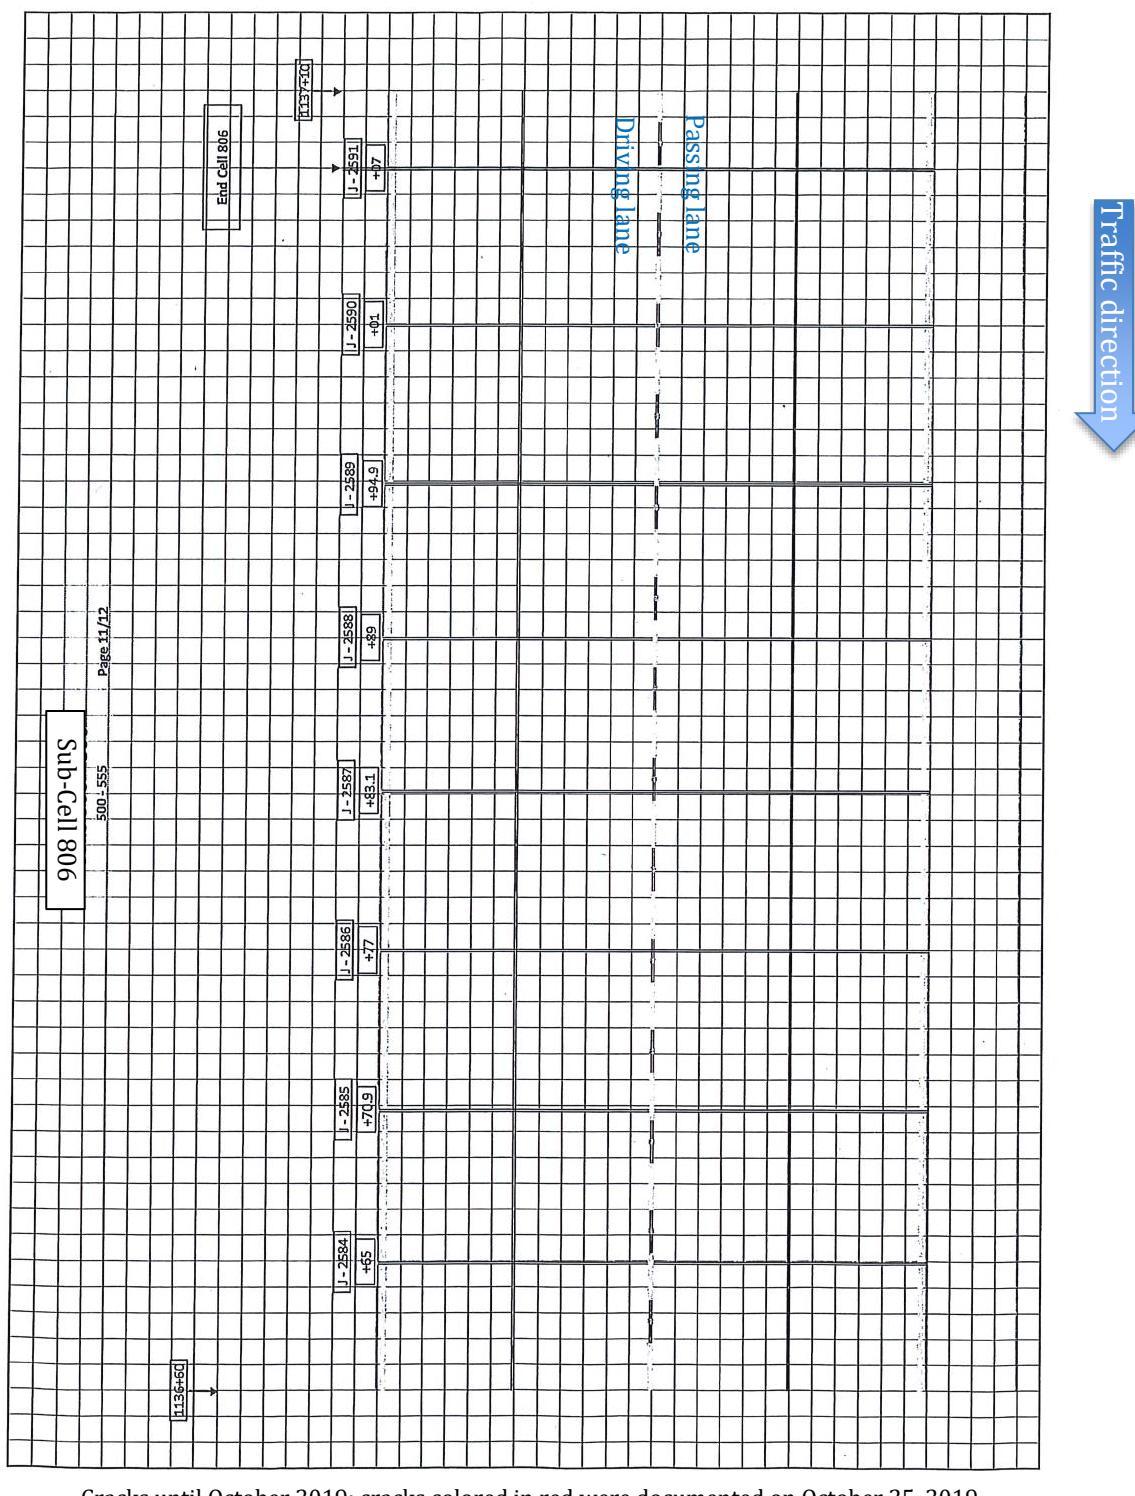
Figure A29: Distress map for Cell 806.. contd.

Cracks until October 2019; cracks colored in red were documented on October 25, 2019.

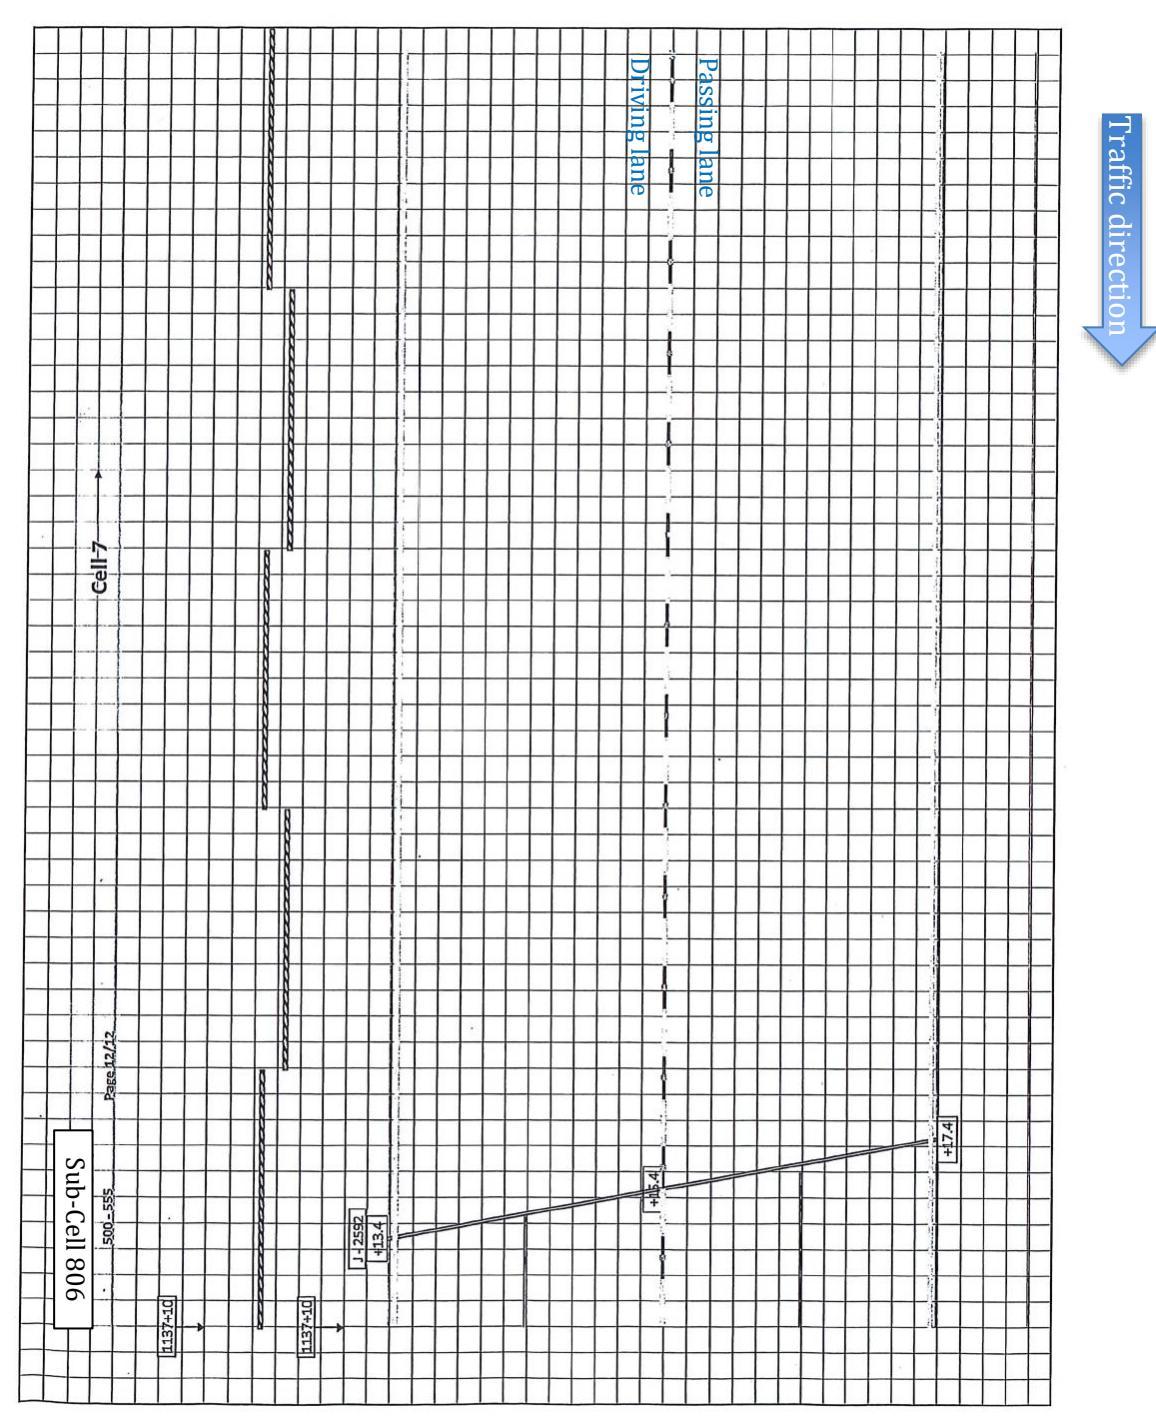
Figure A30: Distress map for Cells 806.. contd.

Cracks until October 2019; cracks colored in red were documented on October 25, 2019.

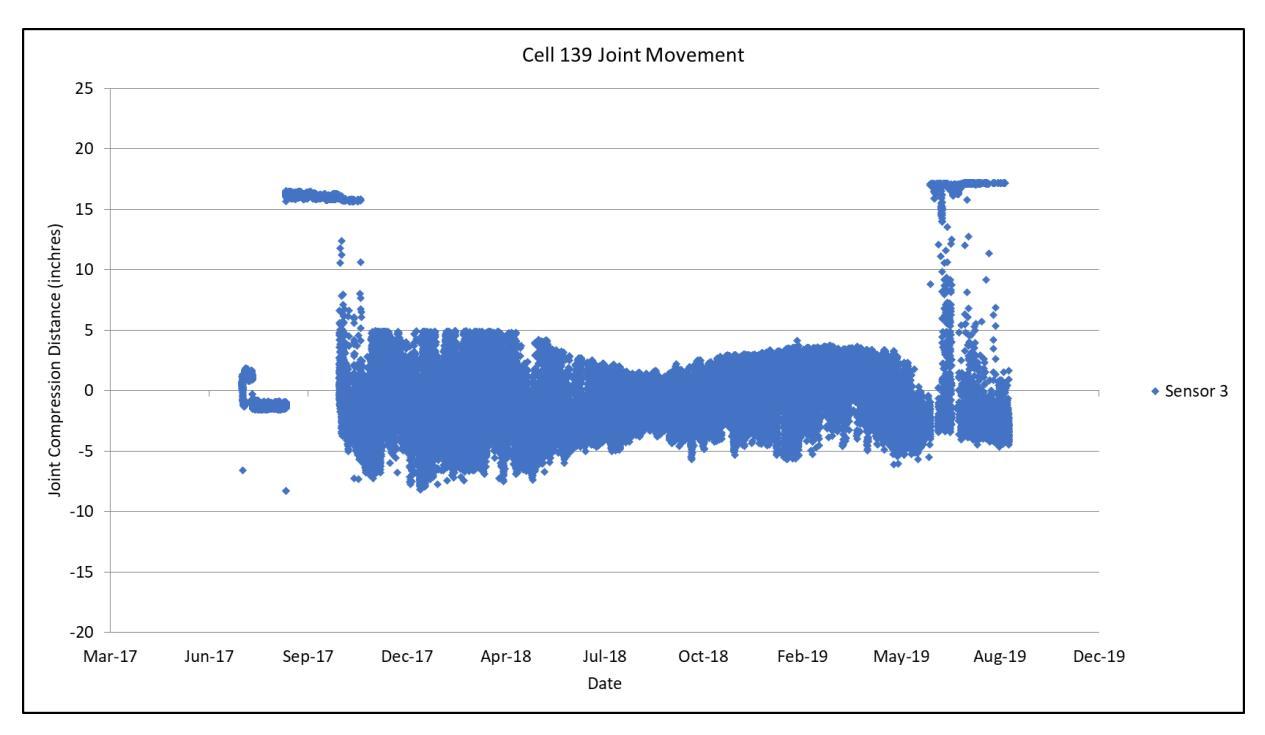
Figure B3. Joint movement data for Cell 139, Sensor 3 (Bad sensor).

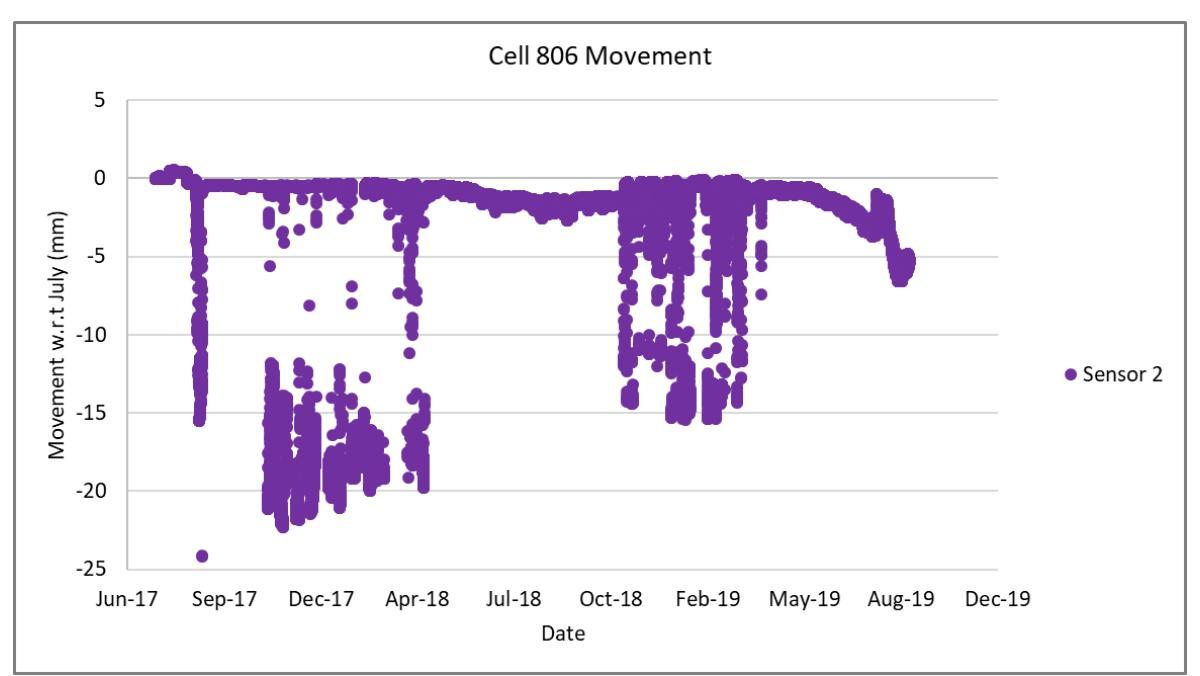
Figure B27. Joint movement data for Cell 806, Sensor 2 (Bad sensor).
