MnDOT Contract, No. 1003325, Work Order No. 56

NRRA Long-term Research Project

**Performance Benefits of Fiber-reinforced Thin Concrete
Pavement and Overlays**

**Task-2: Third Year Annual Cell Performance Report
(2019-2020)**

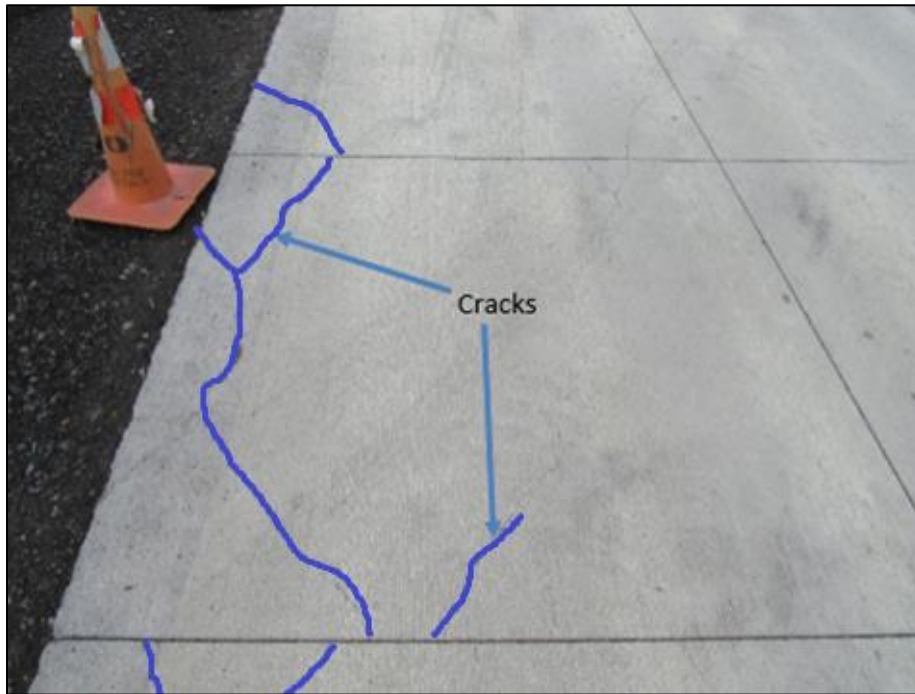
Figure 2-2. Cell 139 after exposure to construction trucks.

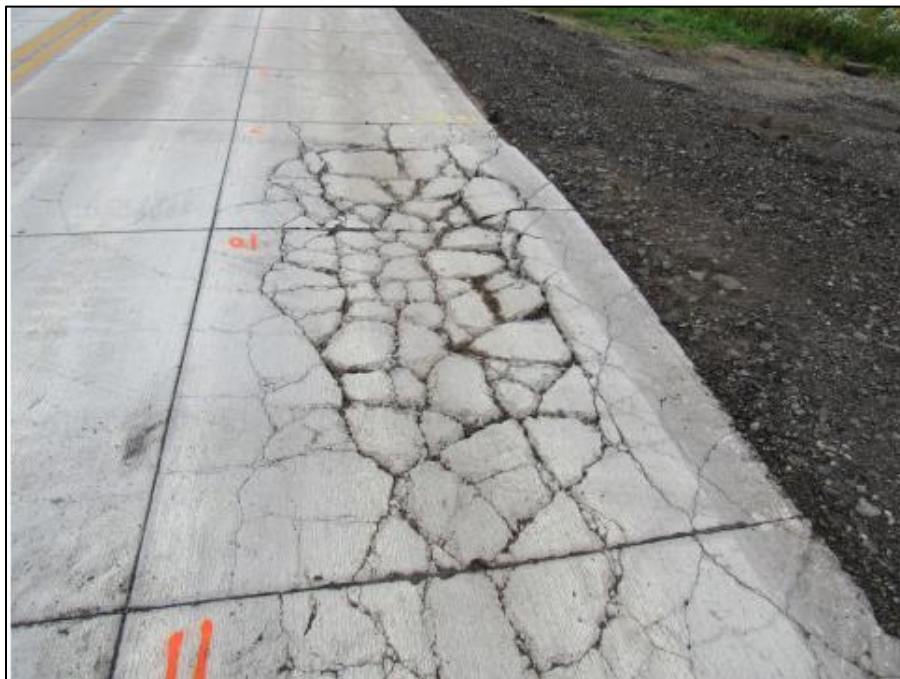
Figure 2-3. Shattered slabs in Cell 139 .

Because of the occurrence of the high severity of the distresses (slab shattering and depression along the wheel path), as many as 14 of the 44 slabs of the inside lane were replaced on September 27, 2018. Figure 2-5 shows a few photos collected during the removal of broken slabs and the construction of the replacement slabs. The replacement slabs were 4-inch thick, with eight of them containing fiber reinforced concrete and the other six with plain concrete. The fibers used in the replacement slabs were different and laterally stiffer than those used in 2017, as shown in [Figure 2-6](#)~~Figure 2-6a~~. The dosage of the fiber was 5.5 lb/cy, which corresponds to a 30% residual strength ratio. [Figure 2-6](#)~~Figure 2-6b~~ shows the ASTM C1609 test results for the two numbers of beam samples prepared at the site during the construction of replacement slabs in Cell 139. The replacement slabs have performed well; the distress survey conducted in the spring of 2020 showed only one crack in one of the fiber-reinforced replacement slabs. The location of this crack was at the transition joint of the new 4 inch thick replacement slabs and old 3 inch thick slabs. The reason behind this crack is more due to the repetitive impact of the wheel load than fatigue stresses.

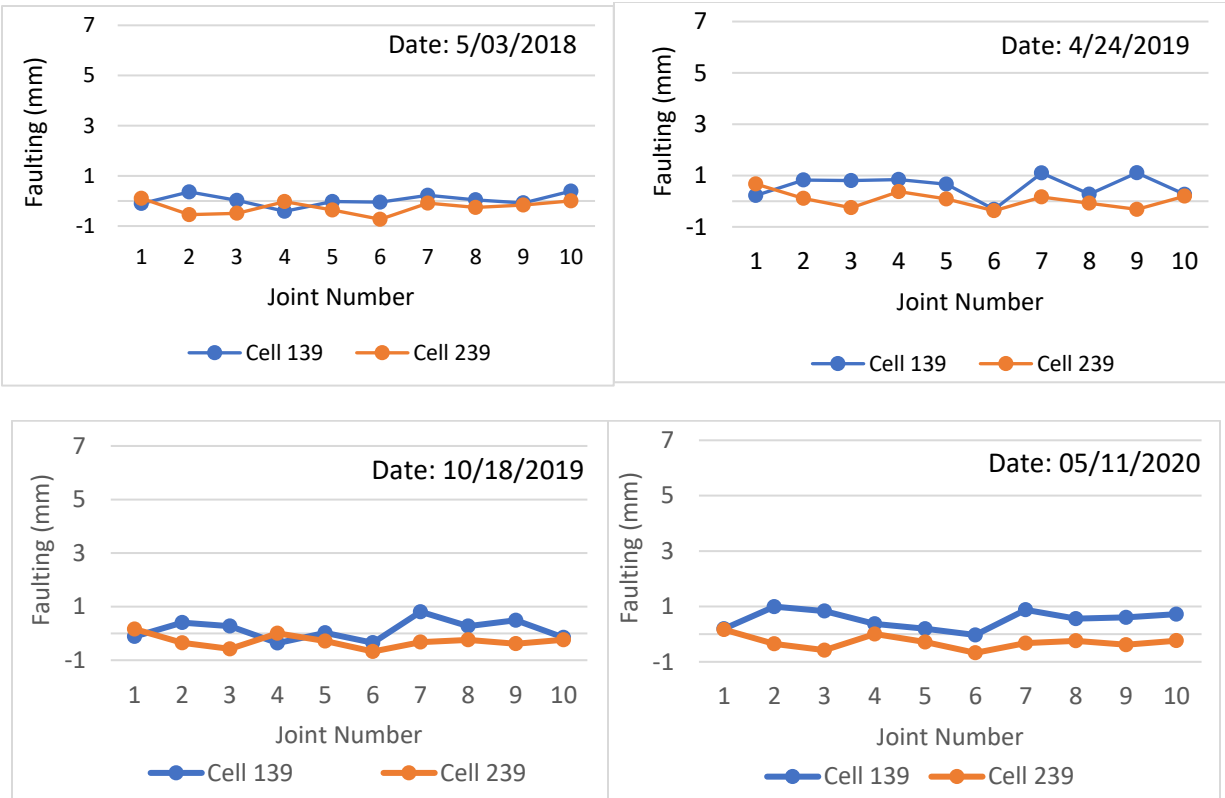
~~Figure 2-27~~ Figure 2-27 shows the faulting measured at various transverse joints of Cells 139 and 239. As previously mentioned, Cell 139 had experienced depression along the wheel path, so it may not also be appropriate to compare the faulting results between Cells 139 and 239. Interestingly, faulting results for Cell 239 showed mostly negative values. In general, a negative faulting value indicates that the leave side of the joint is at a higher elevation than the approach side. Negative faulting is usually not typical (Selezneva et. al., 2000), but since the magnitude of the faulting in Cell 239 is below -1 mm, it can be stated that there was not any notable faulting until the third year of service, at least at the joints where the faulting values were recorded. This shows that only three years of data (approximately 150,000 ELALs) is not enough to comment on the joint faulting trends of Cells 139 and 239. It can also be stated that the joint faulting was not the dominant distress for Cell 239; the fatigue cracking was the dominant distress by far. The other important fact is that the FWD measured deflections for the Cell 139 were significantly higher than the Cell 239 and all other cells considered in this study, which indicates that the lower thickness of the Cell 139 was just not enough to distribute the load on a wider area.

Figure 2-27. Faulting summary of Cells 139 and 239 at four different dates until May 11, 2020.

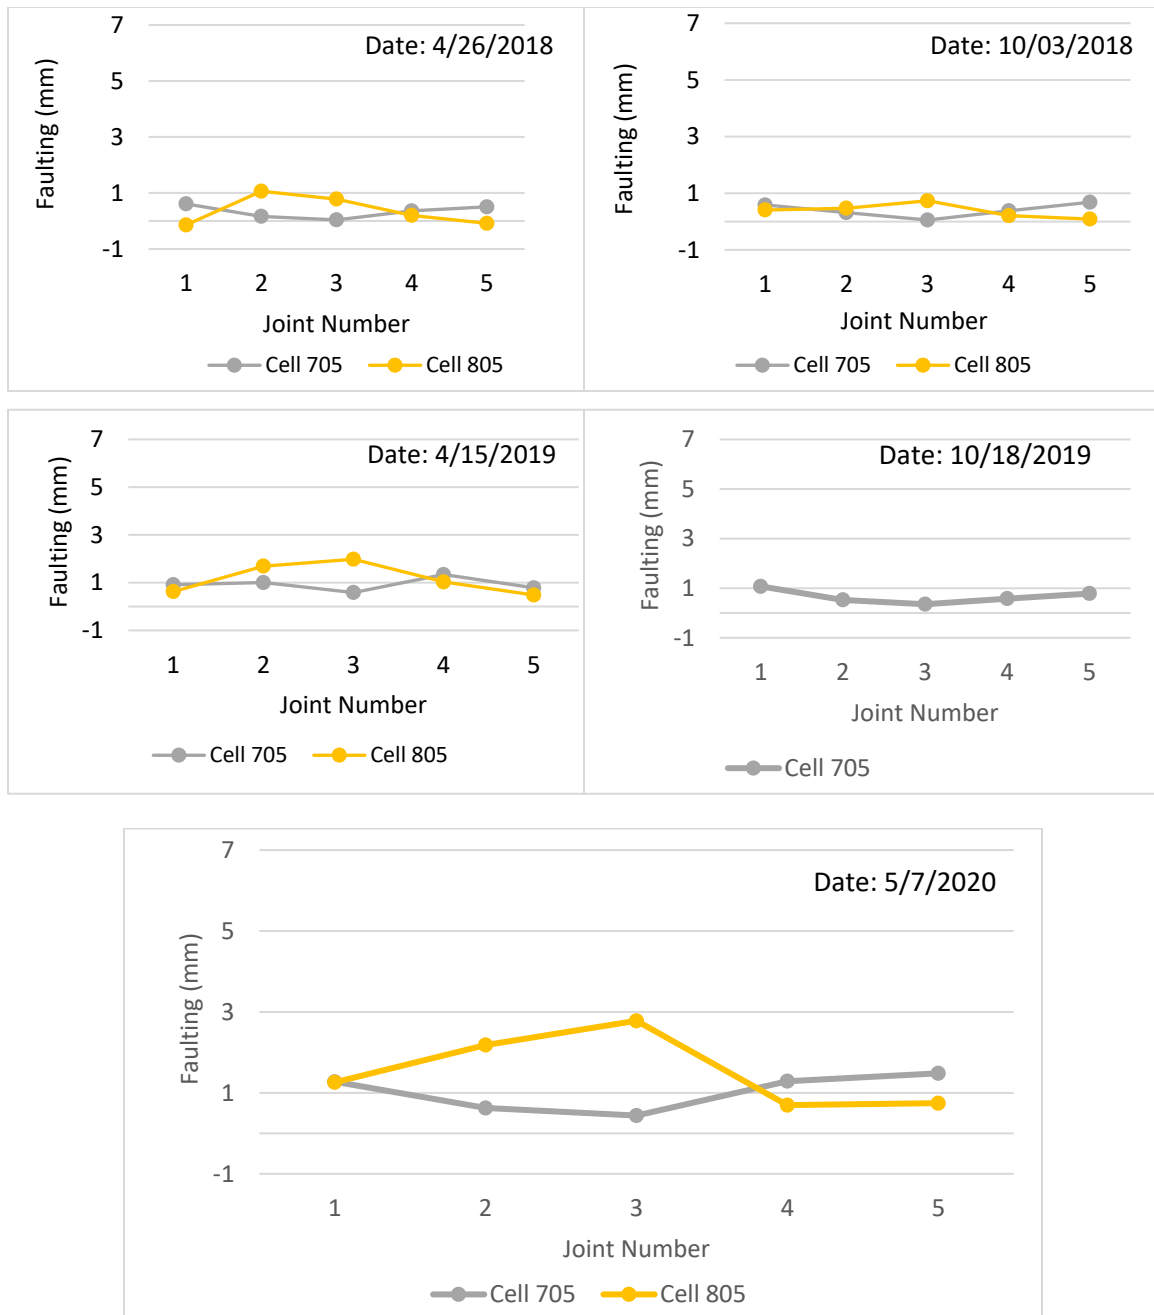
Figure 2-28 shows the faulting for Cells 705 and 805 until May 2020. Both Cells 705 and 805 had shown mostly positive faulting. One noticeable observation was that the faulting at Joint number-2 and -4 of Cell 705 was higher in April 2019 (spring) than what was measured in October 2019. May 2020 showed Joint 4 having more faulting than the previous year's measurement, but Joint number 2 surprisingly reported the same faulting measurement as in October 2019. Even though the faulting values in these cells were around 1 to 2 mm, Cell 805 experienced a slightly higher amount of faulting. It may happen that the narrower and lighter slabs in Cell 805 compared to Cell 705 move relatively more under the wheel load. Faulting values may also have been affected by the large number of cracked panels in these cells.

Figure 2-28. Faulting summary of Cells 705 and 805 until May, 2020.

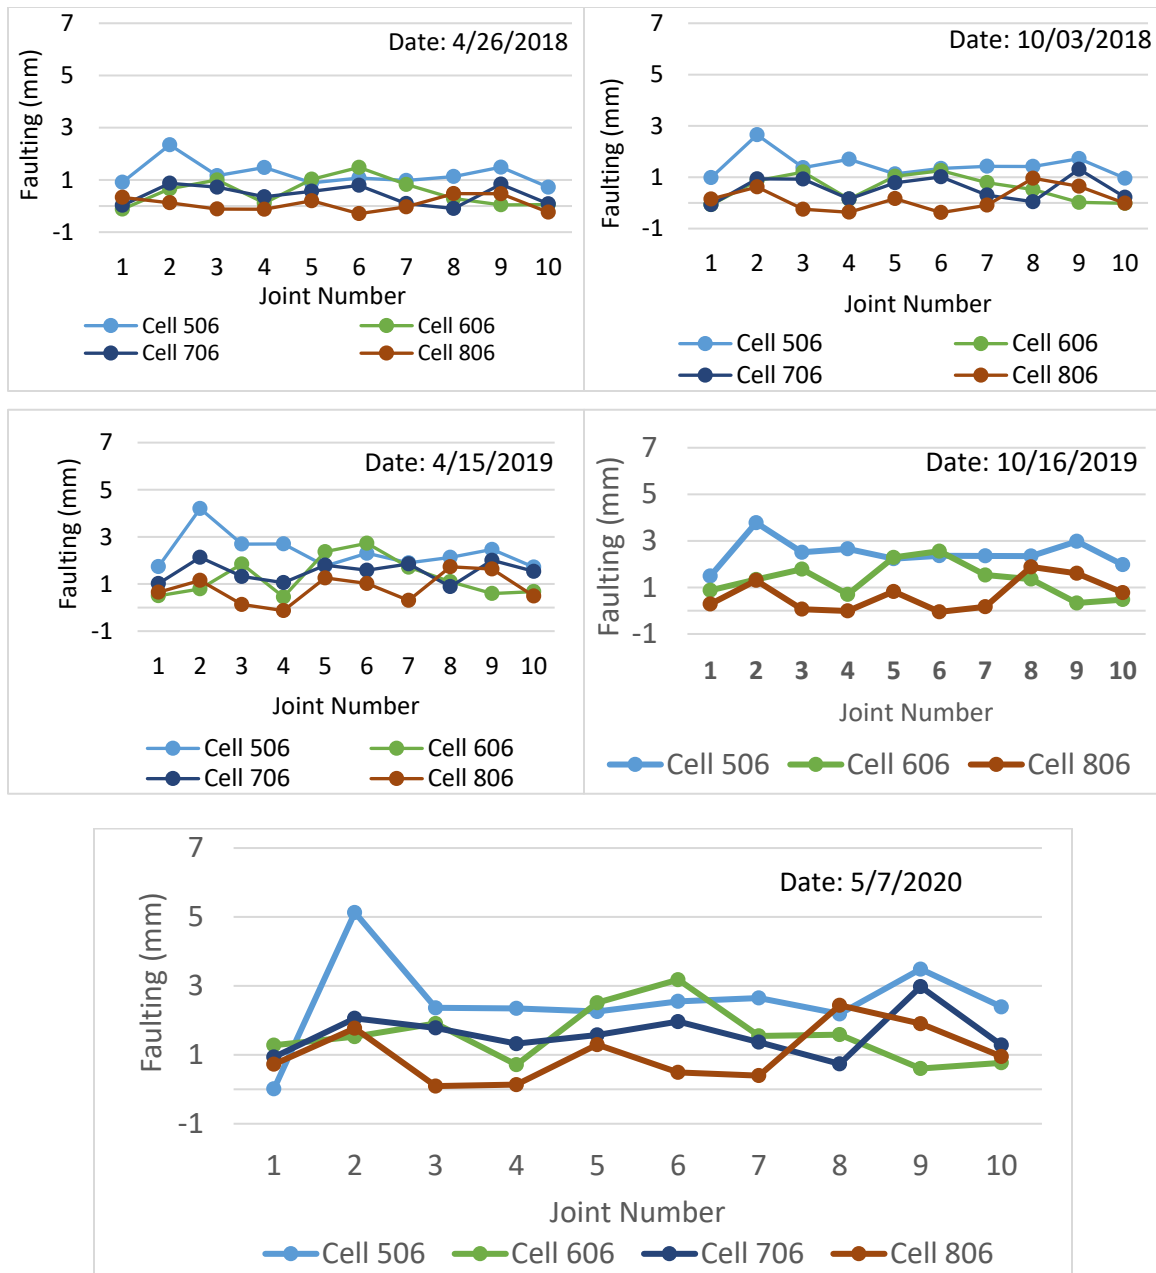
~~Figure 2-29~~Figure 2-29 shows the faulting measured in Cells 506, 606, 706 and 806 until May 2020. Cell 506, which was constructed with plain concrete, experienced the highest faulting (up to 5 mm) among the four cells. ~~Figure 2-30~~Figure 2-30 shows a photograph of noticeable faulting in Cell 506 (note that there is a sunken corner crack in the leave slab, which exaggerated the faulting in the photo). ~~Figure 2-31~~Figure 2-31 shows the trend of average faulting versus fiber dosage. Cell 606, which was 6-inch thick (higher aggregate interlock) and constructed with a fiber dosage of 5 lbs./cy experienced approximately 82% less faulting than Cell 506 until May 2020. Cell 706, with a fiber dosage of 8 lbs./cy, also experienced less faulting than Cell 506. Cell 806 which had the highest fiber dosage at 11.7 lbs./cy, experienced lower faulting compared to any other FRC cell. The faulting in the Cell 806 indicates that 0.75 volume fraction fiber still could not completely arrest the faulting. It may be stated that the interstate type traffic loadings on a 5 inches thick pavement are extreme (3 million ESALs in 3 years in this case) and should therefore be considered as an accelerated loading situation. Normal traffic levels associated on a 5 inches thick concrete pavement (on a gravel base) would be lower, and therefore may not have resulted in this level of faulting so soon.

Figure 2-29. Faulting summary of Cells 506 through 806 until May, 2020.

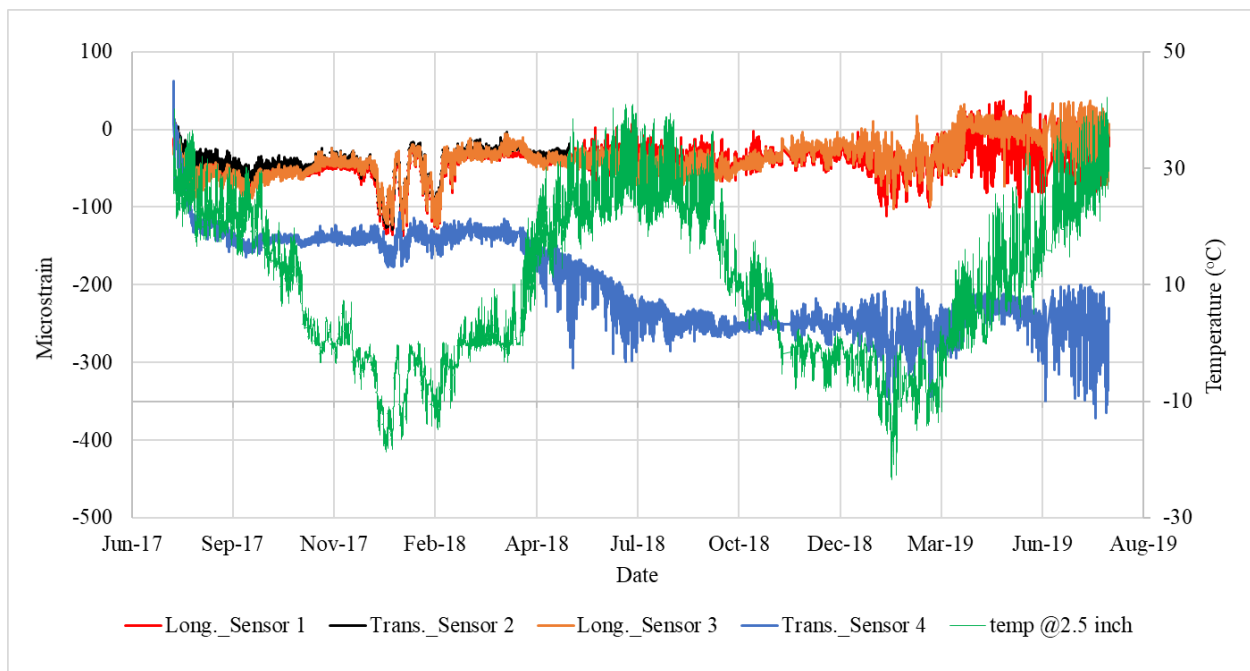
Figure 3-26. Environmental strains and slab temperature for Cell 139.

In Cell 139, four vibrating wire sensors were installed, two in the longitudinal direction and two in transverse directions, all at the bottom of the slab, at a depth of 2.5 inches (a half-inch from the bottom of the concrete). [Figure 3-26](#) shows the environmental

strains measured by the four sensors; sensor data is available until July 2019. Three out of four sensors showed a similar trend, while the fourth sensor, which was in the transverse direction, showed a completely different and higher negative (tensile) strain compared to the other three. The less variation between the two sensors in the transverse direction and one longitudinal direction may be attributed to the small panel size and somewhat similar boundary conditions along three sides of each slab.

Nevertheless, all the sensors have provided negative strains, indicating that slabs were in a state of contraction. A close look at all these plots indicates that the negative strains in all the sensors sharply increased from July 18, 2017, until the mid of August 2017. Although the temperature declined during this period, the drying shrinkage could have played an influencing role. After that, the strains in all the sensors followed the temperature variation, recording higher tensile strain during the winter, and lower tensile strain at warm temperatures.

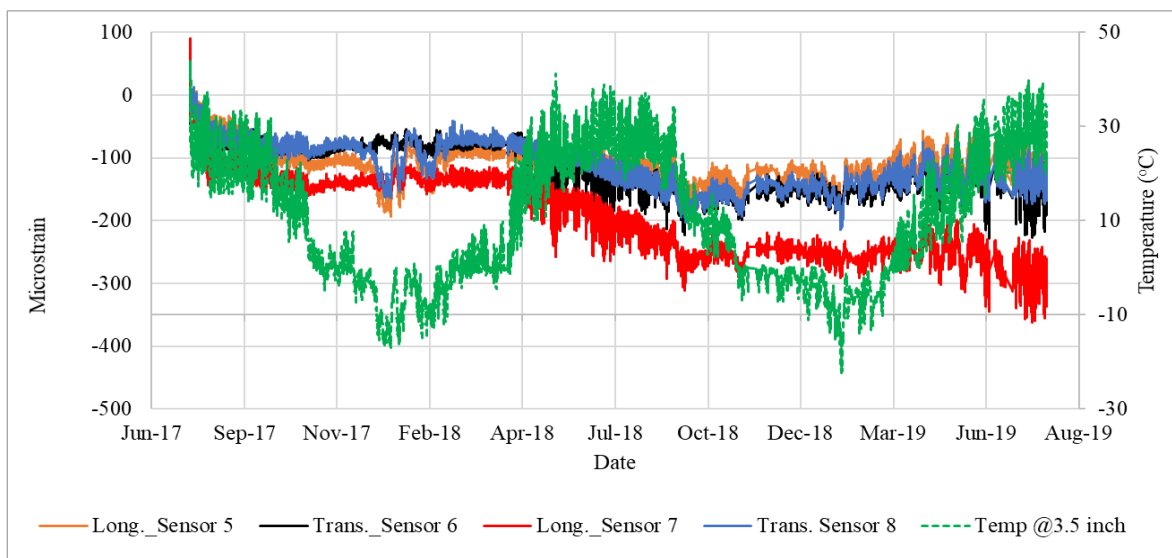
Figure 3-27. Environmental strains and slab temperature for Cell 239.

Figure 3-27 shows plots for the environmental strains and temperature at the 3.5-inch depth of the slab for Cell 239. Like Cell 139, vibrating wire sensors were installed only at the bottom of the slab because of the thickness limitation. As can be seen in Figure 3-27, the strains varied with the seasonal temperature and also experienced a sharp increase in negative strain until the mid of August 2017. The strain measured during the winter was relatively high, in general. Sensor 7, which was placed along the longitudinal direction shown a higher amount of strains than the other three sensors in the cell. The overall trend of the strains measured in Cell 239 was similar to what was observed in Sensor 4 of Cell 139, indicating an increase in the strain values with the age of the pavement. Compared to the sensors in the transverse directions, the sensors in the longitudinal direction experienced greater strains. The difference in magnitude of the environmental strains in both Cells 139 and 239 was not large.

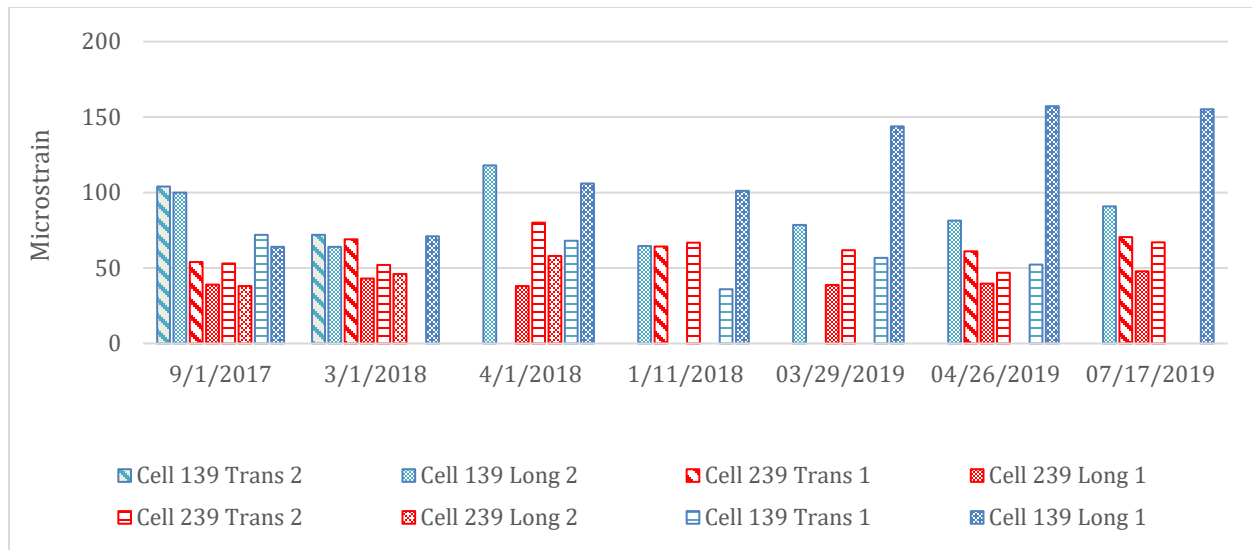
Figure 3-36. Dynamic strains recorded in Cells 139 and 239.

[Figure 3-36](#) shows the dynamic strains recorded by the sensors in longitudinal and transverse directions for Cells 139 and 239. Some strain values are missing at multiple dates because of the malfunction of some sensors, also no data were collected for these two cells in 2020. Overall, the magnitude of the strains in Cell 139 was higher than that was recorded in Cell 239. One sensor in Cell 139, placed in the longitudinal direction, showed that the magnitude of the strain increased with time. Other sensors did not show any trend.

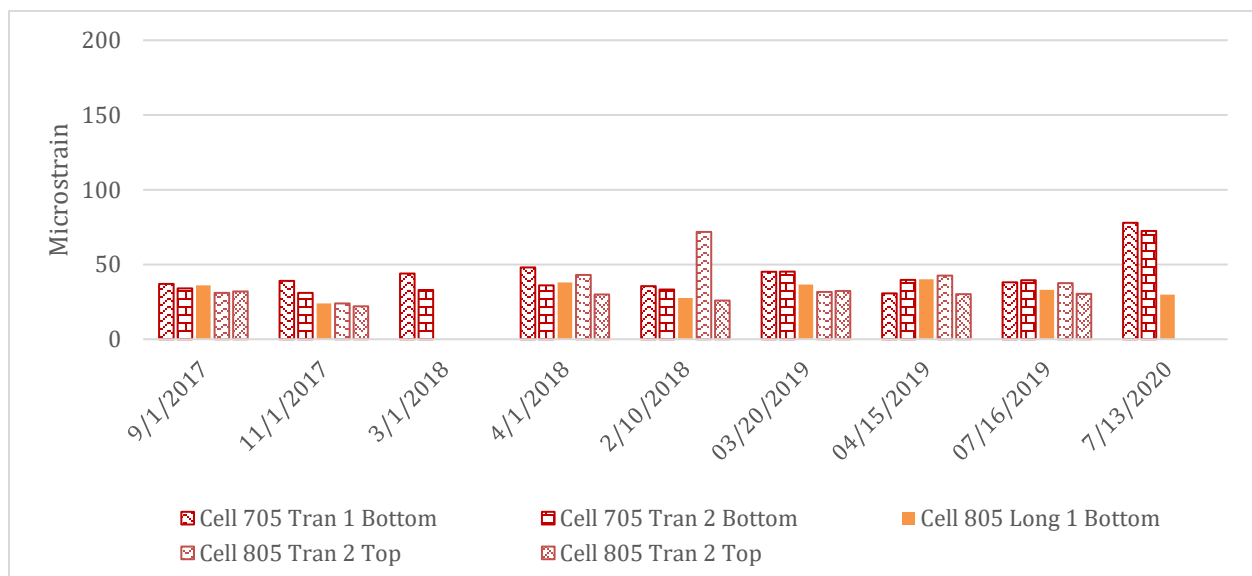
Figure 3-37. Dynamic strains recorded in Cells 705 and 805.

[Figure 3-37](#) shows the comparison of dynamic strains between Cells 705 and 805. Compared to Cells 139 and 239, Cells 705 and 805 experienced far lower strains. The strain measured in 2020 was almost double of the previous reading. The strains recorded in the Cell 705 and 805 did not show a significant difference, with slightly higher strain recorded for Cell 705 for some dates.

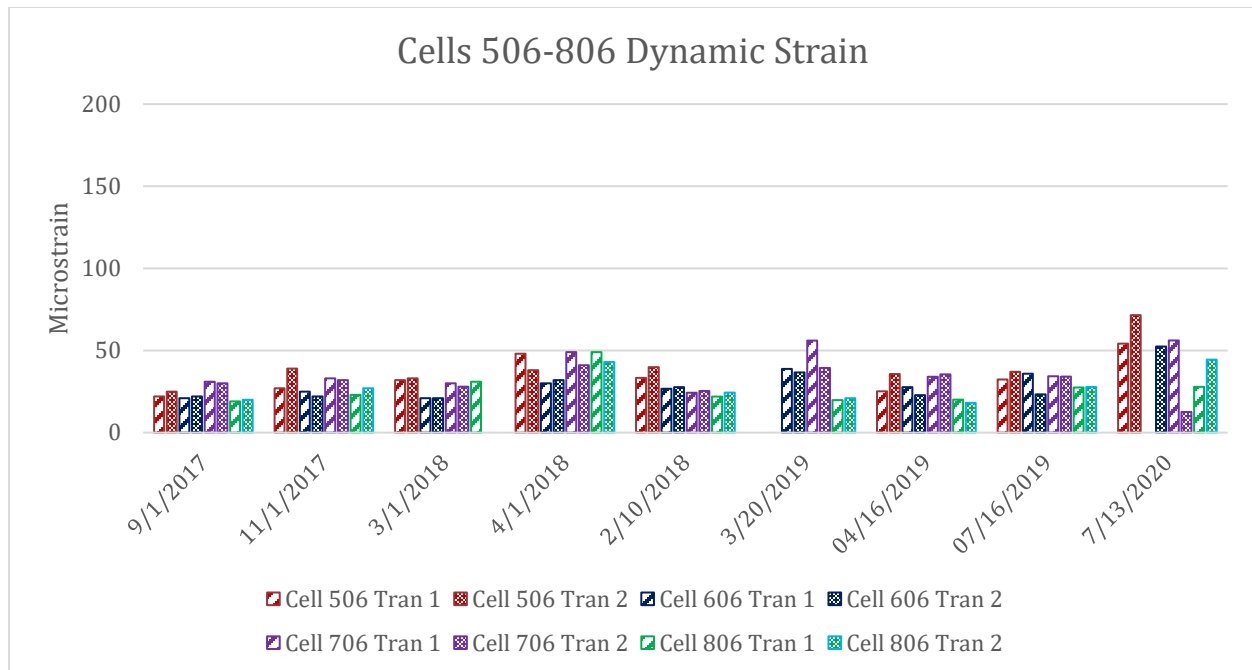
Figure 3-38. Dynamic strains recorded in Cells 506 through 806.

Cells 506, 606, 706, and 806 are the cells that compare the performance for different dosages of fibers. Dynamic sensors in these cells were laid along with the transverse directions only. The magnitudes of the dynamic strains in these cells are comparable. Data collected in 2020 shows that Cell 506 recorded slightly higher strain value compared other cells.

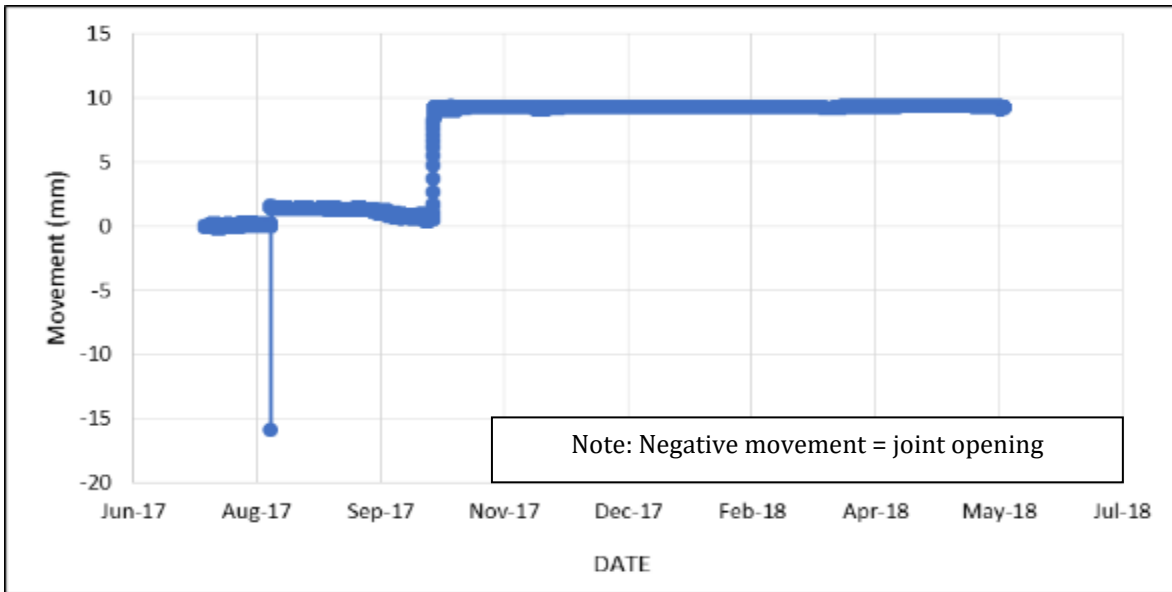
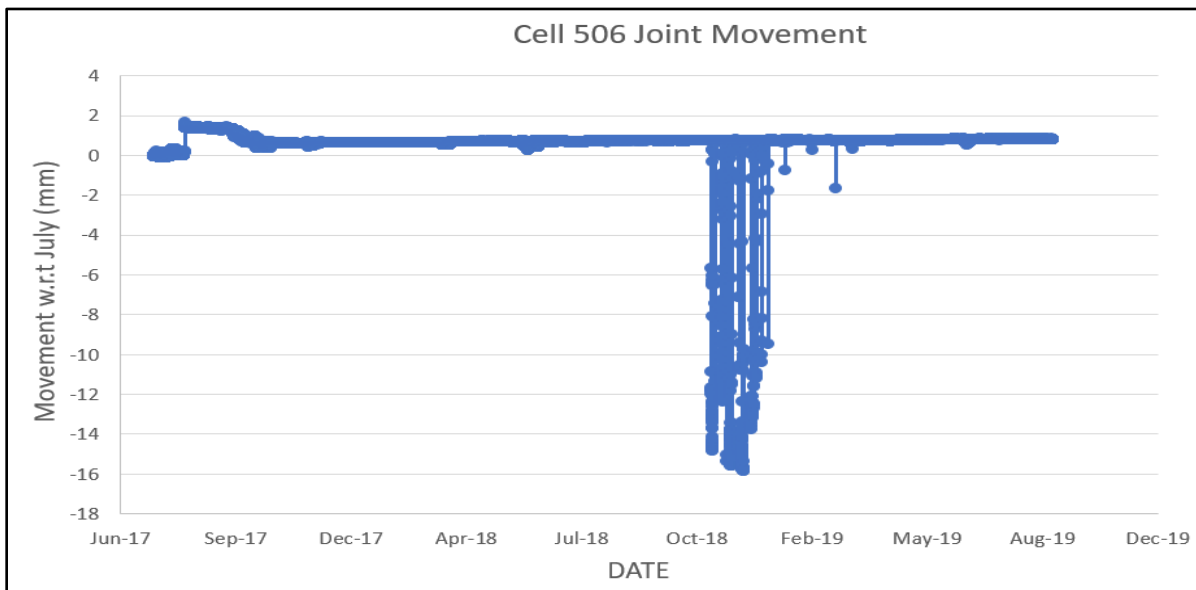
Most of the joint opening sensors had to be re-installed after their first installation; protection for the sensor was applied during the reinstallation time. For the sensors that were reinstalled, data were adjusted to neutralize the re-installation related jump ([Figure 3-41](#)~~Figure 3-41~~). For the sensor data presented in [Figure 3-41](#)~~Figure 3-41~~, it can also be seen that some erroneous data was recorded for some duration between September 2018 through January 2019. [Figure 3-42](#)~~Figure 3-42~~ provides an example of joint movement readings collected by Sensor 3 of Cell 706; in this case, the joint in question probably did deploy before the collection of the first reading. This plot provides a good example of a relative joint opening with respect to the first reading. It can be seen that the joint opening was maximum during the winter months, after which the joint opening reduced with the temperature increase. Some sensor readings were discarded because of erroneous data, where the crack opening readings fluctuated significantly.

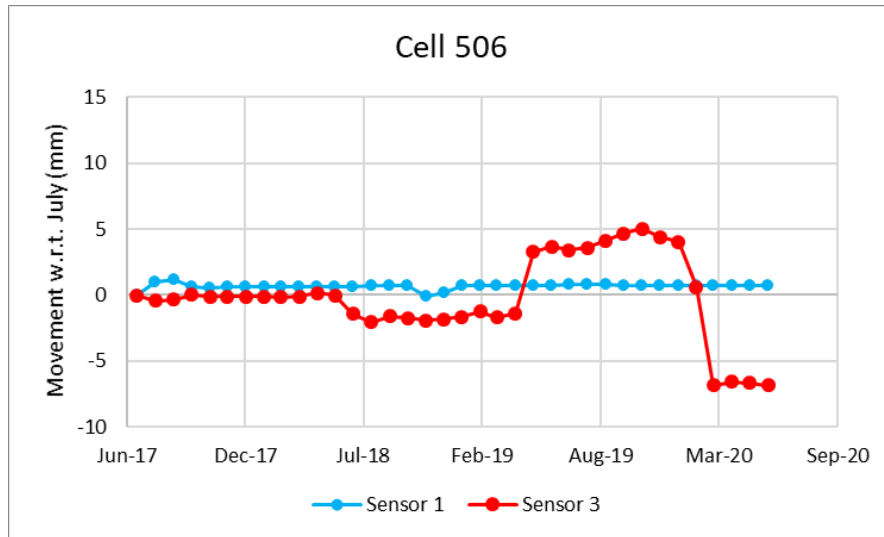
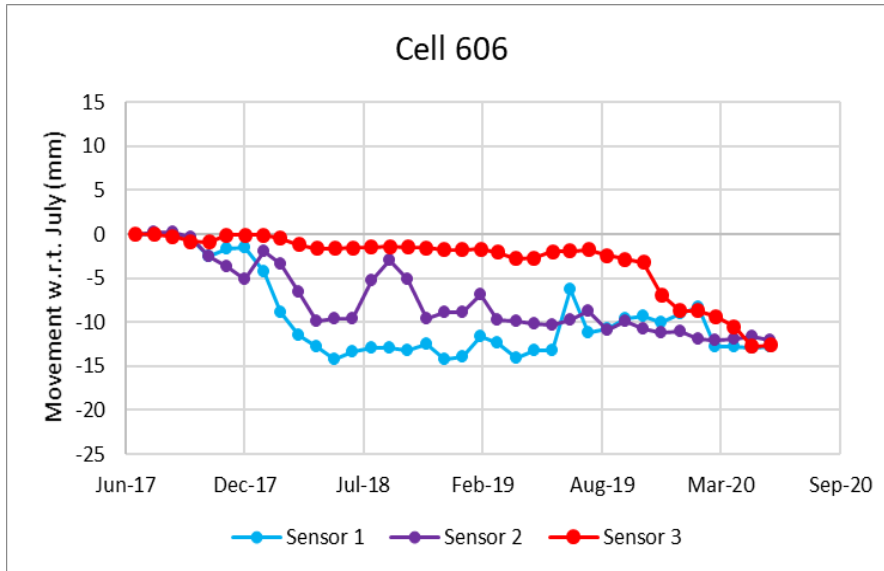
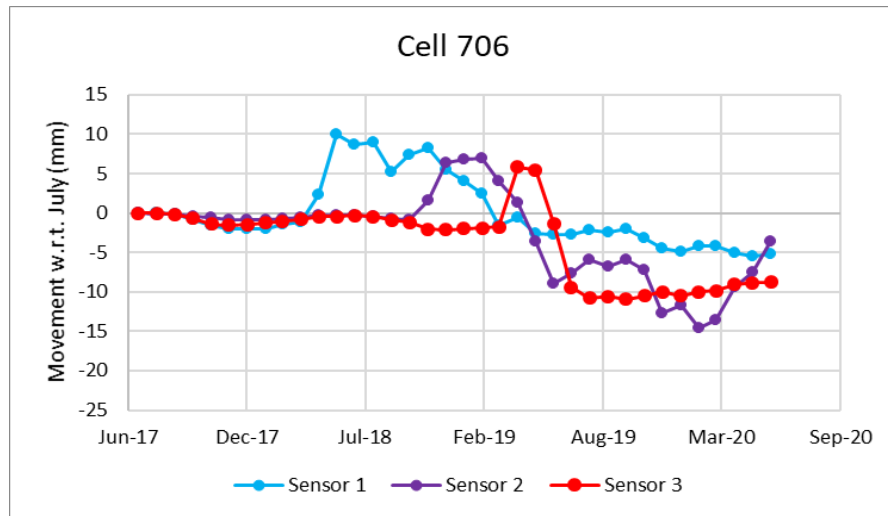
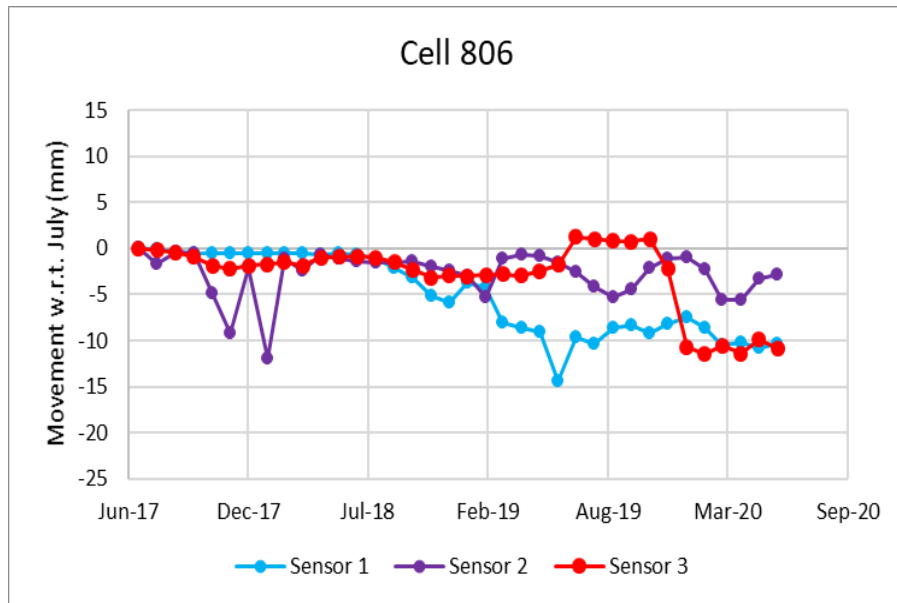
Cell 506 does not contain fibers, and it was anticipated that larger joint openings would be observed in this cell compared to its counterparts (Cells 606 to 806). One sensor in this cell remained dormant throughout the three service years. Cell 606 contained 5 lbs./ cy fibers. Two sensors in this cell indicate that the joints did not close in summer once they opened in the first winter. The other sensor of Cell 606 shows joint opening in fall of 2019. Joints of Cells 706 and 806 showed movement after 2019-2020 winter.

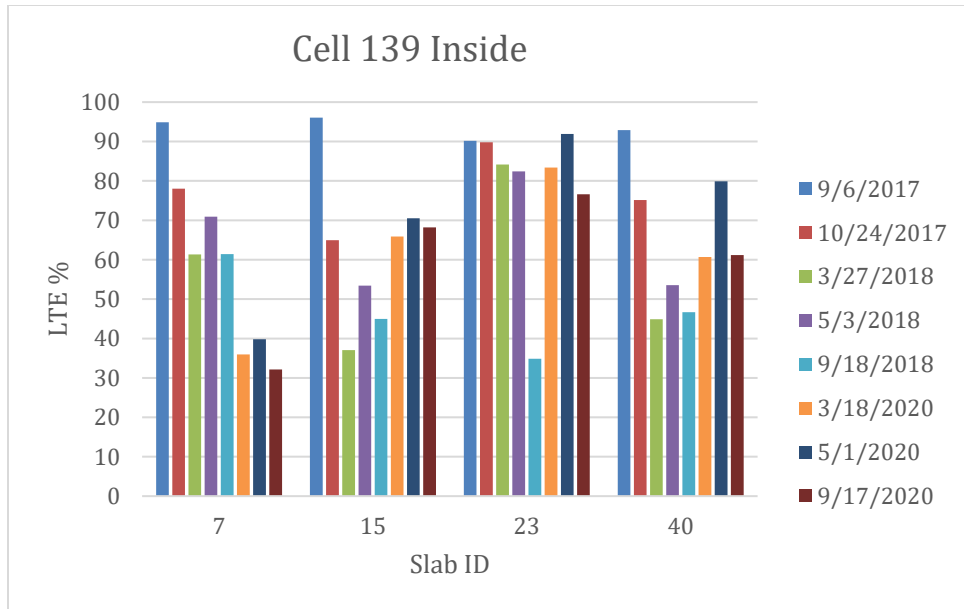
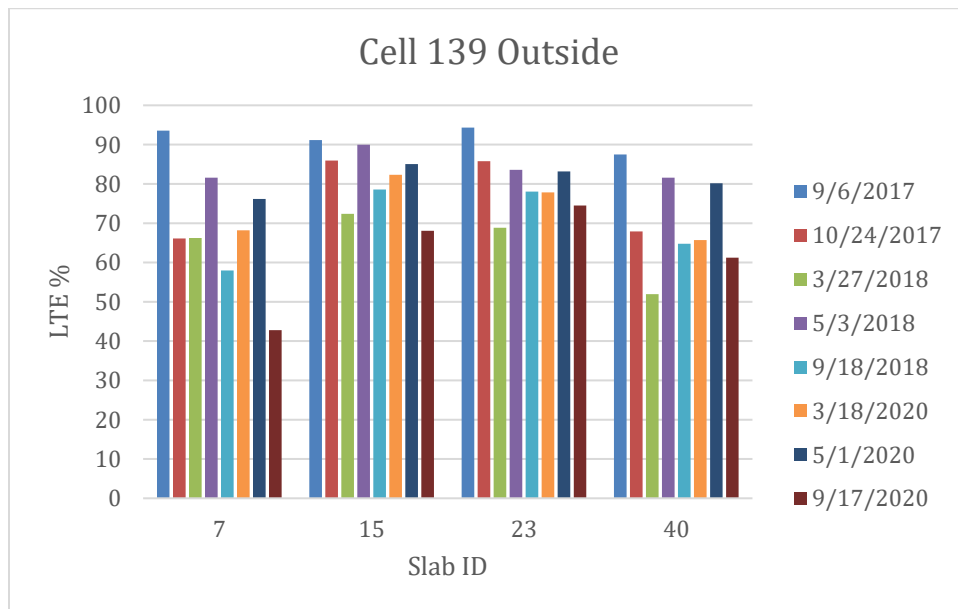
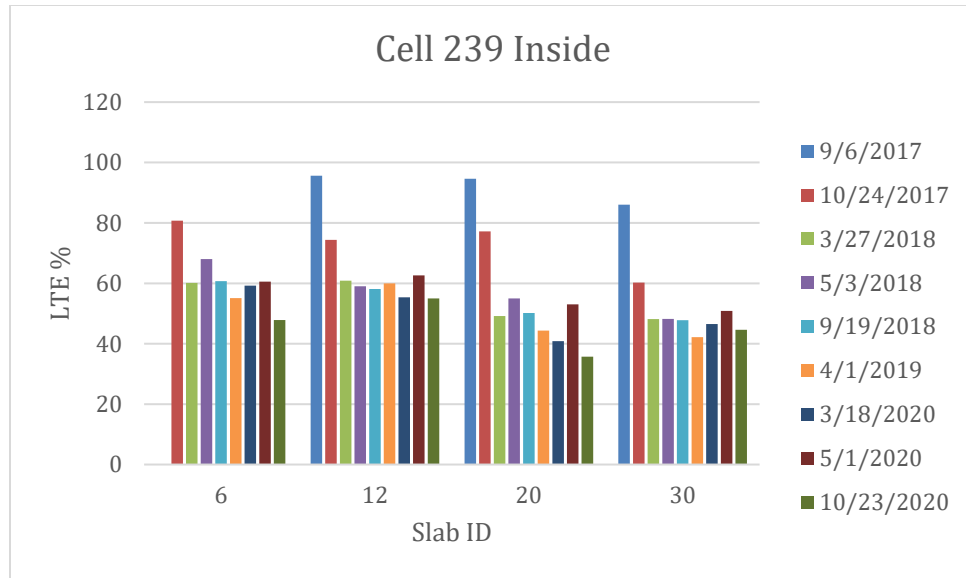
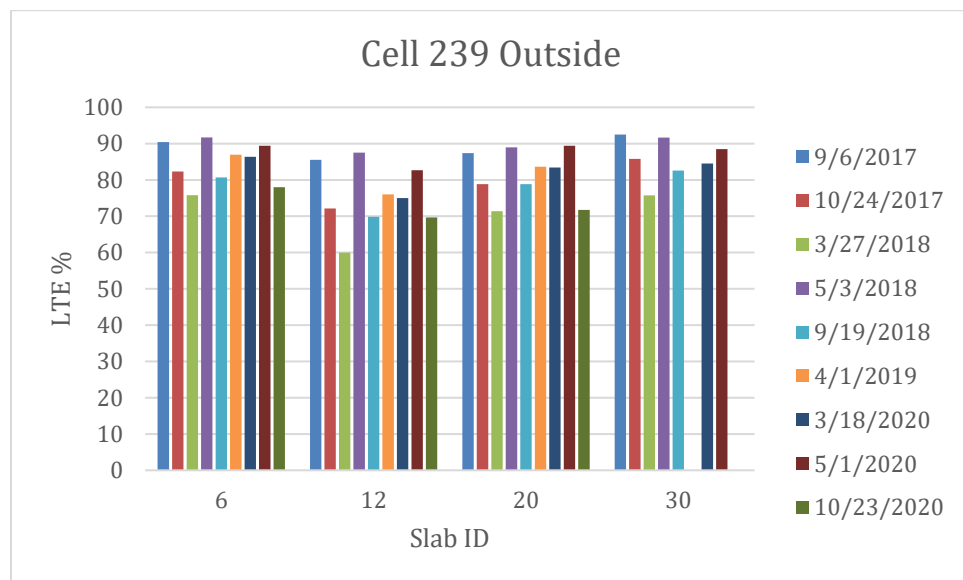
~~Figure 4-1~~ ~~Figure 4-1~~ through ~~Figure 4-16~~ ~~Figure 4-16~~ show the LTE of all the cells. The LTE data of the Cells 139 and 239 were comparable when the first test was conducted on September 6, 2017 and it ranged between 85 and 94%. The LTE of these two cells then continued to drop with the traffic load. The outside lane of both the cells, where traffic load is not applied, showed consistent higher LTE values than the inner lane, even though the Cell 139 experienced some LTE drops with age. In the year 2020, the Cell 139 inner lane showed more LTE when it was expected to be lesser than the previous years. The slab ID 23 showed the maximum LTE which is understandable because this slab was replaced by September 2018 and since then it has been performing better when compared to the other slabs of Cell 139 which were not replaced. Although, slab ID 7, 15 and 40 were not replaced. Hence their increase in LTE is not understood.

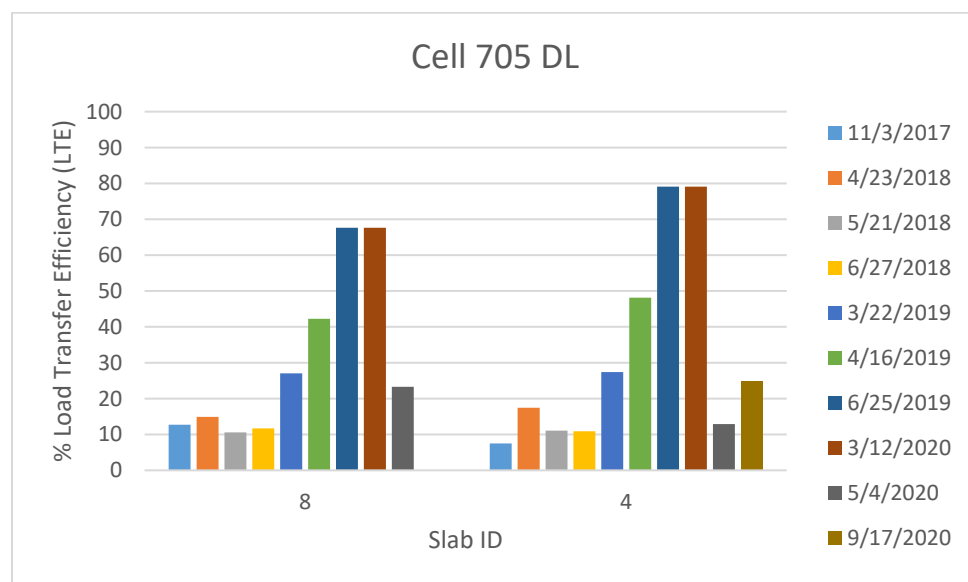
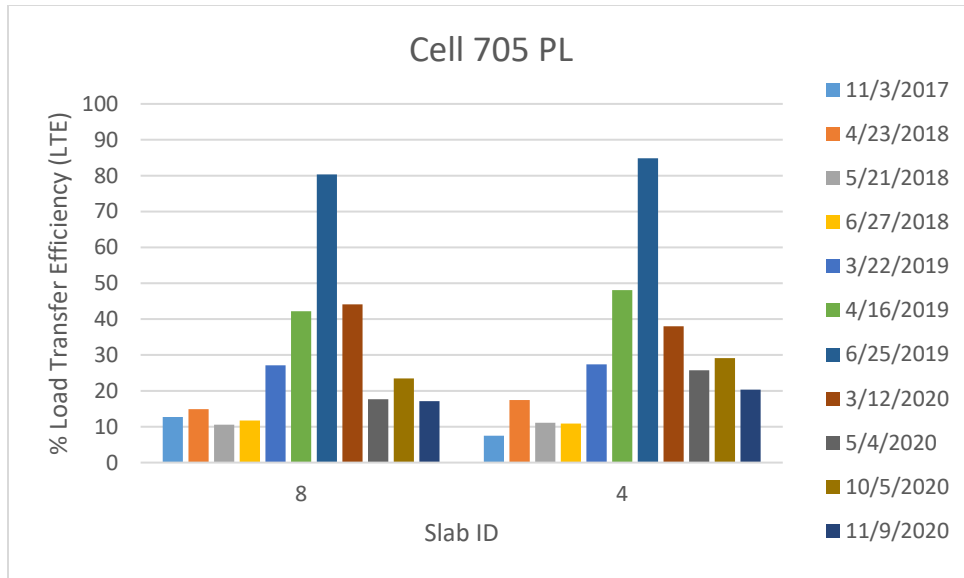
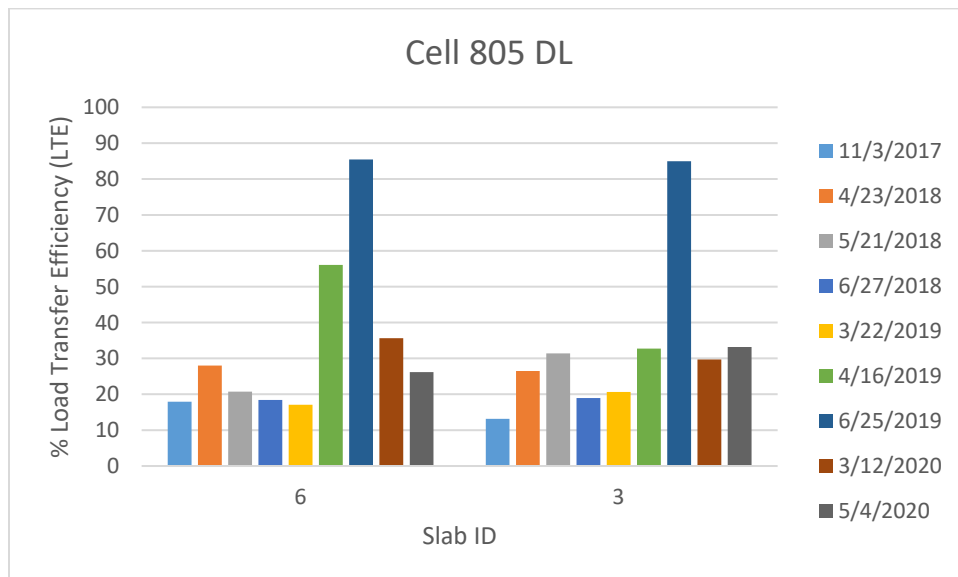
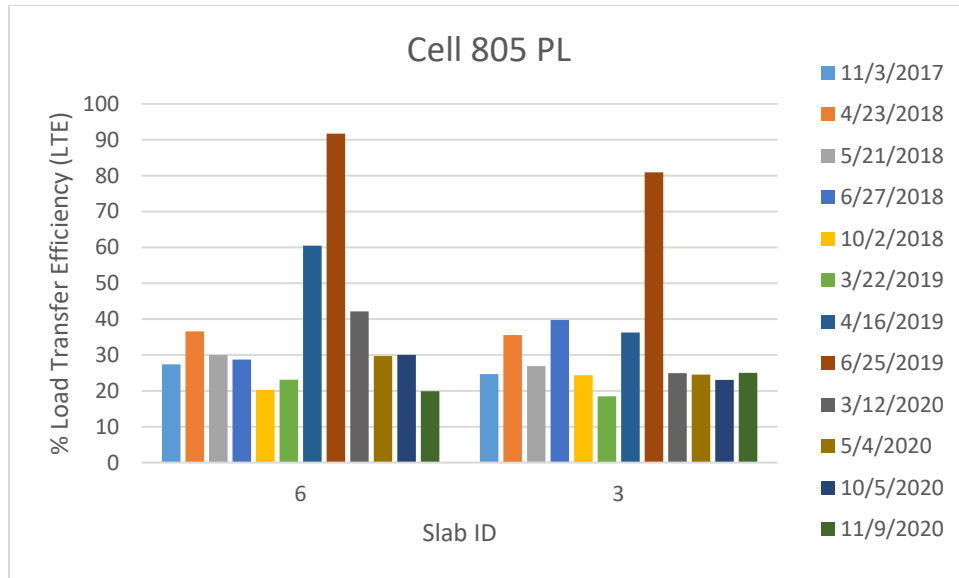
The wide joint opening of Cells 705 and 805, as discussed in Section 4.5, appeared to have influenced the LTE significantly. Contrary to the low faulting results, these two cells exhibited surprisingly very low LTE, at least in the joints considered in FWD testing. Based on the joint opening sensor data, some of the cracks were wider than 10 mm. The LTE of

concrete pavement at such wide joint opening is usually very low. The FWD test conducted during the April and June 2019 however shown some increase in the LTE in the driving lane of these two cells. The exact reason for this increase is not known; however, upon investigating the joint movement data, it was found that one joint movement sensor (Sensor 3) of Cell 506 (~~Figure 3-50~~Figure 3-50) detected significant joint contraction (~5mm) during April 2019. It might happen that the thawed water in the spring expanded slabs leading to joint contraction. One of the co-authors of this report, Mr. Tom Burnham, mentioned observing such joint contraction during spring at much lower temperatures than the recommended FWD testing cutoff limit of 75°F in the summer. The LTE for these cells again dramatically decreased in 2020. Some of the panels in Cells 705 and 805 were cracking up, possibly effecting the slab support condition near several joints. The driving lane of these two cells were completely replaced with a 5 inch thick Hot Mix Asphalt (HMA) layer on October 10, 2020.

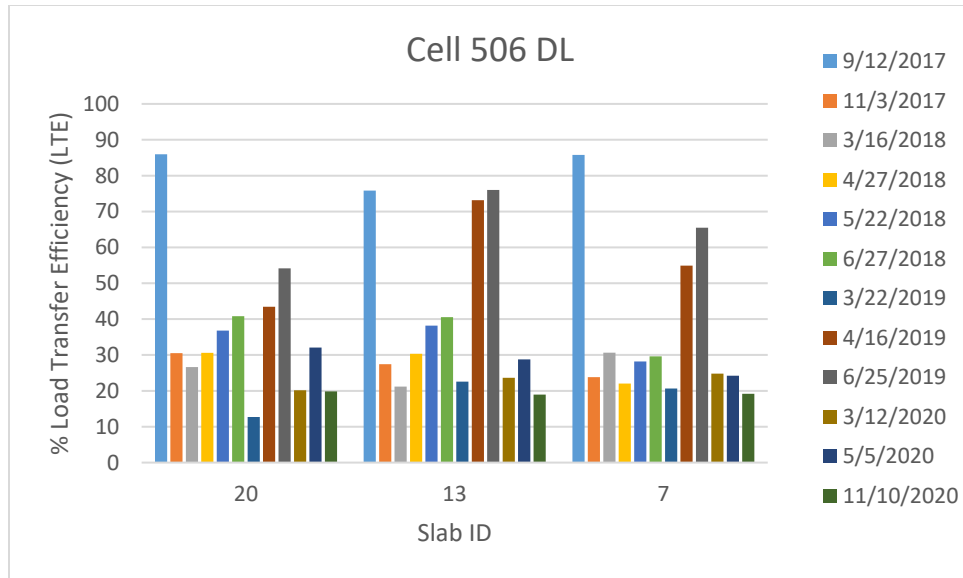
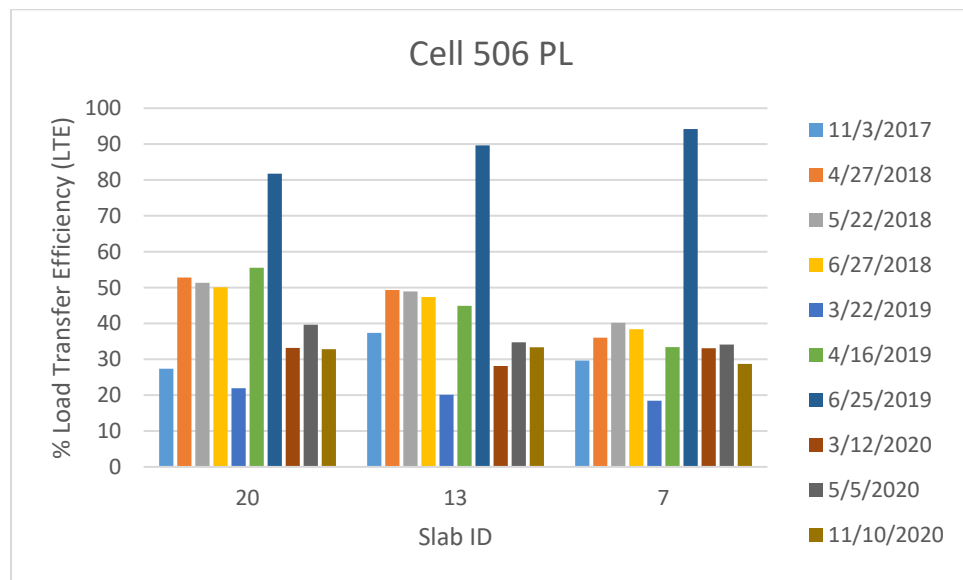
The LTE results of Cells 506 through 806 clearly reveals the contribution of structural fibers in keeping the LTE high. For Cell 506, even though the FWD test conducted on the driving lane in September 2017 showed a range of LTEs between 75 and 85%, the LTE afterwards significantly decreased overall. Surprisingly, the FWD tests conducted during the April 2019, shown relatively higher LTE at all the three joints considered. The reason for this may be similar to what happened in the Cells 705 and 805. The LTE in the passing lane of Cell 506 was always low, with a maximum of around 50%. The 2020 FWD test results show a considerable and steady decrease in LTE for Cell 506.
