MnDOT Contract, No. 1003325, Work Order No. 56

NRRA Long-term Research Project

**Performance Benefits of Fiber-reinforced Thin Concrete
Pavement and Overlays**

**Task-2: Third Year Annual Cell Performance Report
(2019-2020)**

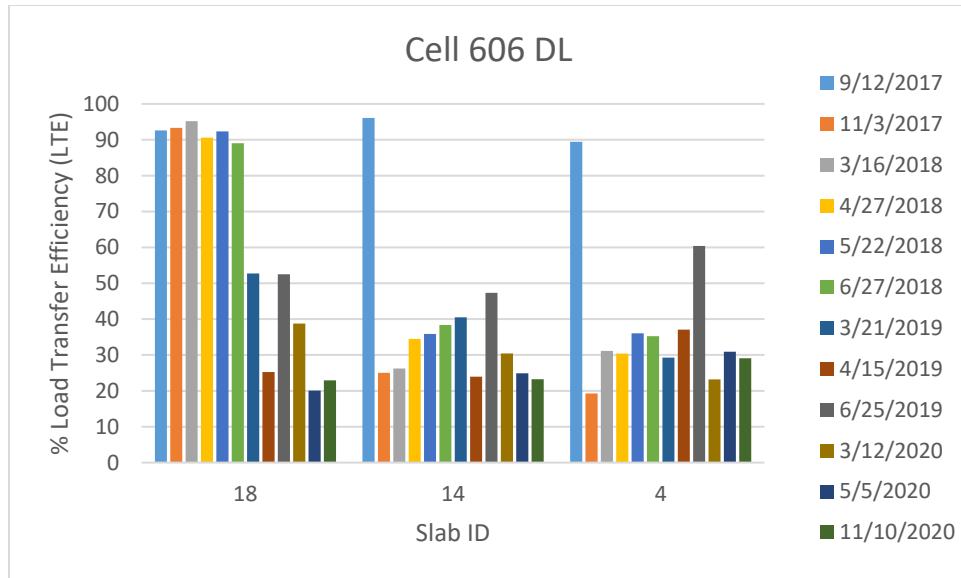
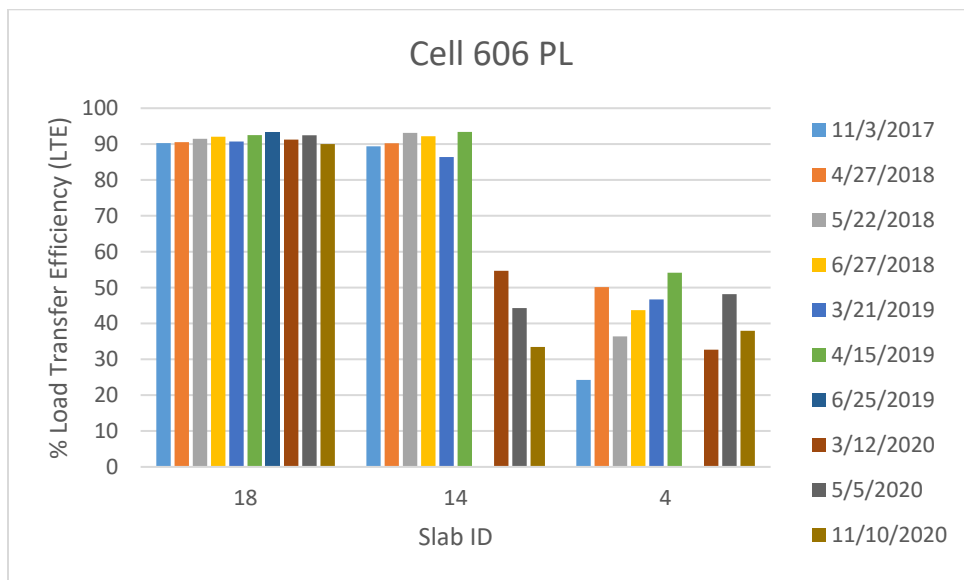
The LTE results of Cell 606, which is 6-inch thick, were at or above 90% when measured in September 2017, except one joint in the passing lane which always did show a low LTE (around 25 to 50%). The LTE for this cell had dropped significantly over the time. The FWD tests conducted on Cell 606 over the third year of service showed a gradual decrease in LTE for all the joints, which was expected. The LTE in the passing lane has also dropped significantly.

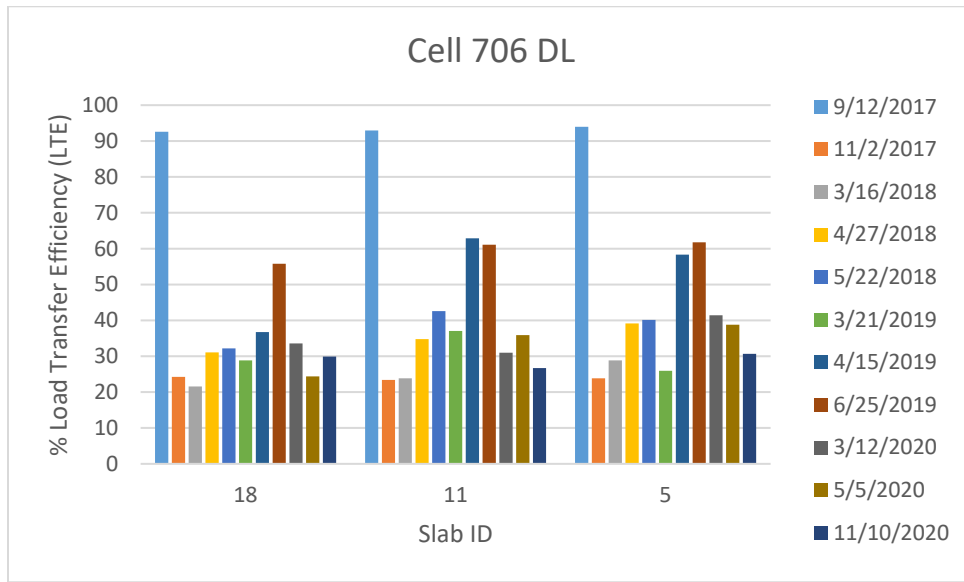
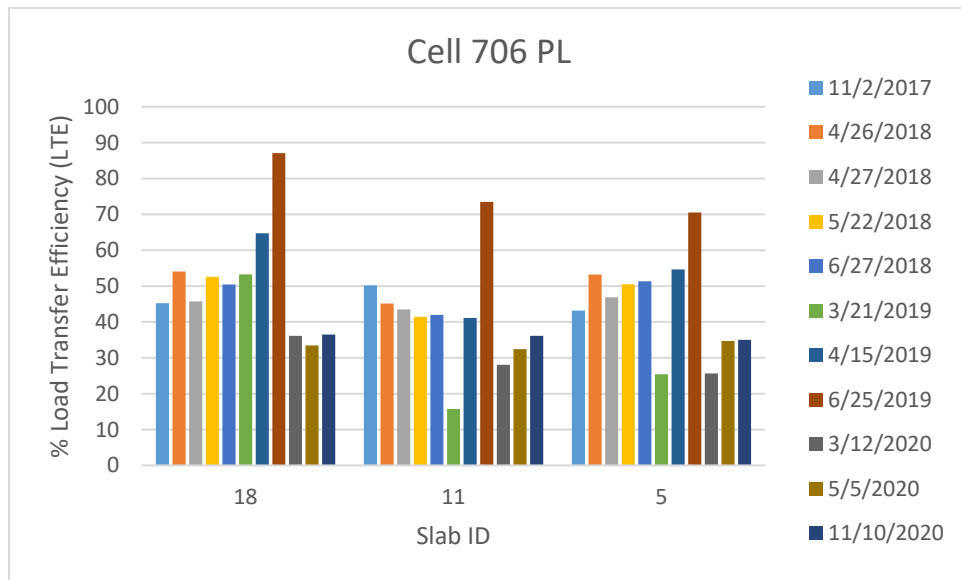
The LTE of Cell 706, which is 5-inch thick and contains 8 lbs./cy fibers, was initially high at three joints (at the driving lane) out of total of six joints measured. However, when measured at later dates, these joints exhibited 40 to 56% LTE.

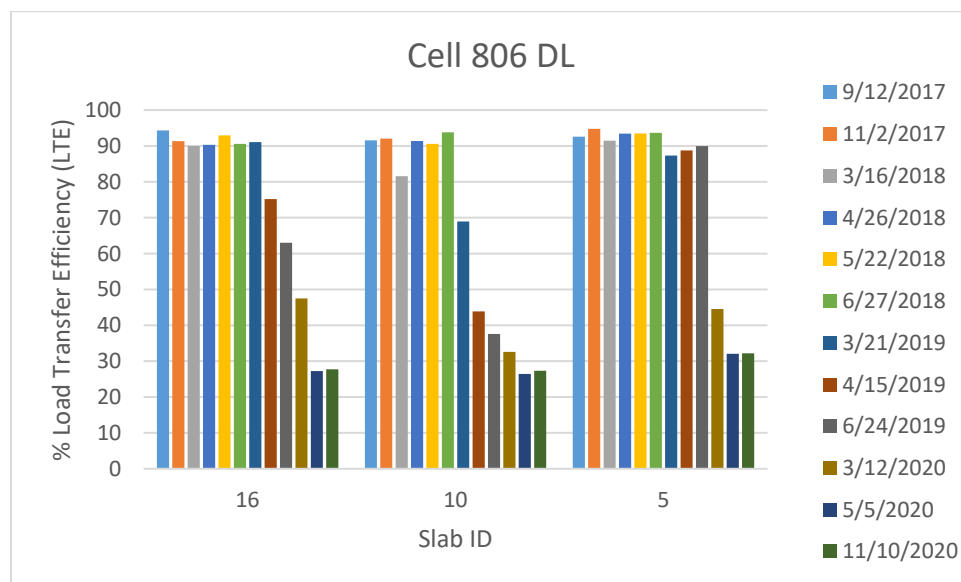
Figure 4-15. LTE of Cell 806 driving lane.

Cell 806, which is 5-inch thick and contains 11.7 lbs./cy of fibers, consistently exhibited the highest LTE among all the cells, until 2019. Notably, all the joints were able to maintain a

very good LTE between 88 to 94% throughout the first two years of service life. The higher LTE of this cell helped in keeping the faulting to the lowest among all the eight cells. Third year data for Cell 806 showed that for the driving lane, the LTE decreased overall to an average of 30%. However, the passing lane LTE showed an average value of 90%, which was significantly higher when compared to all the other cells. The dramatic decline in the LTE values for the Cell 806 driving lane indicates that the contribution of fibers and/ or aggregate interlock have significantly reduced after approximately 2.5 million ESALs.

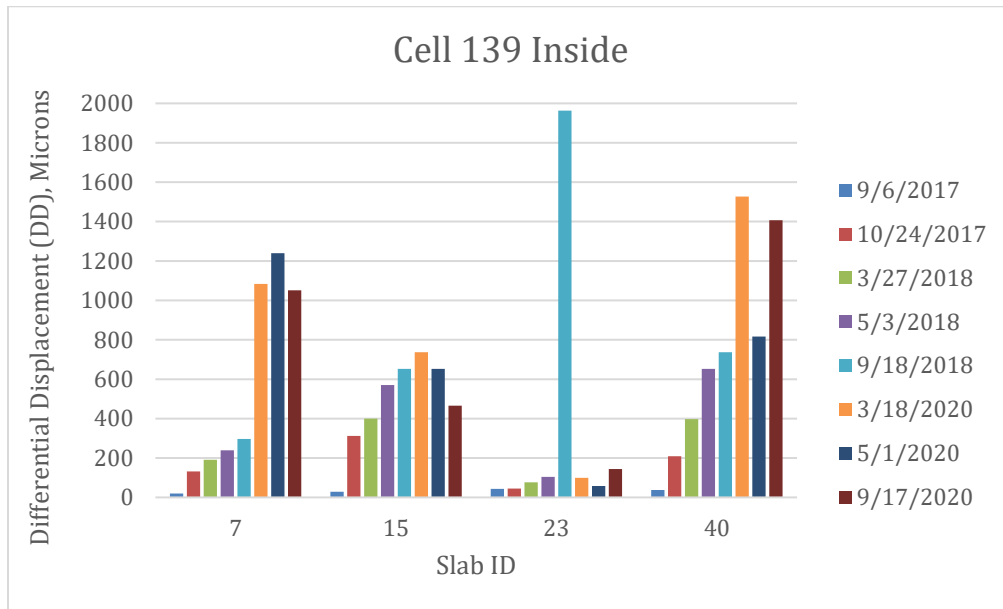
Figure 4-17. Differential displacement of Cell 139 inside line.

~~Figure 4-17~~ ~~Figure 4-17~~ through ~~Figure 4-32~~ ~~Figure 4-32~~ show the plots for differential displacements for all the cells. The general trend of the differential displacement is similar to the trends observed for the LTE. The differential displacements for both Cells 139 and 239 continuously increased with the traffic load. The FWD test result for the Joint 23 of cell 139 resulted in a very high value of differential displacement, also the 2020 data shows excessive differential displacement in most of the joints of Cell 139. For the Cell 239, as anticipated, the driving lane shown higher differential displacement compared to the passing lane and overall significantly lower than Cell 139.

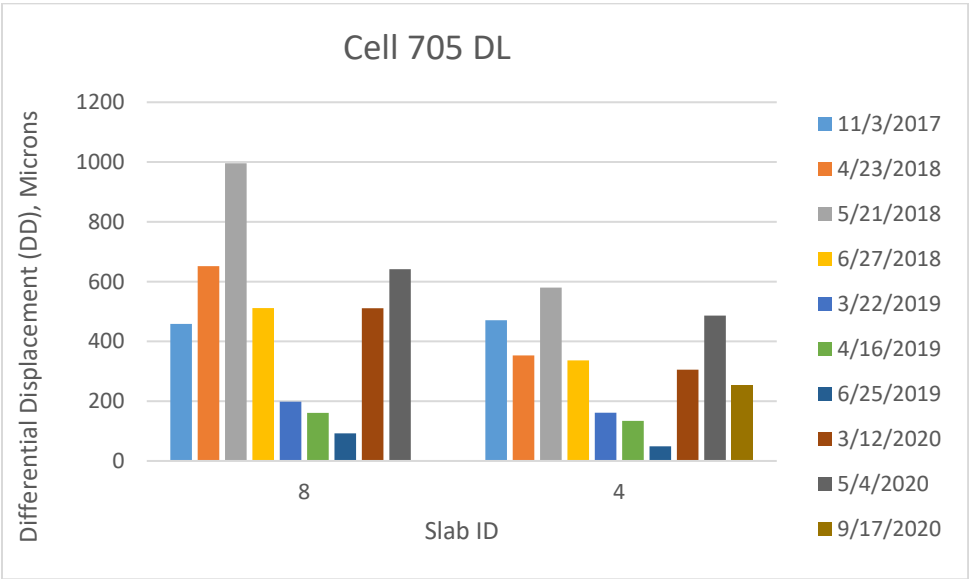
Figure 4-21. Differential displacement of Cell 705 driving lane.

Cells 705 and 805 both have experienced high differential displacements at the transverse joints; the differential displacements of Cell 705 (~1000 micron) was almost twice of the Cell 805 (~460 microns). Even though the differential displacements was relatively high, the fabric interlayer provided in these cells is expected to limit the faulting. The other notable observation is that the differential displacement for Cell 705 decreased with traffic,

this is surprising, but it may be possible if the joint support condition weakend and both the slabs experience higher overall displacement. The driving lane of Cell 805 shown steady increase on the differential displacement, while the passing lane shown somewhat similar values over the years.

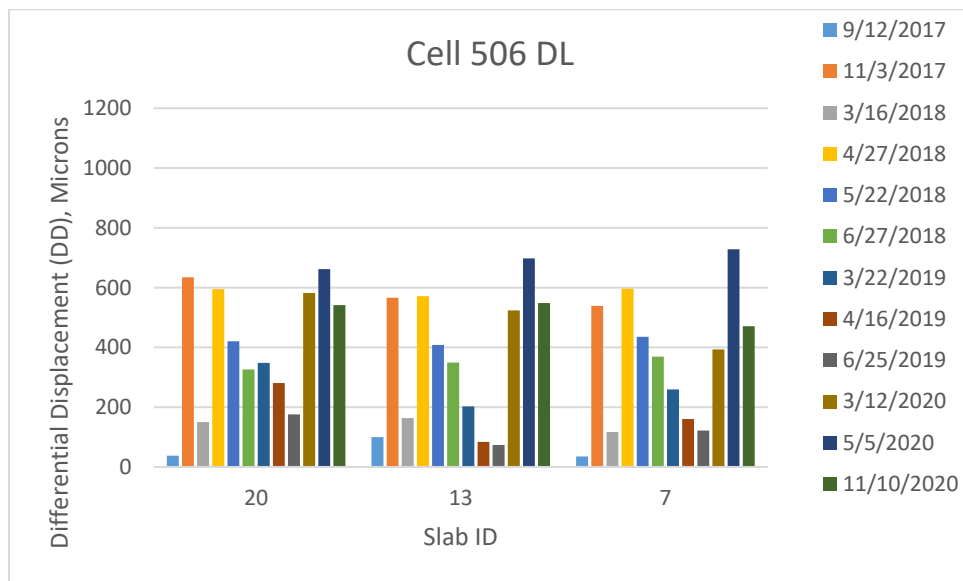
Figure 4-25. Differential displacement of Cell 506 driving lane.

The contribution of fibers in joint performance can also be seen in the differential displacement plots for Cell 506 through 806. The driving lanes of Cells 506, 606 and 706 exhibited higher differential displacements than Cell 806. Cell 506 showed higher

differential deflection initially, but then decreased with traffic and then again increased in 2020. The Cell 806 driving lane had negligible differential deflection compared to aother cells, until spring of 2020 when it started increasing with the traffic (matches with the LTE observations).

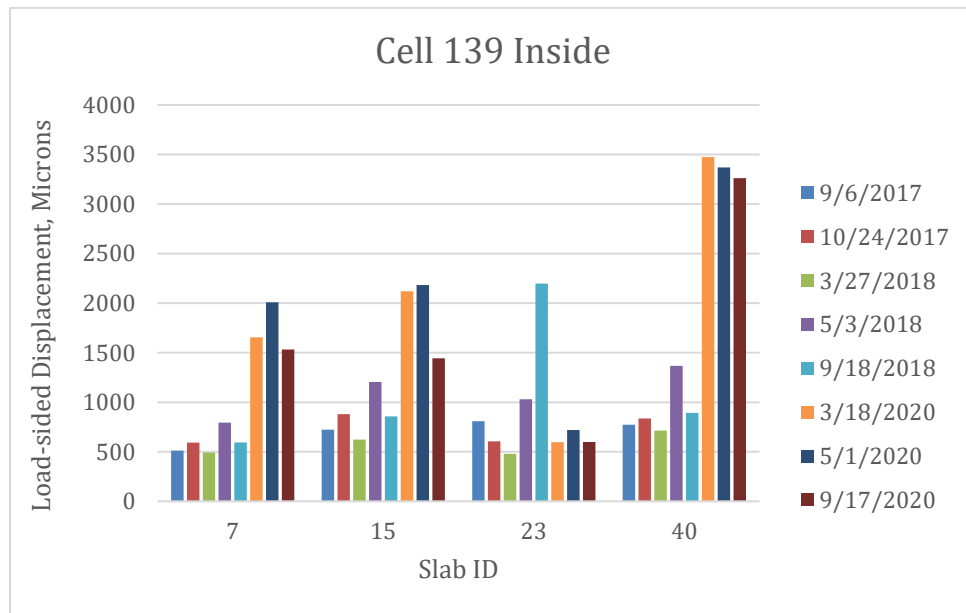
Figure 4-33. Loaded-side displacement of Cell 139 inside lane.

Figure 4-33 through Figure 4-48 shows loaded-side displacement, which is a good indicator of joint performance. Even though the LTEs and differential displacements for the Cells 139 and 239 were somewhat comparable, the Cell 139 had significantly higher loaded-side displacement. This clearly indicates that cell 139 had poorer joint stiffness or weaker support compared to Cell 239.

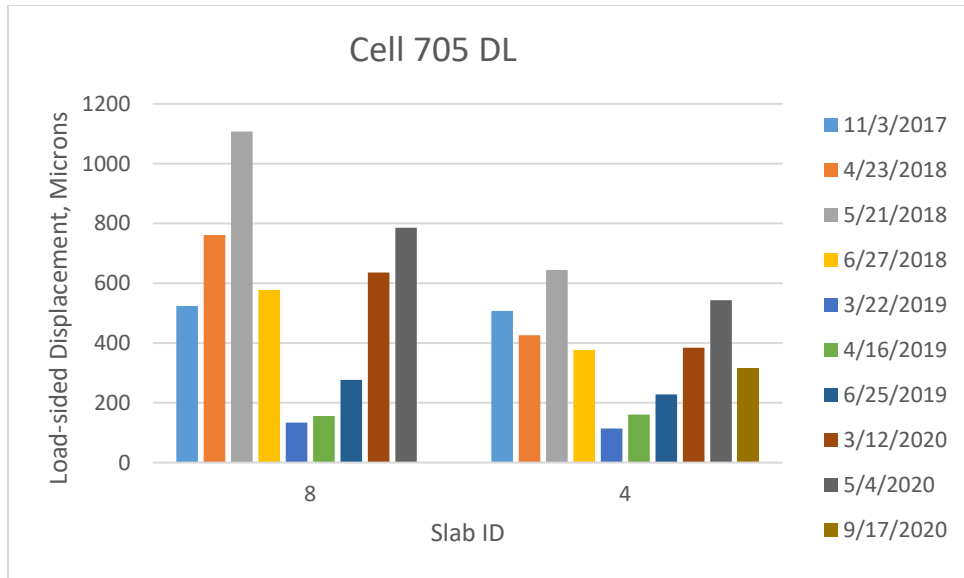
Figure 4-37. Loaded-side displacement of Cell 705 driving lane.

Between these Cells 705 and 805, the Cell 705 compared to Cell 805 had experienced higher, and as much as twice, the loaded-side displacements initially. But then the 2020 readings indicate that Cell 805 has higher loaded-side displacement. The loaded-side displacement of Cells 506 through 806 also showed that the 806 performed better than the other three cells initially until approximately 2.5 million ESALs. The 2020 readings (beyond 2.5 million ESALs) indicate that all four cells have similar loaded-side displacement, with Cell 506 (no fiber) slightly higher than the other three. Overall, it can be stated that the influence of fibers has diminished after 2.5 million ESALs.

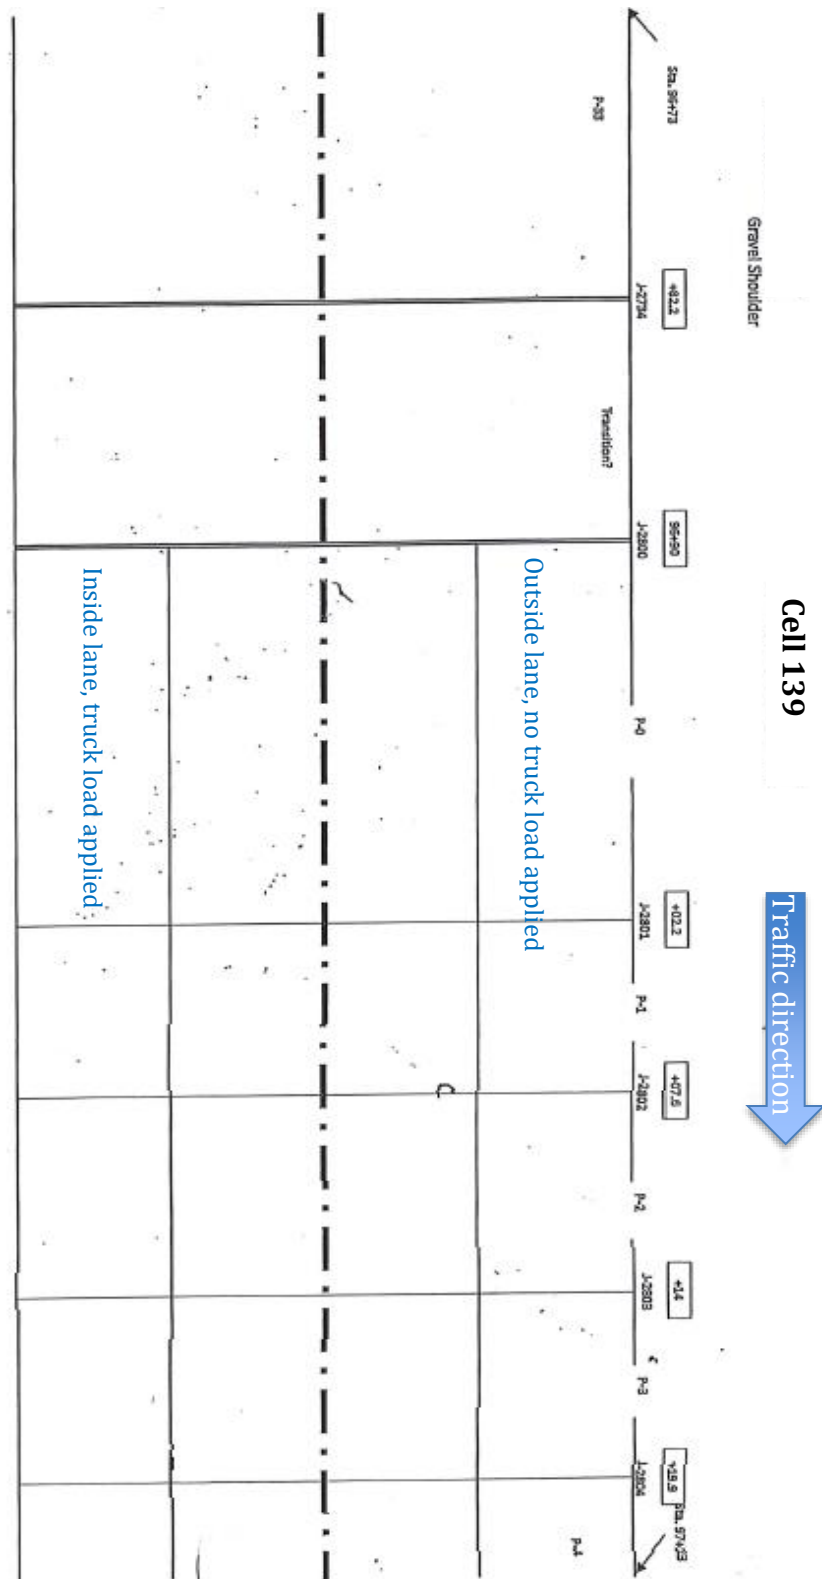
Figure A1: Distress map for Cell 139

- In Cell 139, 75% slabs cracked with ~80,000 ESALs. The thickness of this cell was 3 inches, which is probably too extreme on a 6-inch un-stabilized aggregate base. The cracks observed in this cell were more like bottom-up fatigue cracks of asphalt pavement with shattered slabs along the wheel path.

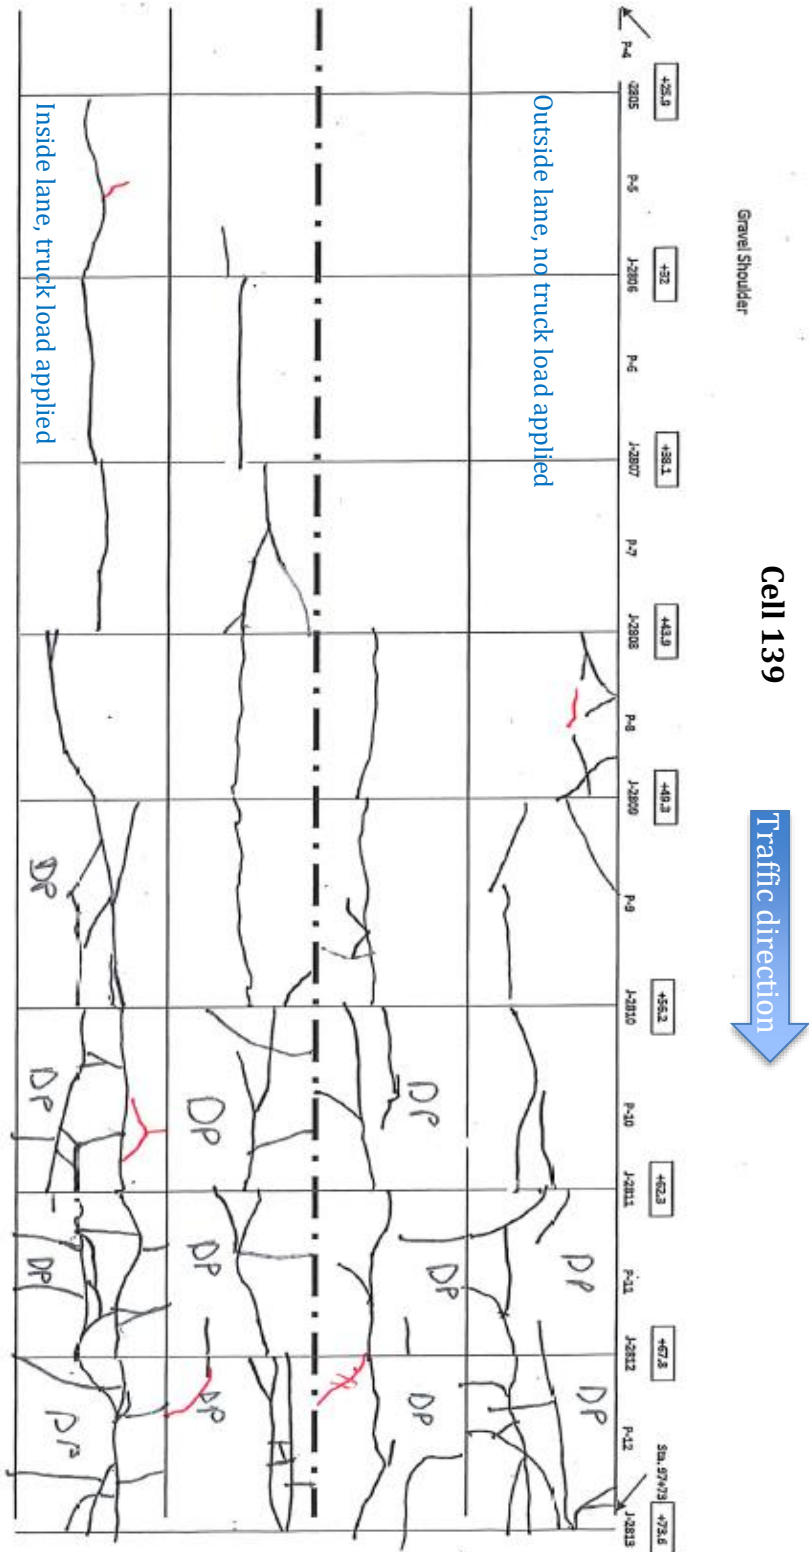
Figure A2: Distress map for Cell 139 contd.

Cracks until March 2020; cracks colored red were documented on March 24, 2020.

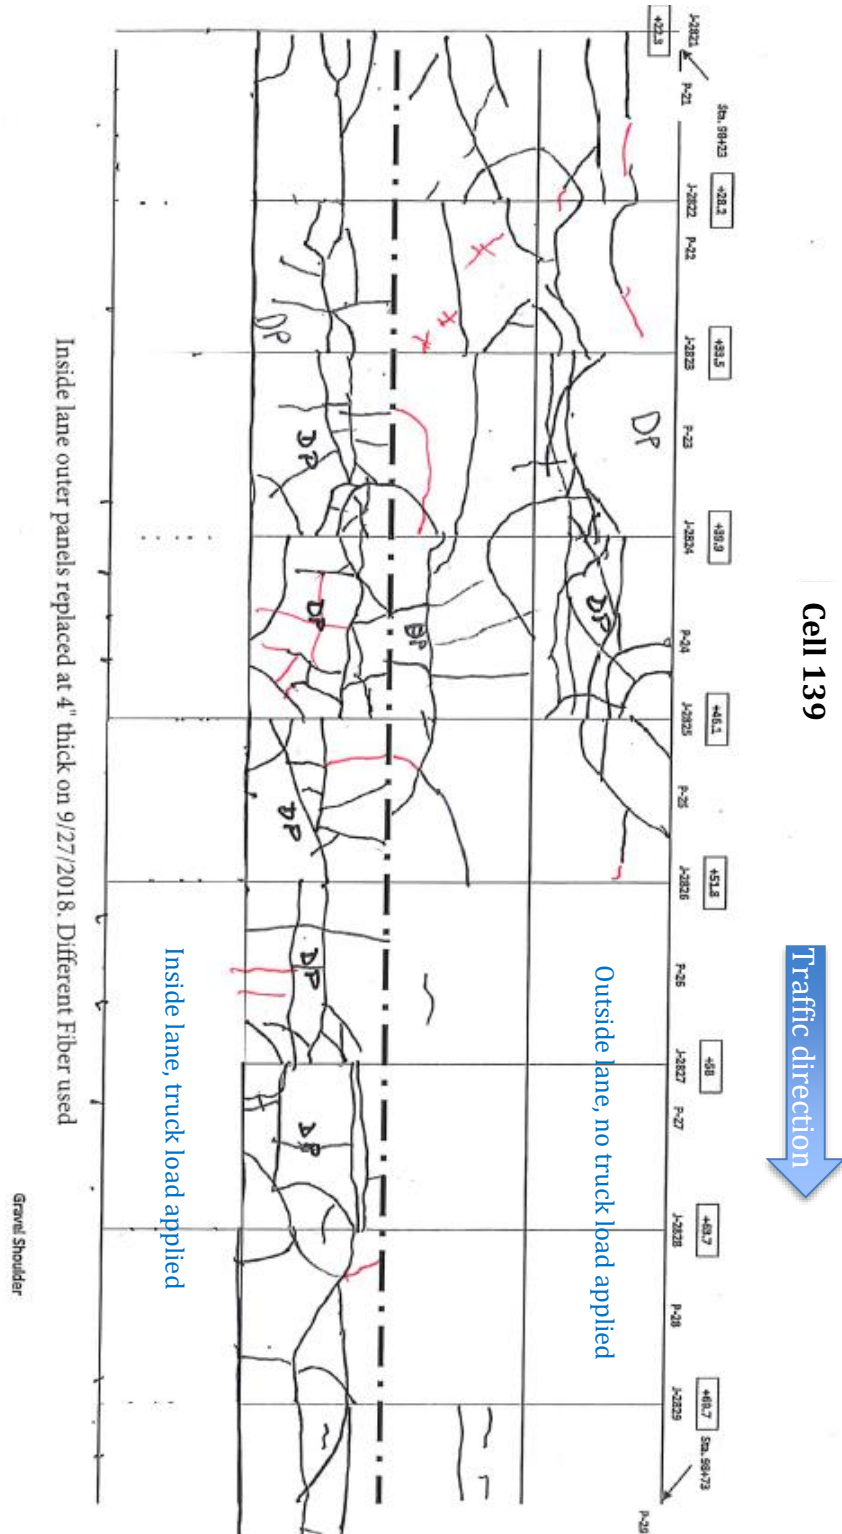
Figure A4: Distress map for Cell 139 contd.

Cracks until March 2020; cracks colored red were documented on March 24, 2020.

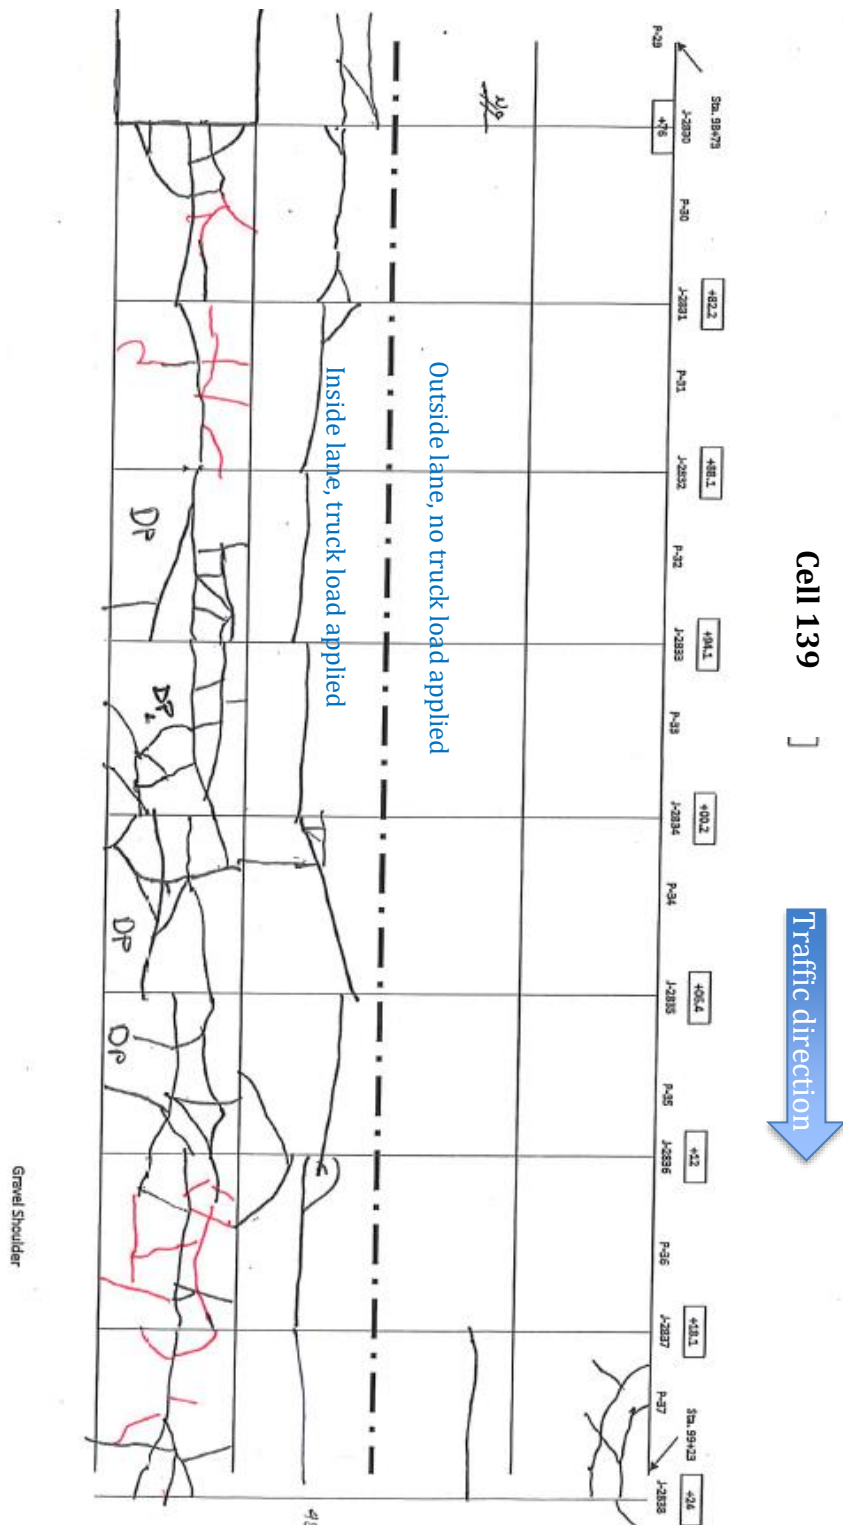
Figure A5: Distress map for Cell 139 contd.

Cracks until March 2020; cracks colored red was documented on March 24, 2020.

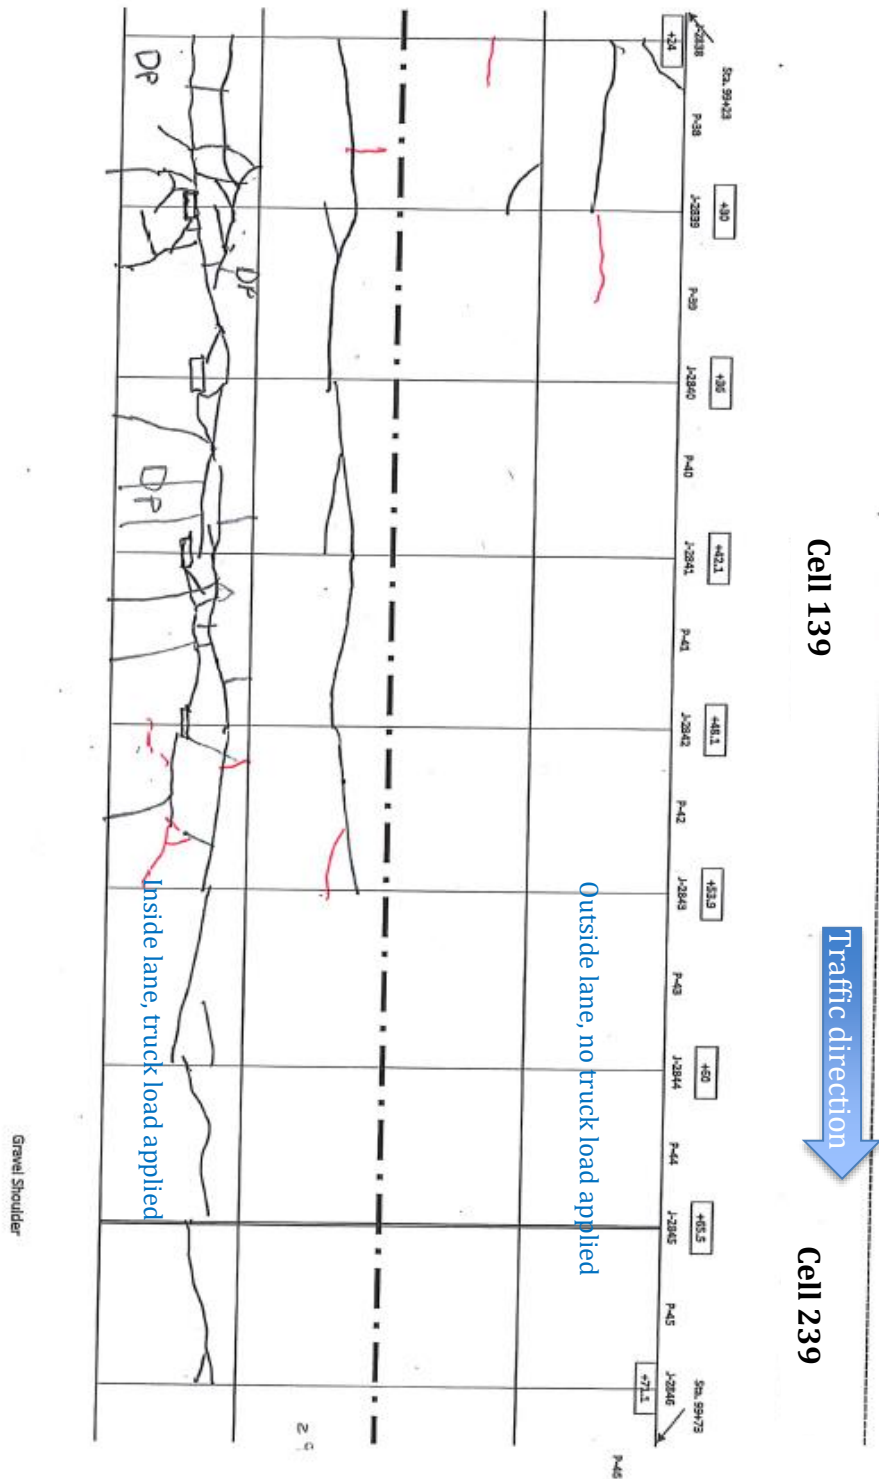
Figure A6: Distress map for Cell 139 contd.

Cracks until March 2020; cracks colored red was documented on March 24, 2020.

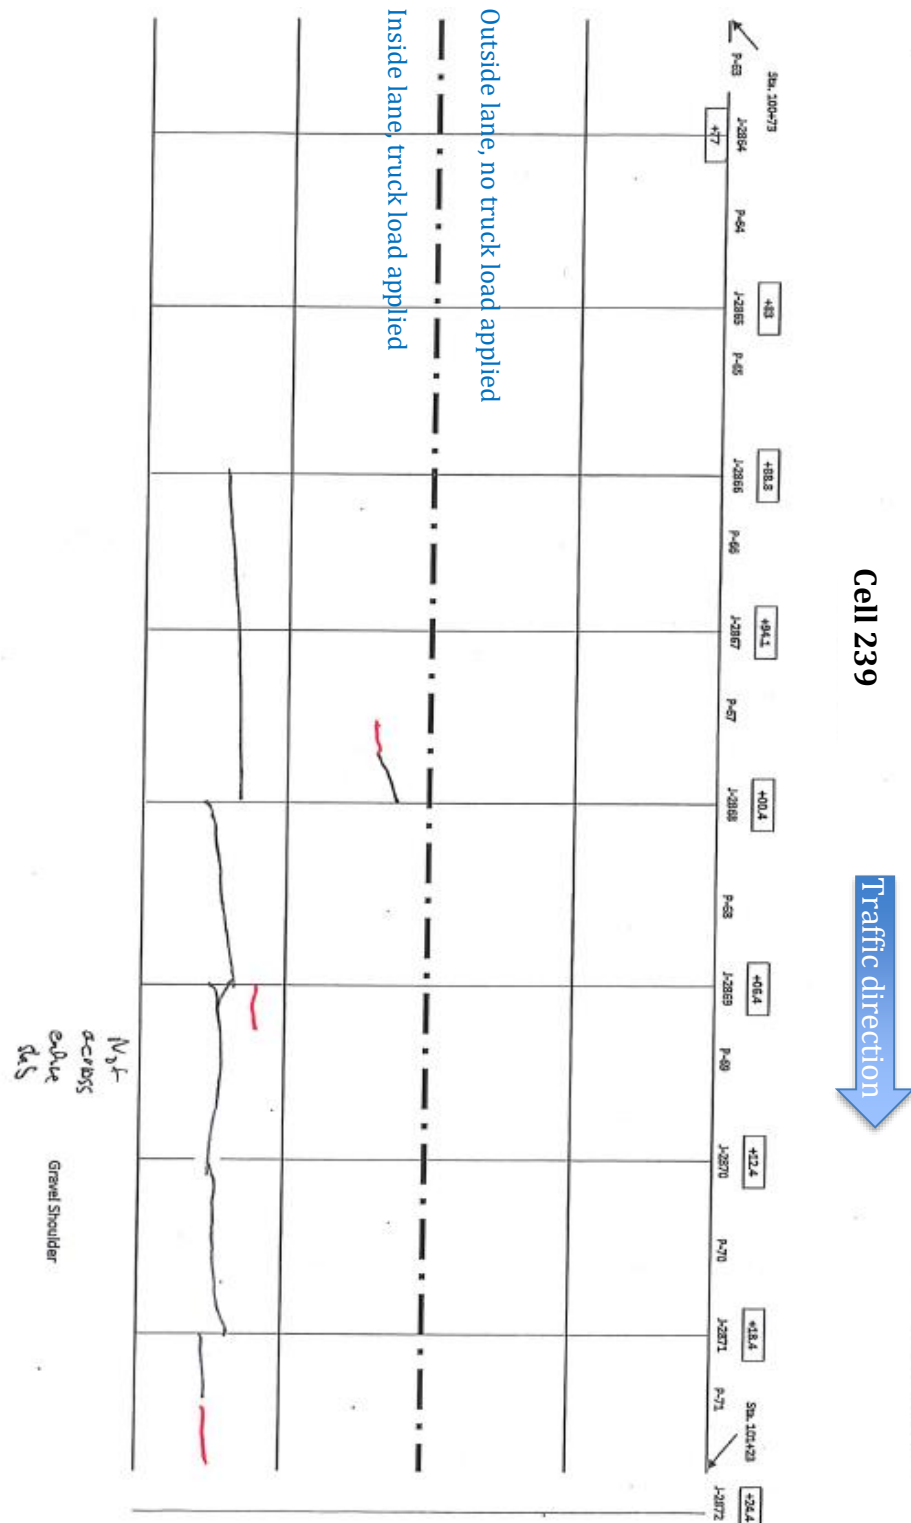
Figure A8: Distress map for Cell 239 contd.

Cracks until March 2020; cracks colored red was documented on March 24, 2020.

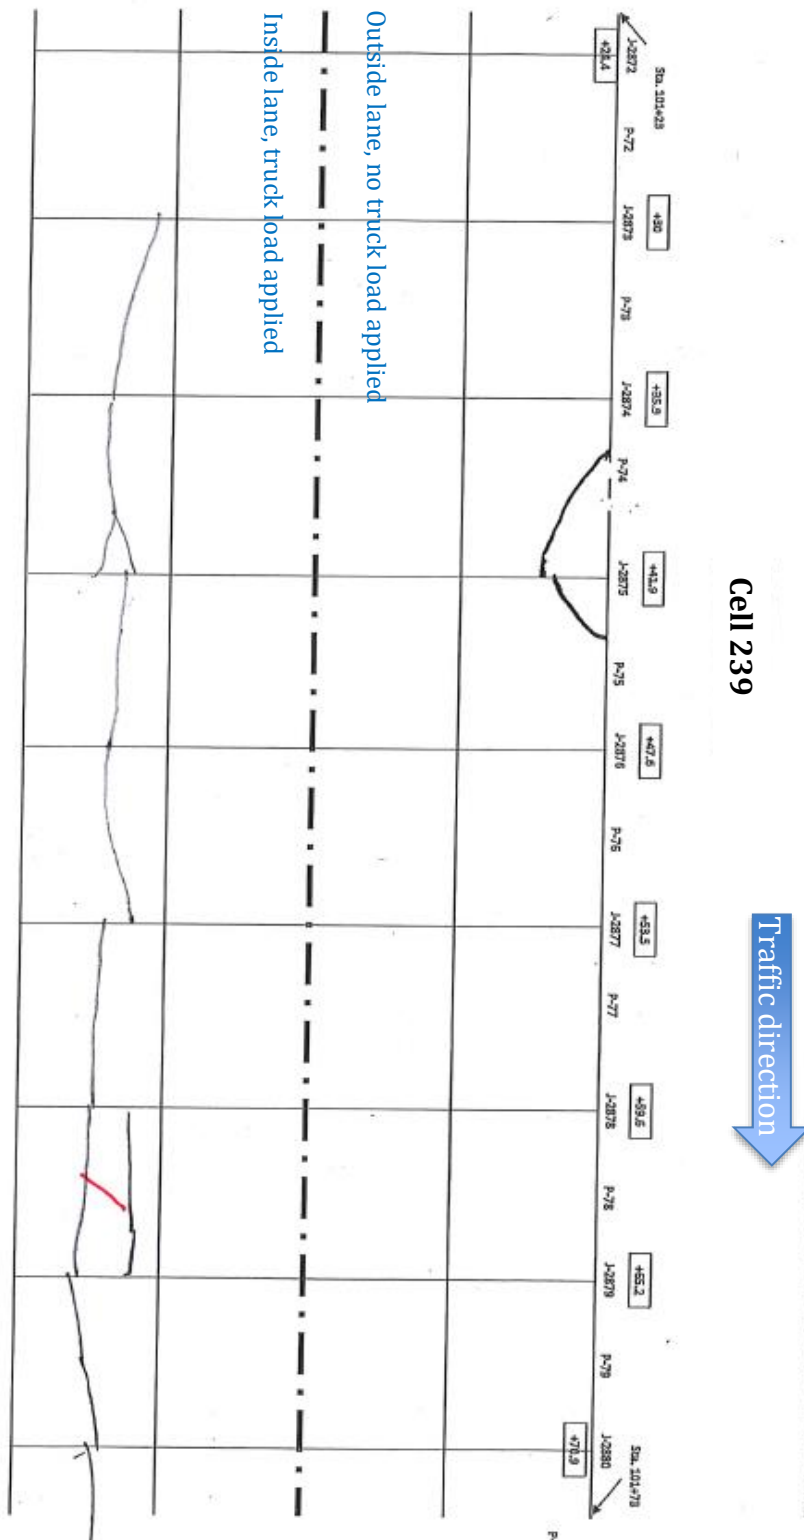
Cracks until March 2020; cracks colored red were documented on March 24, 2020.

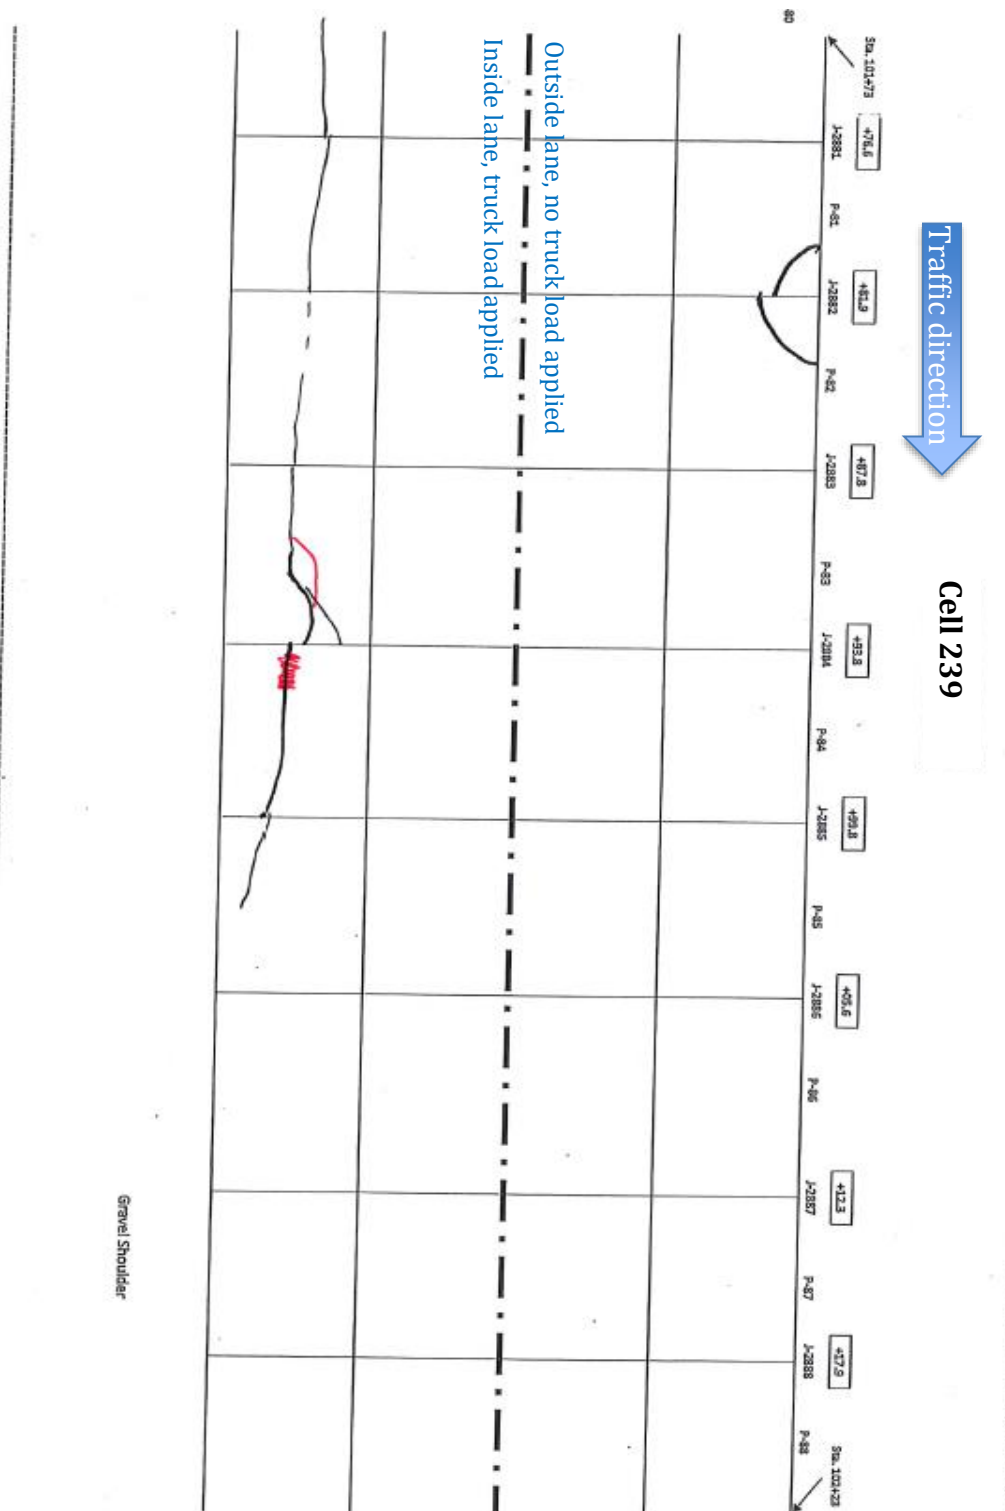
Figure A9: Distress map for Cell 239 contd.

Cracks until March 2020; cracks colored red were documented on March 24, 2020.

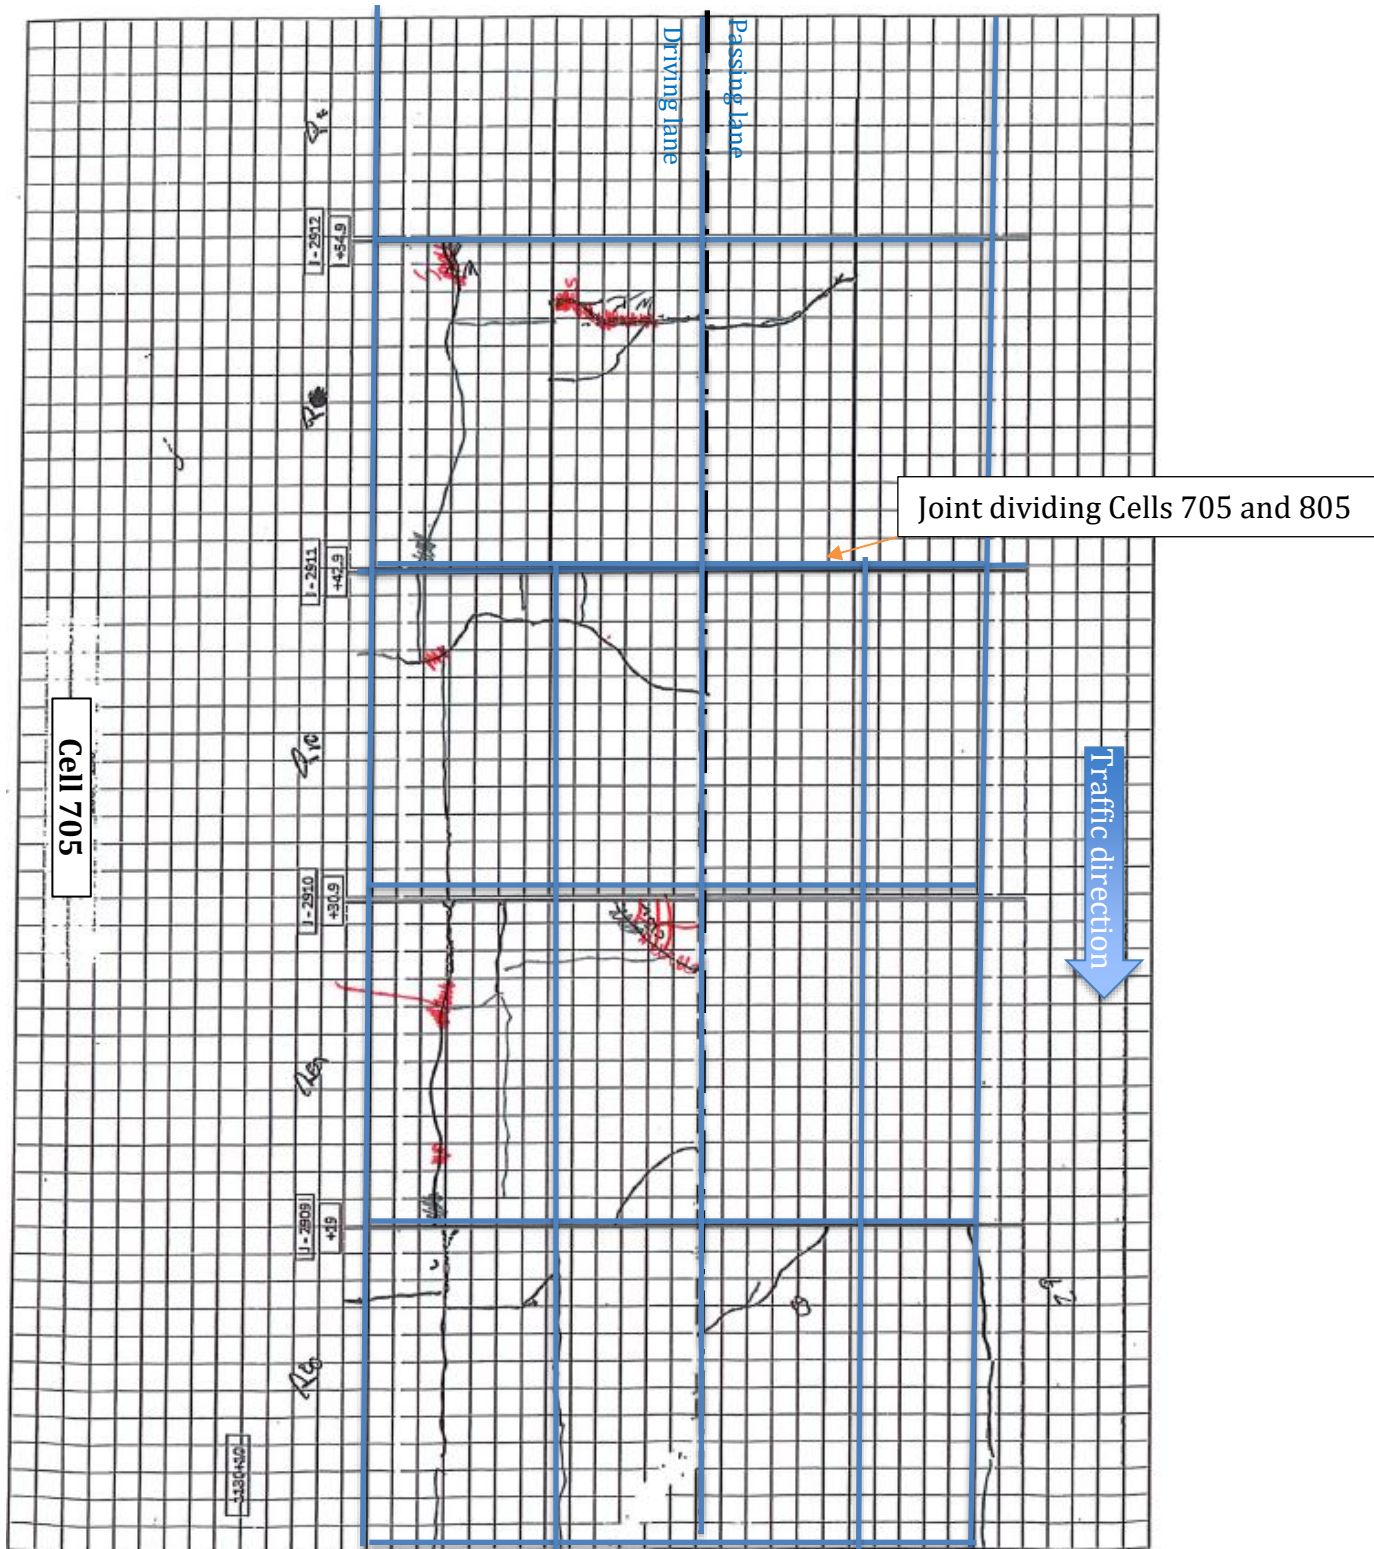
Figure A12: Distress map for Cell 705.

Cracks until March 2020: cracks/spalls colored red were documented on March 5, 2020 (not to scale).

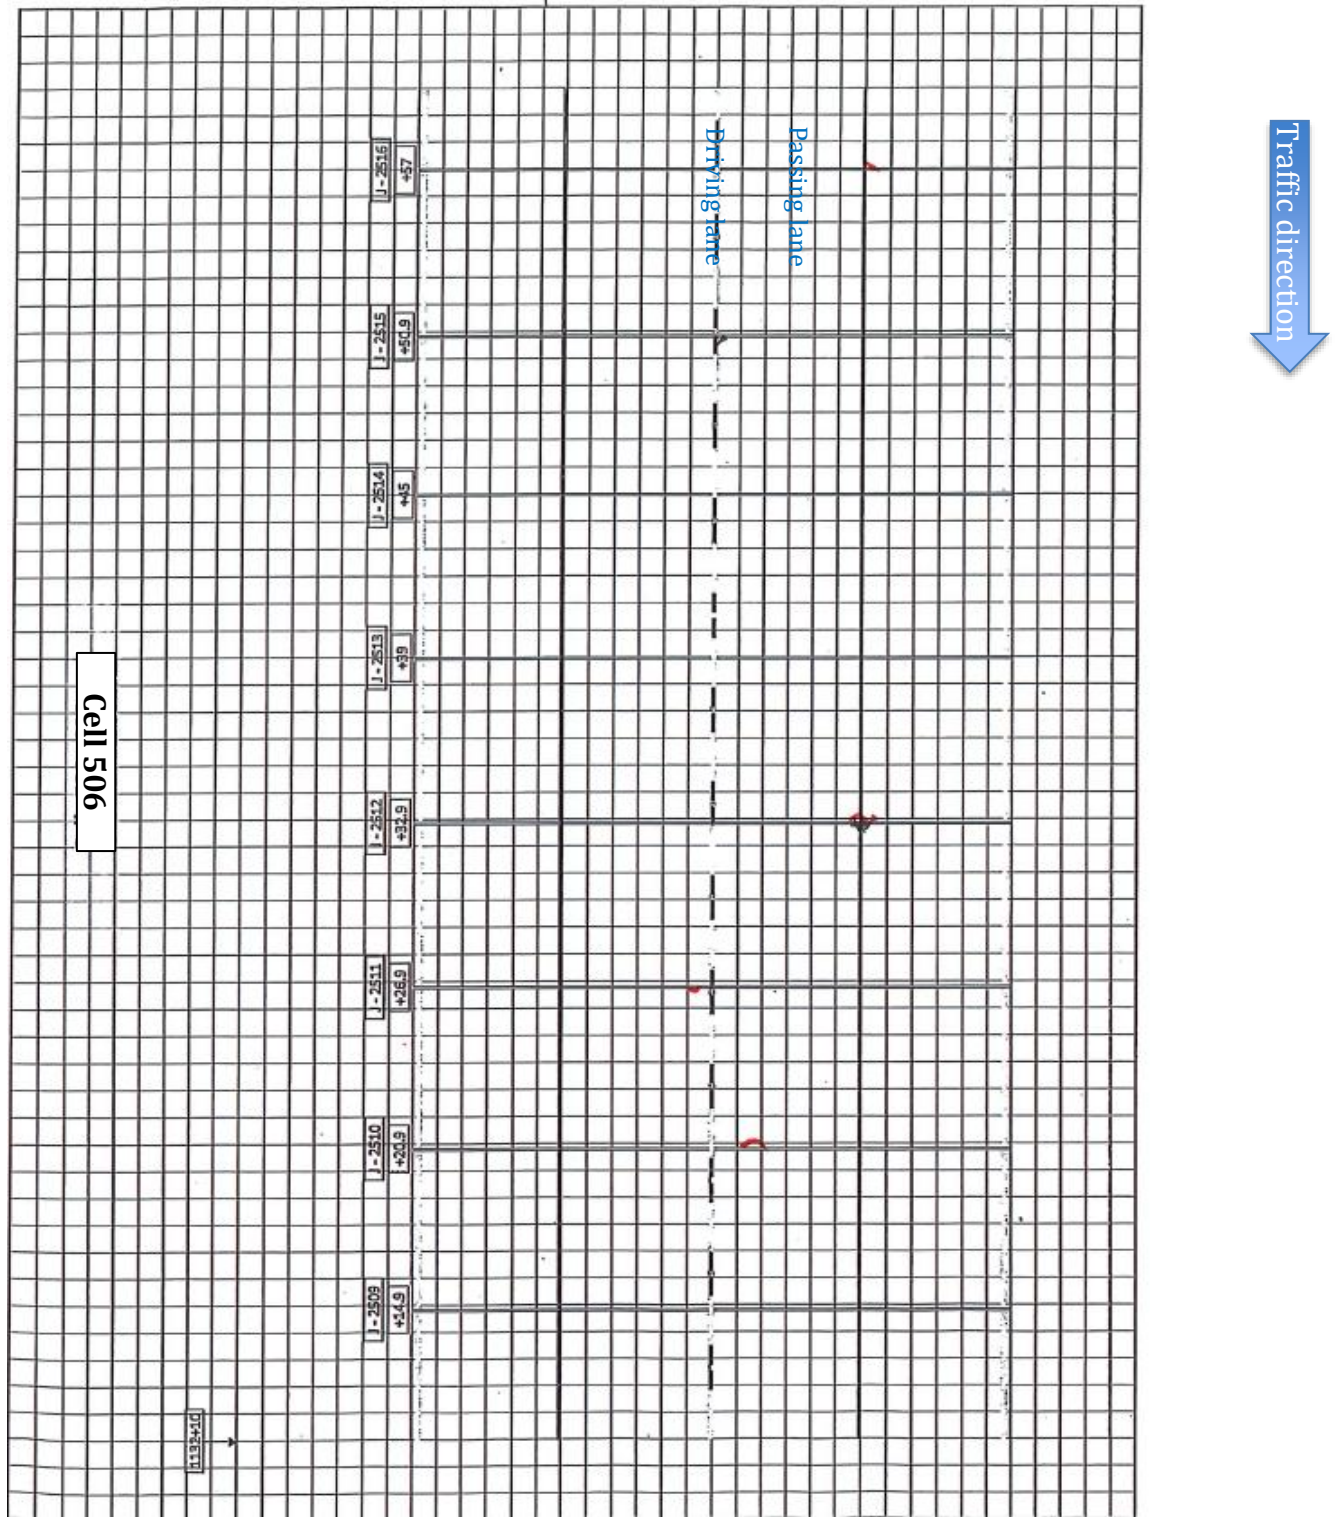
Cracks until March 2020; cracks/spalls colored red were documented on March 5, 2020.

Figure A18: Distress map for Cell 506 contd.
