MnDOT Contract, No. 1003325, Work Order No. 56

NRRA Long-term Research Project

**Performance Benefits of Fiber-reinforced Thin Concrete
Pavement and Overlays**

**Task-2: Third Year Annual Cell Performance Report
(2019-2020)**

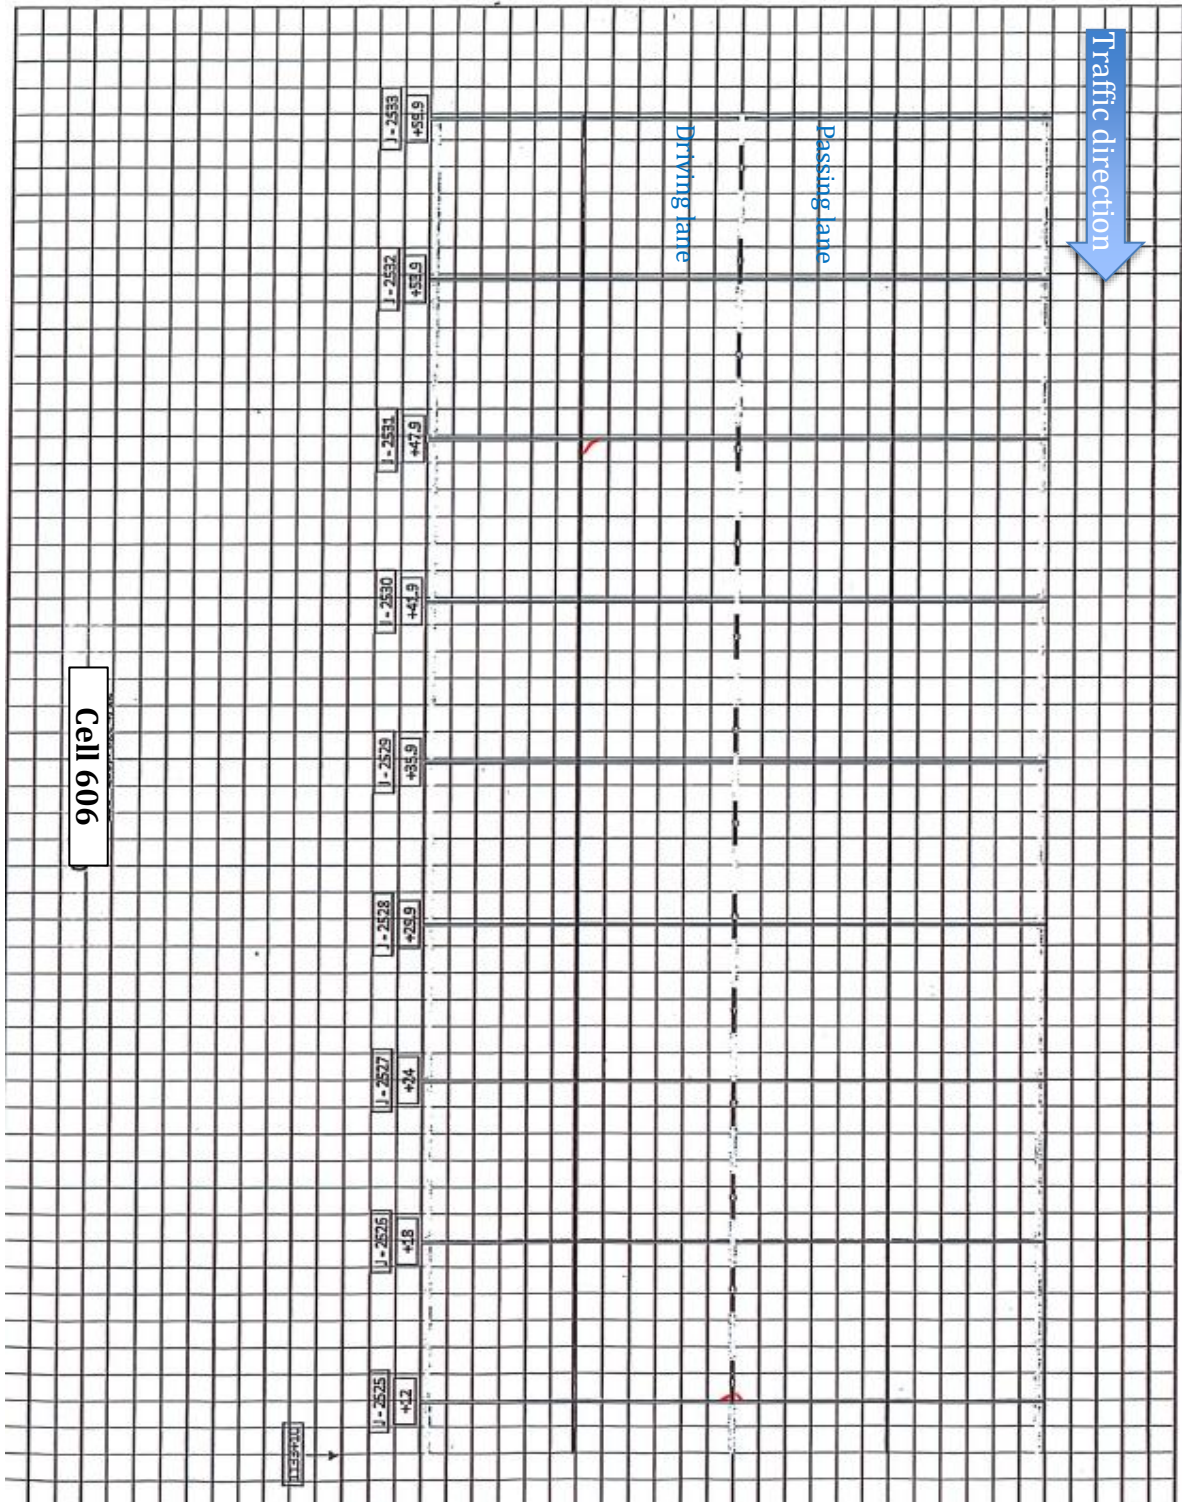
Cracks until March 2020; cracks/spalls colored red were documented on March 5, 2020.

Figure A20: Distress map for Cell 606 contd.

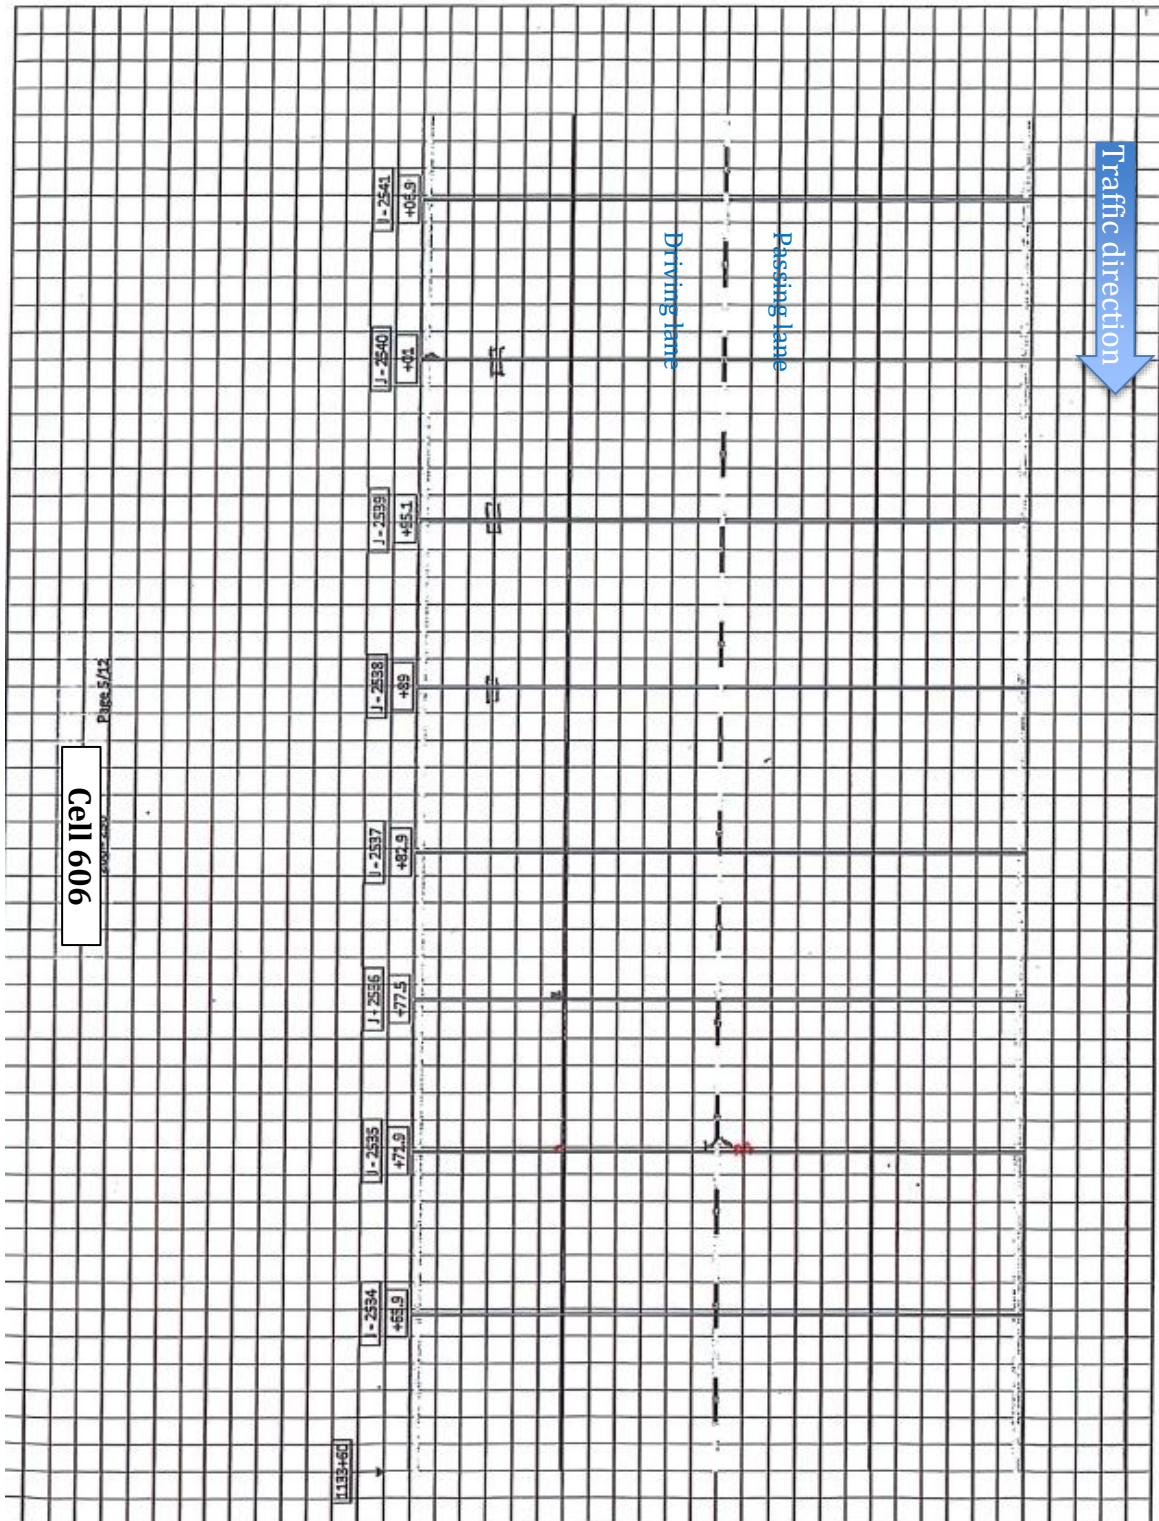
Cracks until March 2020; cracks/spalls colored red were documented on March 5, 2020.

Figure A21: Distress map for Cell 606 contd.

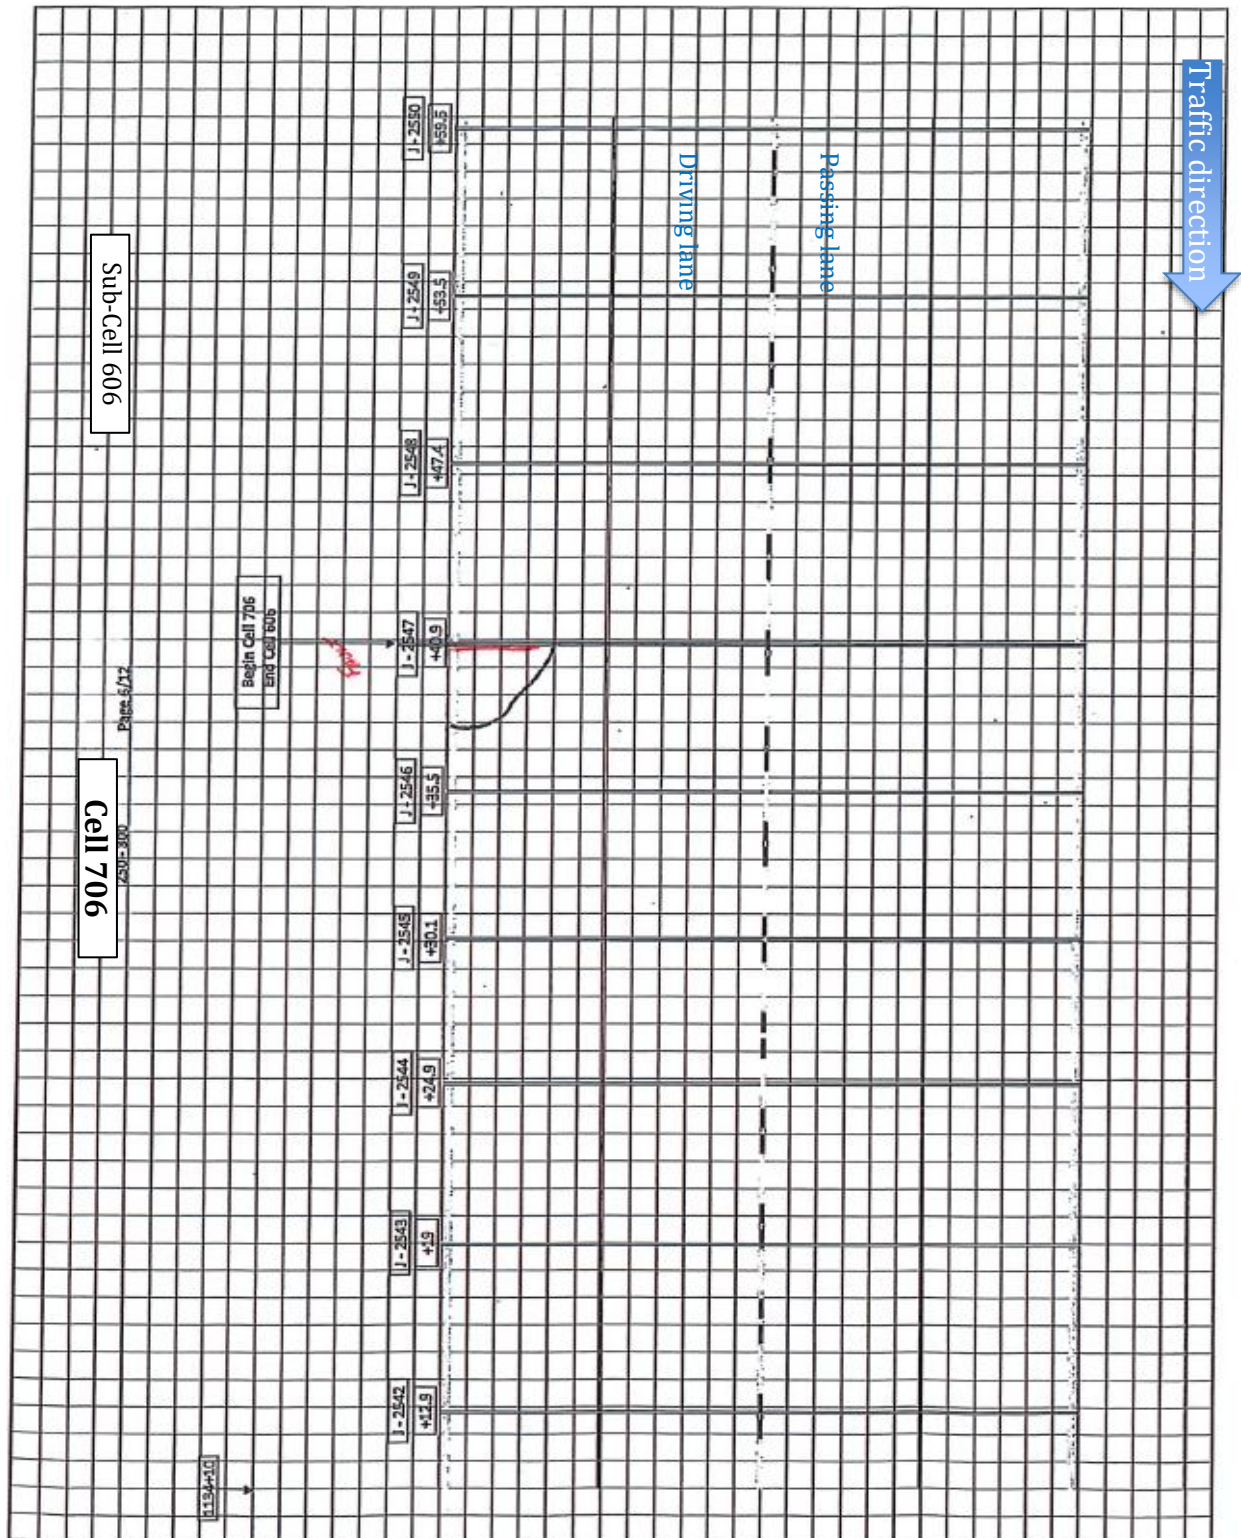
Cracks until March 2020; cracks/spalls colored in red were documented on March 5, 2020.

Figure A23: Distress map for Cells 606 through 706.

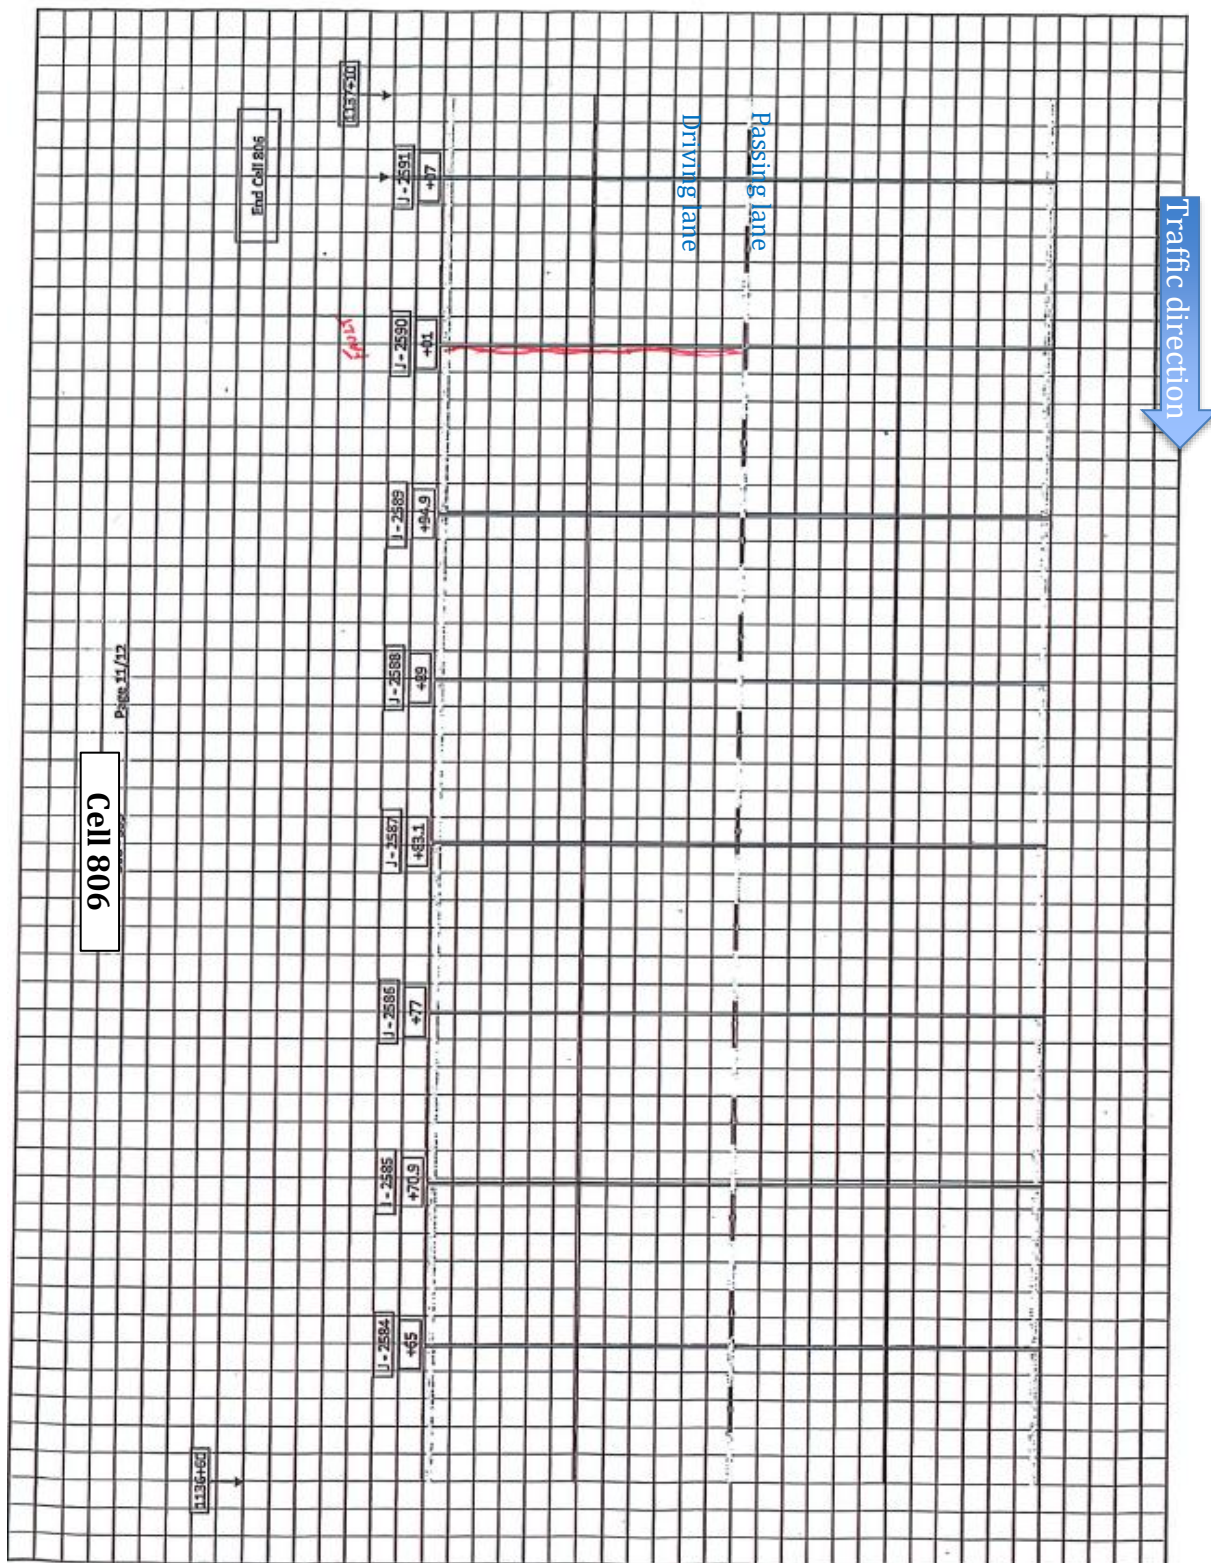
Cracks until March 2020: cracks/spalls colored in red were documented on March 5, 2020.

Figure A28: Distress map for Cell 806 contd.

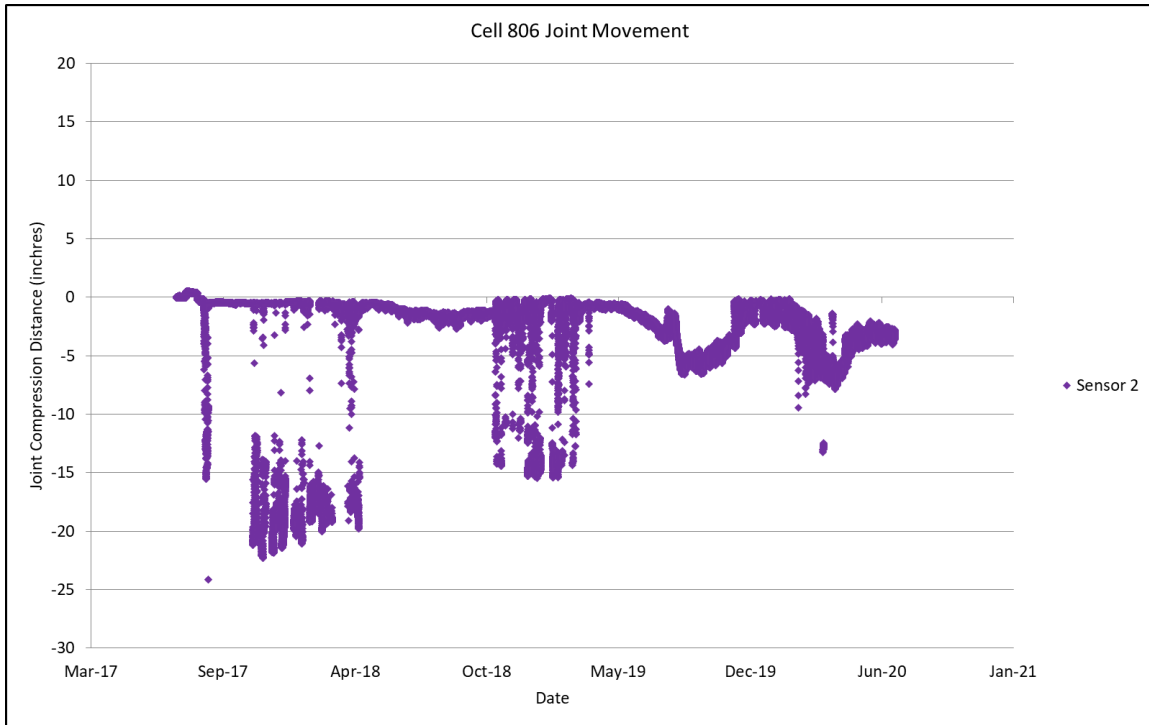
Figure B27. Joint movement data for Cell 806, Sensor 2 (**Bad sensor**).
