# Minnesota Department of Transportation (Mn/DOT)

## Historic Bridge Management Plan

Bridge Number: 3355

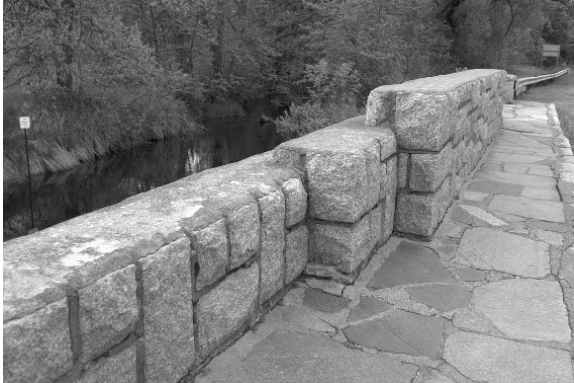
Feature 1. Architectural design and treatment. The 1939 headwalls and railings faced with granite present an unusual combination of Art Deco form with a rustic, stone-masonry surface treatment. The 1939 design was prepared by the National Park Service for the Minnesota Highway Department as part of a roadside and wayside beautification program. The work was completed by the Civilian Conservation Corps as part of the work relief programs of the New Deal. This feature includes the two granite sidewalks.

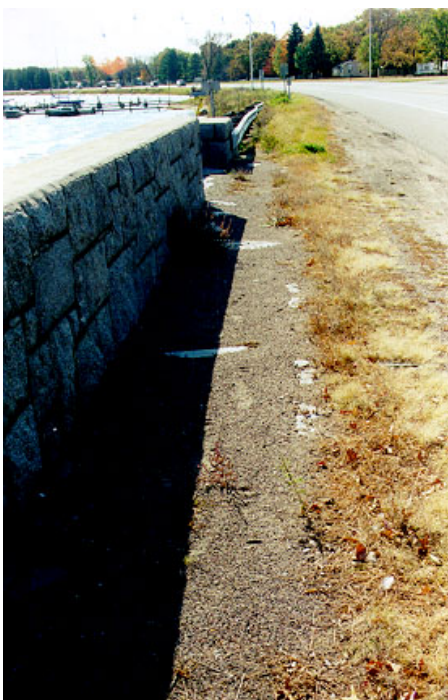
5. North Wall looking South (*Curb is not visible*)
