Unmanned Aerial Vehicle Bridge Inspection Demonstration Project

Minnesota
Department of
Transportation

Barritt Lovelace, Principal Investigator
Collins Engineers, Inc.

Research Project
Final Report 2015-40

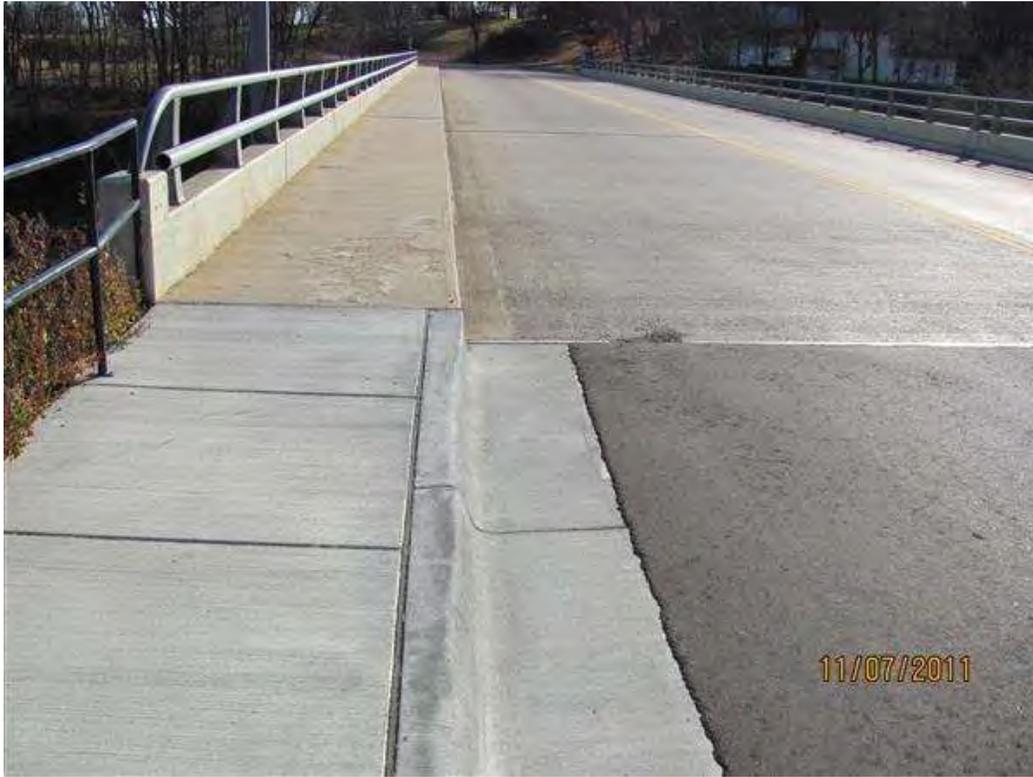
Photo 1 - New sidewalk and curbs at North abutment.

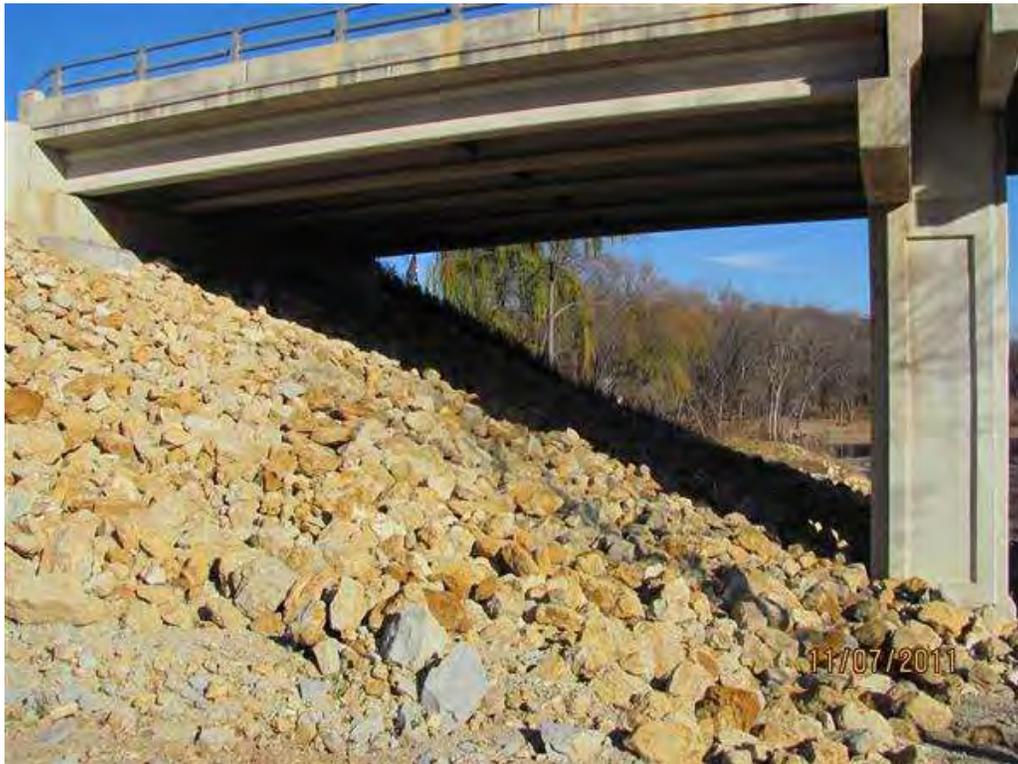
Photo 2 - New Rip rap at North abutment.

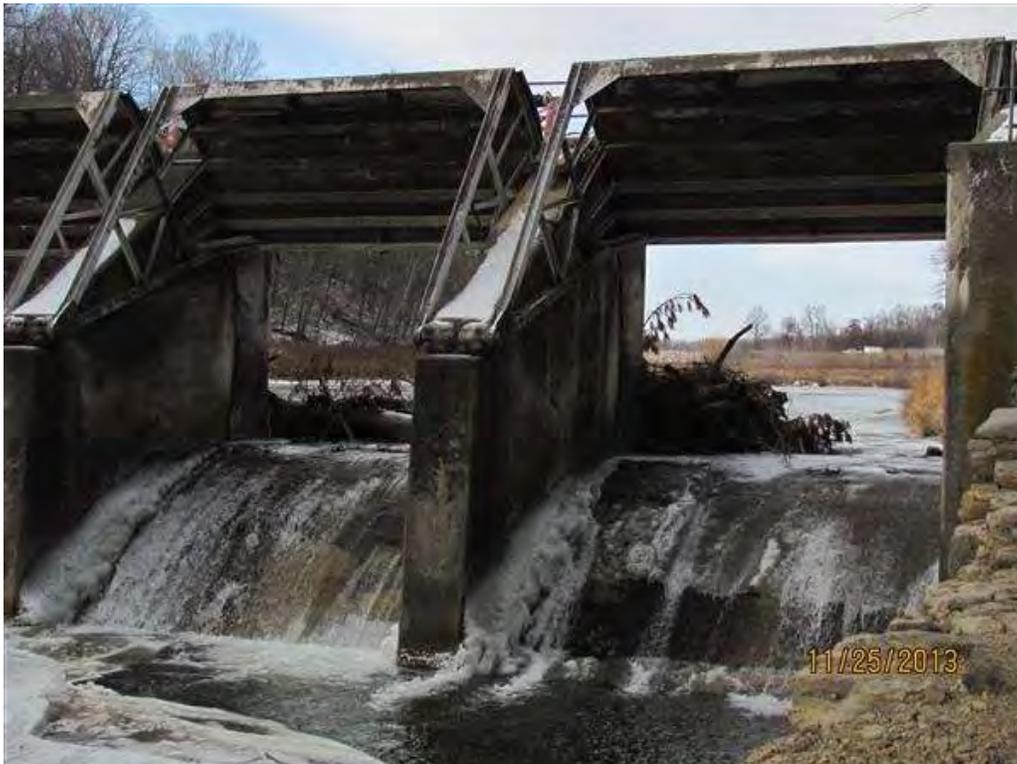
Photo 10 - Timber debris at dam.

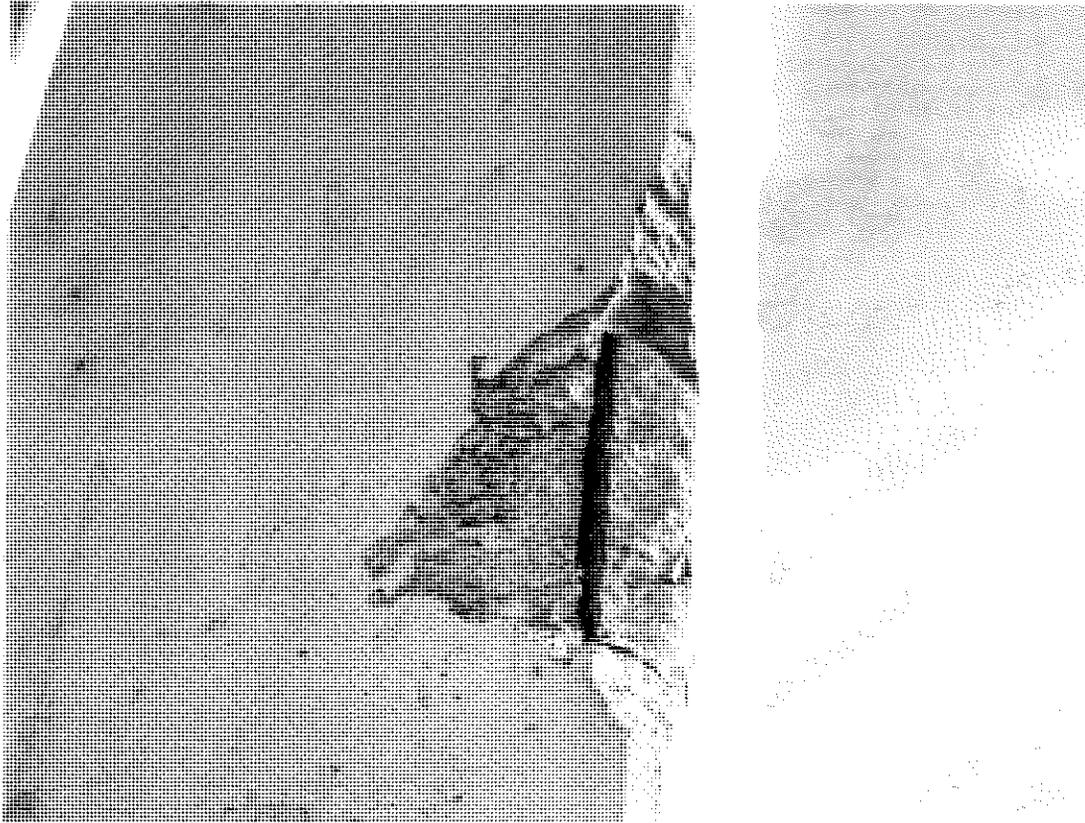
Column 2 southeast corner 15'8" up from the arch, there is a 3' long x 13" wide spall with exposed reinforcement (Photo 1). Southwest corner directly beneath the horizontal strut there is a 4' long x 11" wide spall with exposed reinforcement (Photo 2). Northwest corner 18'2" up from the arch, there is a 6' long x 22" wide spall with exposed reinforcement (Photo 3). Extending down from this spall is a vertical crack that is 38" long. Section loss to the exposed reinforcement at all of these spalls would be considered incidental at this time.

Photo 1 - East Arch Column 2 South End (54)

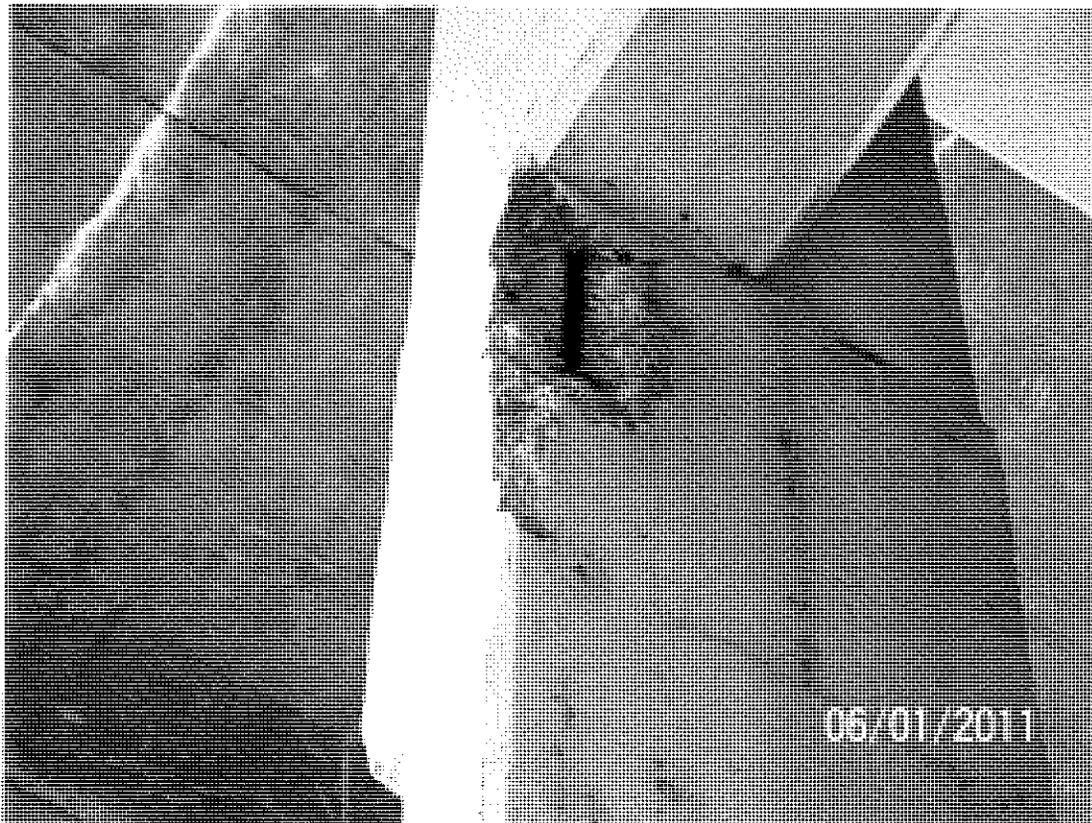
Photo 2 - East Arch Column 2 South End

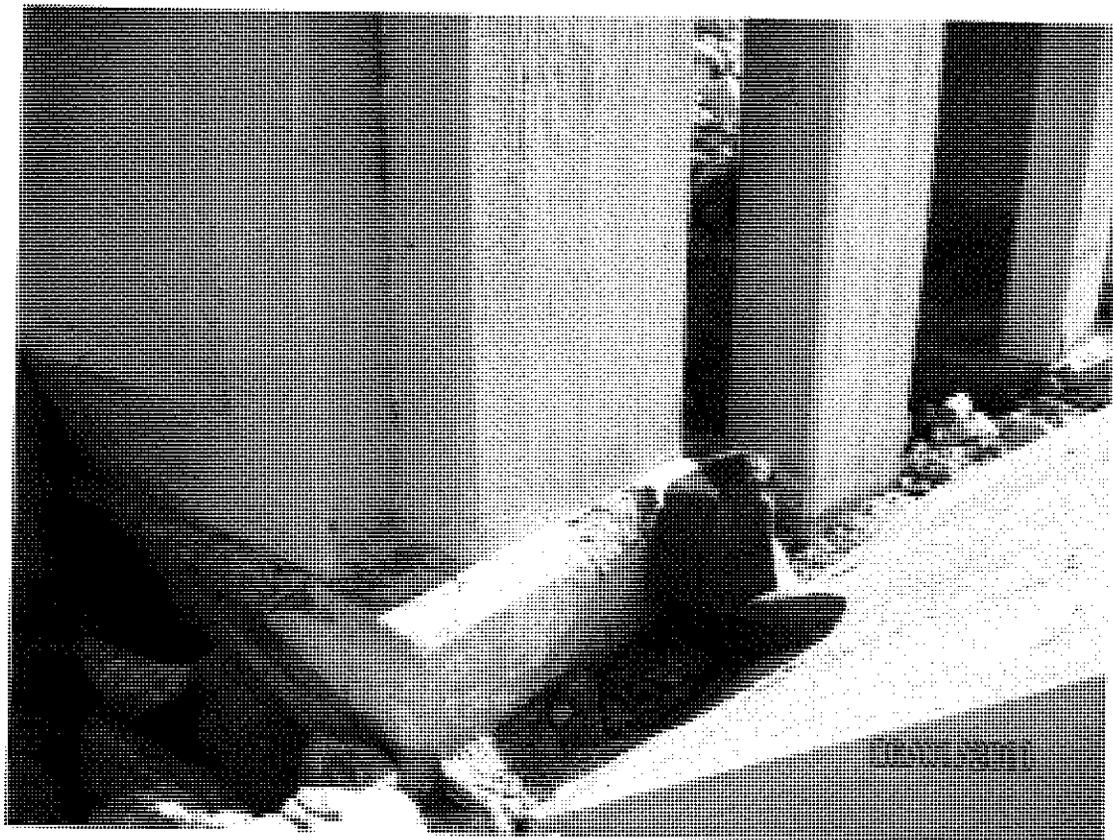
Column 1 at the bottom south side there is a 17" long x 10" wide x 4" deep spall (Photos 8 & 21). The entire south face of the column is cracked and has scattered delaminated areas. On the north side of the same column there is an 8" x 3" spall with exposed reinforcement.

Photo 8 - West Arch Column 1 North End

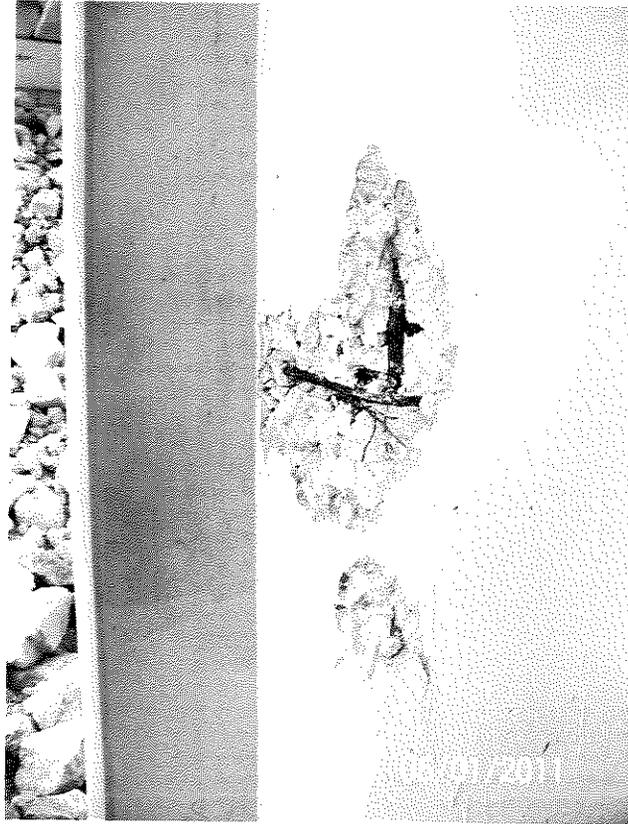
Column 3 has a 30" x 20" spall with exposed reinforcement along the southeast edge 10'6" up from the bottom of the column (Photo 9). There is a 50" x 16" spall with exposed reinforcement in the south face of the column directly below the horizontal strut (Photos 10 & 11).

Photo 9 - West Arch Column 3 North End

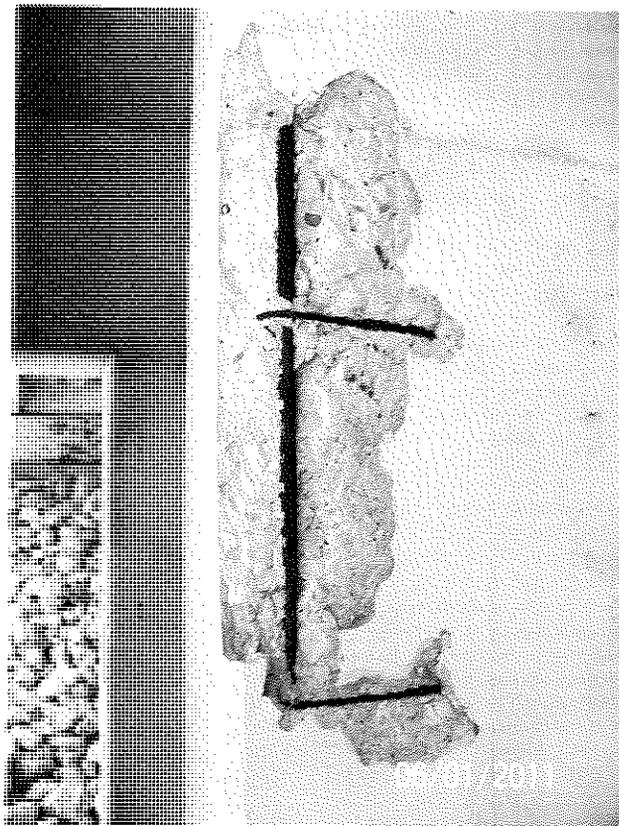
Photo 10 - West Arch Column 3 North End

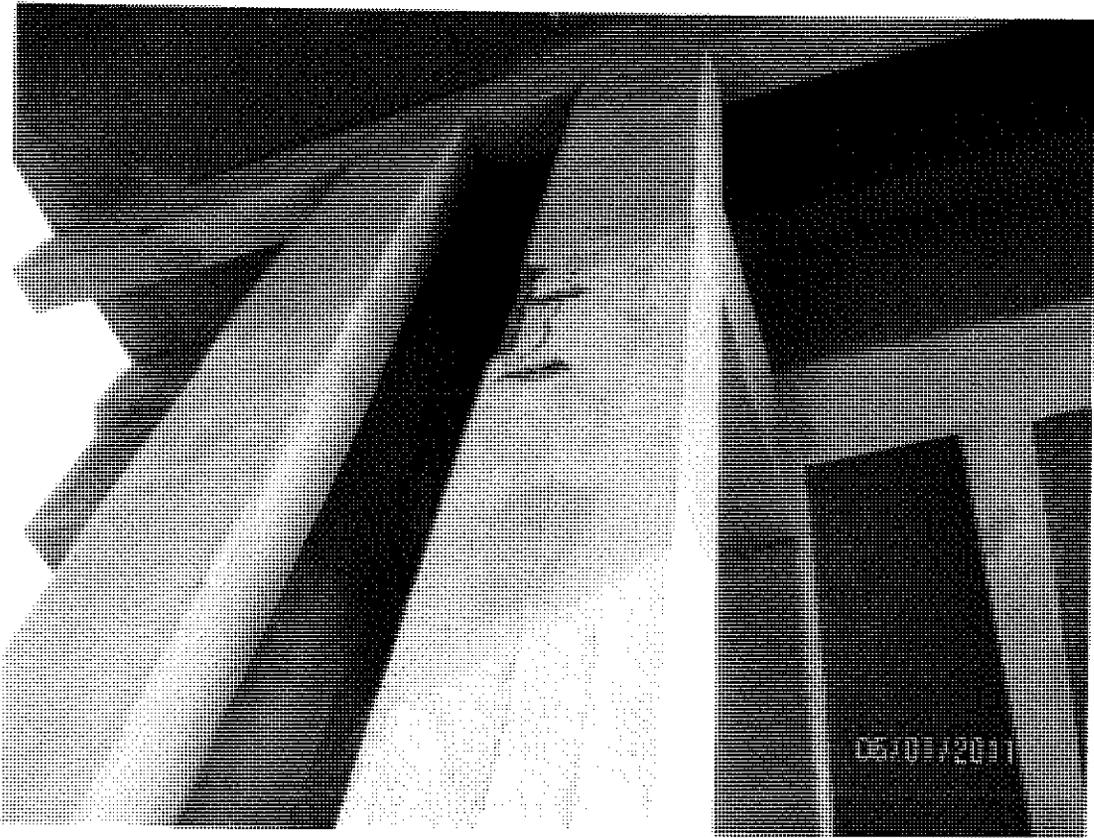
Photo 11 - West Arch Column 3 North End

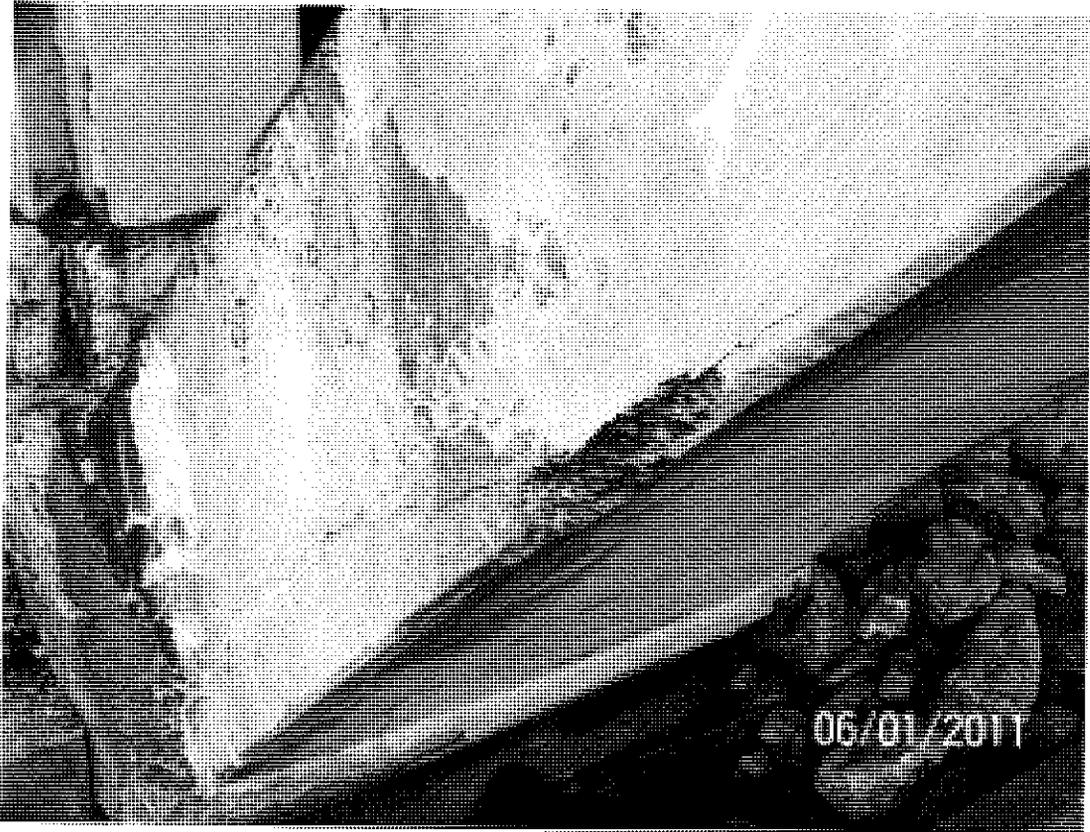
There is cracked and delaminated concrete starting at the bottom of the arch extending to spandrel column 2 (Photos 13, 14, & 15). There is an 8" x 20" spall with no exposed reinforcement 58" up from the bottom of the arch top edge (Photo 13). Around this spall there is a large area of cracked and delaminated concrete. Directly beneath spandrel column 2, there is a 12" x 28" spall with no exposed reinforcement (Photo 14). Directly beneath spandrel column 1 bottom edge, there is a 6" x 30" spall with no exposed reinforcement (Photo 15). There is cracked and delaminated concrete around this spall. On the top edge starting just north of spandrel column 3 and extending 8' towards spandrel column 2, there is cracked, delaminated and spalled concrete. Starting north of spandrel column 5 extending towards spandrel column 4 there is a 10'6" area of cracked and delaminated concrete along the top edge down to the middle of the arch. There are scattered vertical cracks that extend the entire thickness of the arch 7" deep as seen from the top of the arch. These cracks are located between spandrel columns 9 & 10, 10 & 11, 11 & 12, and 12 & 13. There is a 6" x 16" spall with no exposed reinforcement 4' north of spandrel column 13 (Photo 16). Starting south of spandrel column 16 extending to spandrel column 15 there is an area of horizontal and random cracking and scattered small delaminations (Photo 17). This cracking extends into the bottom face of the arch 2'6".

Photo 15 - East Arch South End @ Spandrel Column 1

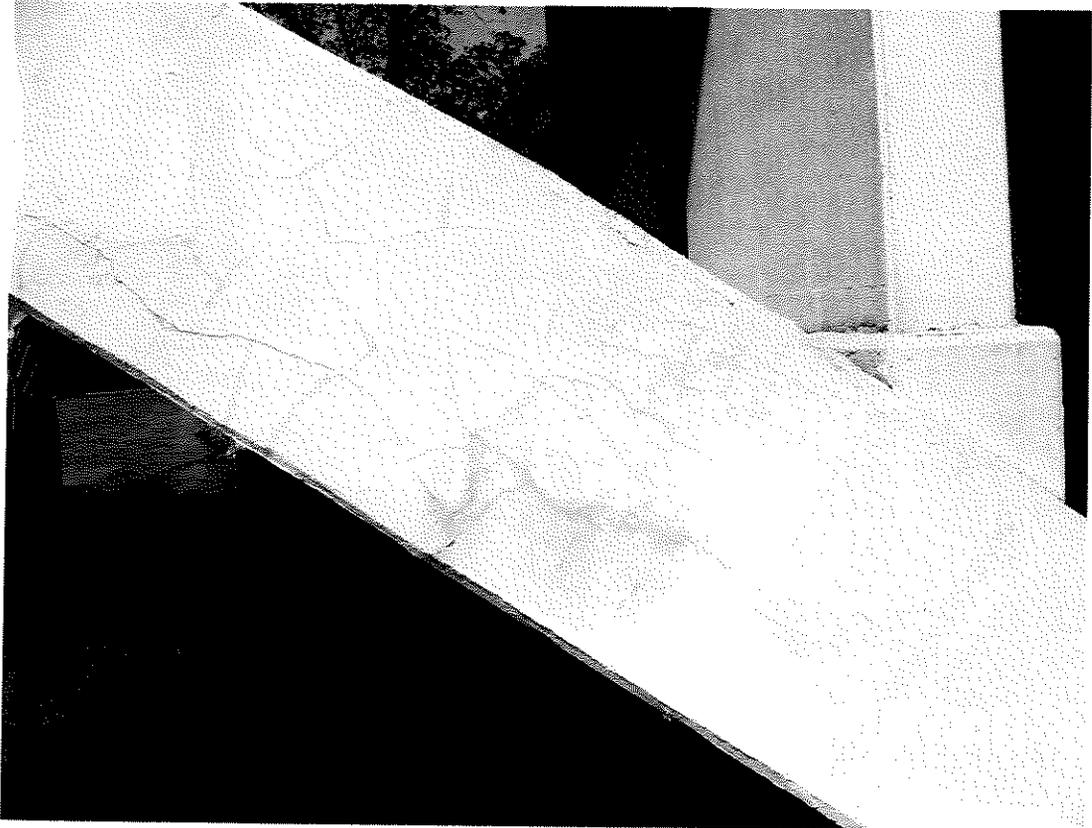
Photo 17 - East Arch Between Spandrel Columns 15 & 16

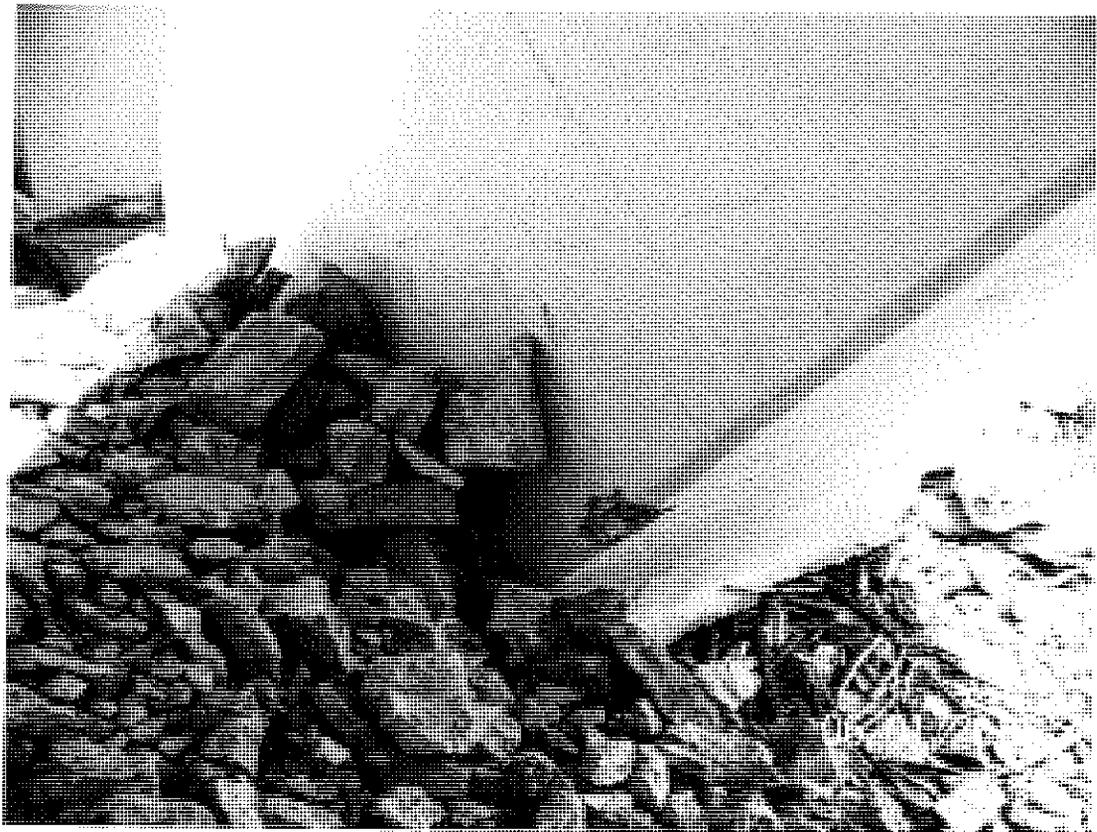
Starting from the north end of the arch 34" in from the west face, there is an 18'6" long longitudinal hairline crack. This crack starts and terminates as a horizontal crack. From the bottom north end there is an 8" long x 5" wide x 6" deep spall that extends up the west face (Photo 18). There was no exposed reinforcement in this spall. Starting from the

Photo 18 - East Arch North End West Face

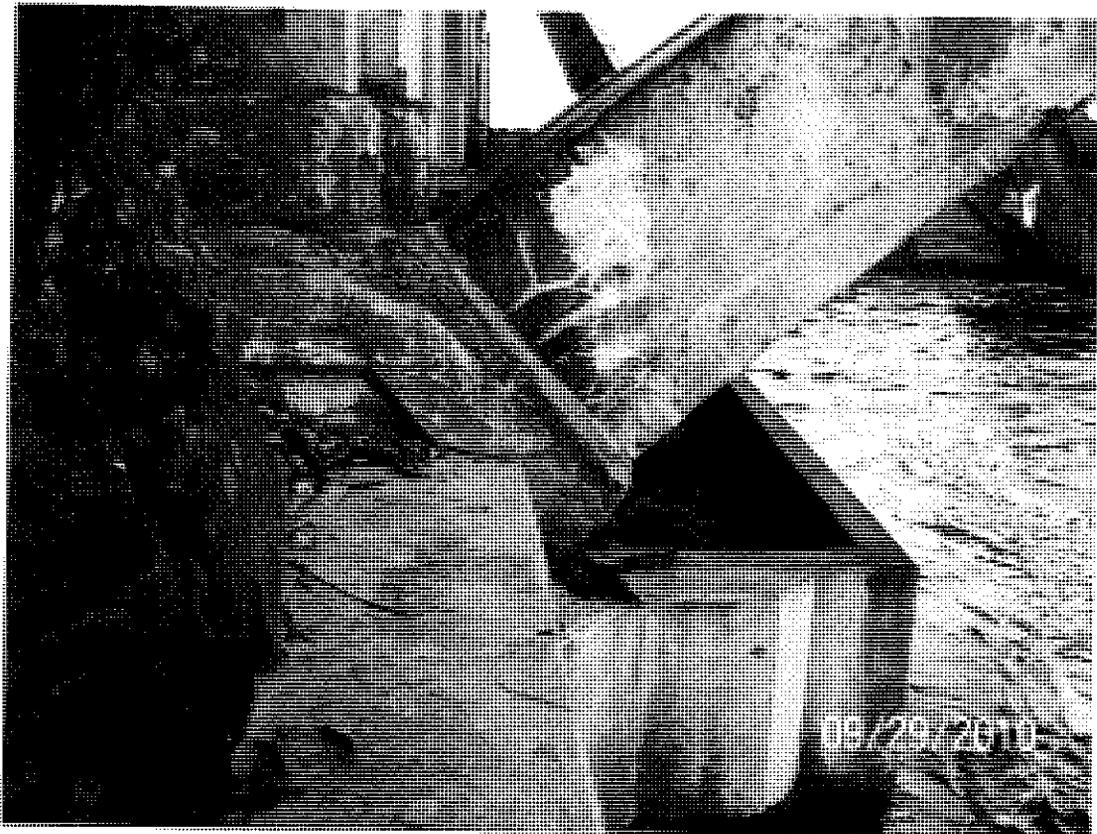
bottom south end of the arch 30" in from the east face extending up to spandrel column 3, there is an area of longitudinal and random cracking. This area corresponds to a repair patch completed in the past. The south end thrust block east side is cracked, spalled and delaminated (Photo 13 & 20).

Photo 20 - East Arch East Face @ Thrust Block

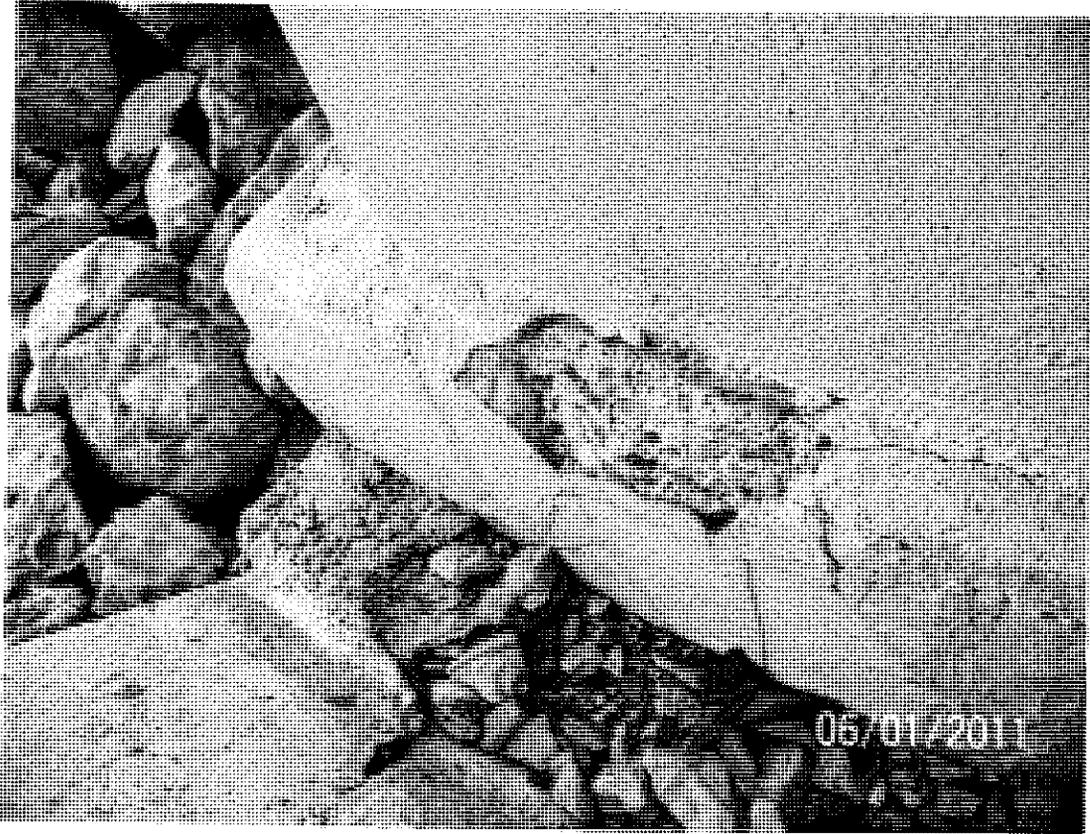
Photo 21 - West Arch North End South Side Column 1

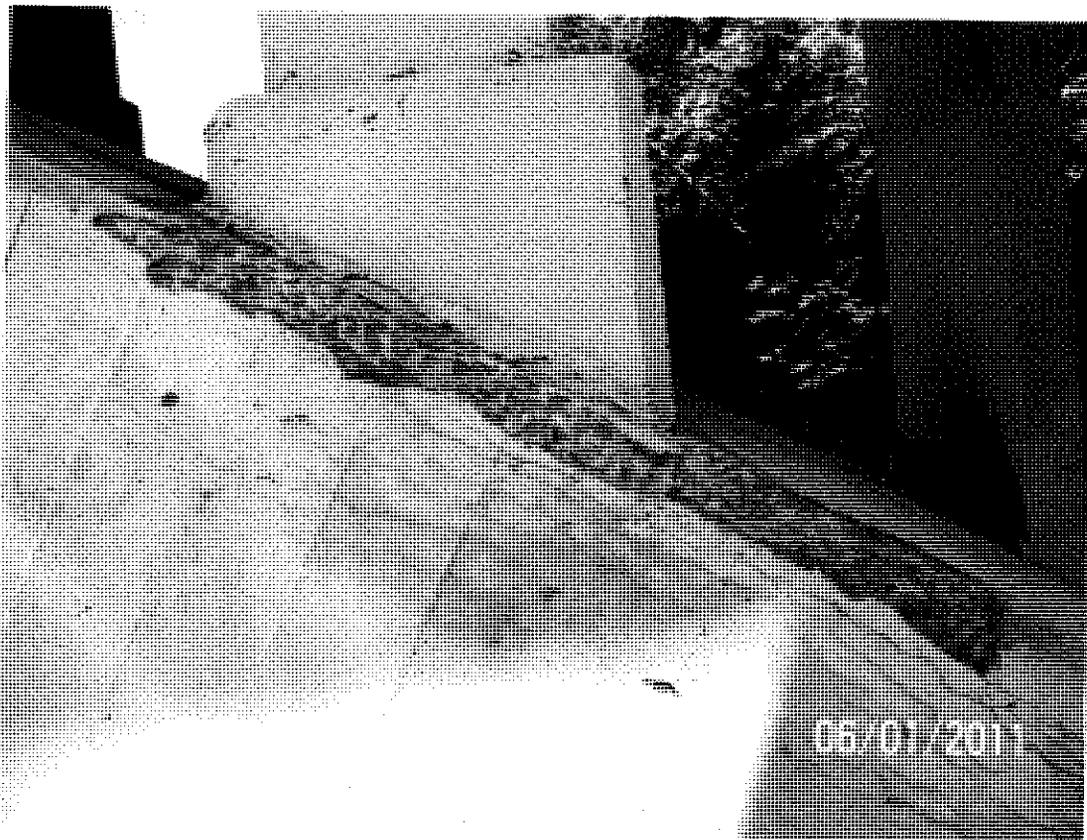
There is a hairline horizontal crack that runs between spandrel columns 1 and 2. South of spandrel column 1 there is a 16" wide x 50" long area of cracked and delaminated concrete. Directly under spandrel column 2 top edge extending to the south there is a 6' long x 10" wide x 6" deep spall (Photo 22). Directly under spandrel column 3 extending to the south along the bottom edge there is a 36" x 6" x 7" deep patched area that is cracked and delaminated. There is a 36" long x 8" deep spall along the top edge 40" north of spandrel column 3 (Photo 23). Under spandrel column 5 there is a 33" long x 12" wide x 4" deep top edge spall (Photo 24). There is a hairline horizontal crack that extends the entire distance between spandrel columns 4 and 5. Under spandrel column 6 there is a 26" x 4" area of cracked and delaminated concrete top edge. Directly under spandrel column 11 there is a full height hairline vertical crack. Just south of spandrel column 12 there is a 4" x 10" top edge spall that is adjacent to an 18" cracked and delaminated area. Between spandrel columns 14 and 15 there is an 8' long mid-point horizontal crack. There are seven hairline vertical cracks scattered between the north end of the arch and spandrel column 15.

Photo 22 - West Arch West Face @ Spandrel Column 2

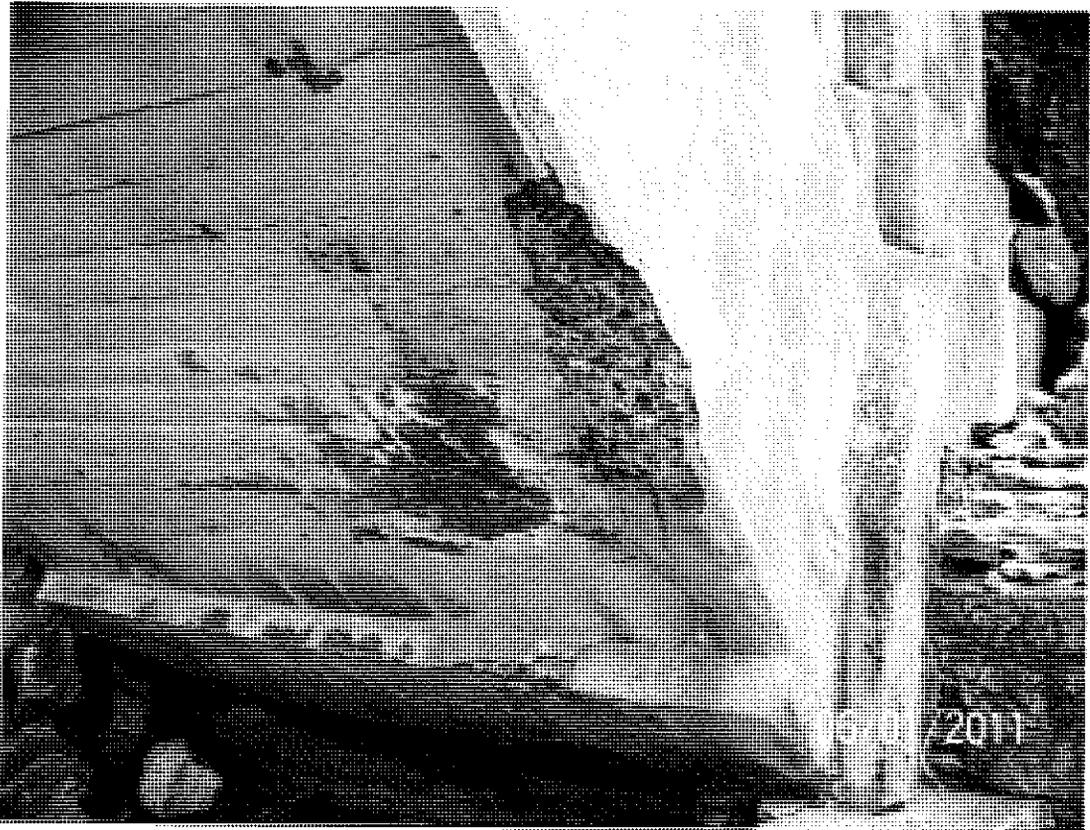
Photo 25 - West Arch Bottom South End

The bottom south end of the arch is spalled, cracked and delaminated (Photo 25). Starting 34" up from the bottom south end of the arch west edge there is a 56" long x 18" wide spalled, cracked and delaminated area (Photo 25). Directly above the bottom south end of the arch 24" in from the west edge there is a 4' long x 22" wide area of spalled, cracked and delaminated concrete (Photo 26). There is a hairline transverse crack 33" from spandrel column 2. This crack runs across the entire bottom of the arch and up 6" vertically into the east face. There is a 9" x 14" x 7" deep spall at the north end of the arch west corner (Photo 27). South of spandrel column 2 and 16" in from the west face there is a 15" x 45" area of cracked and delaminated concrete with no spalls.

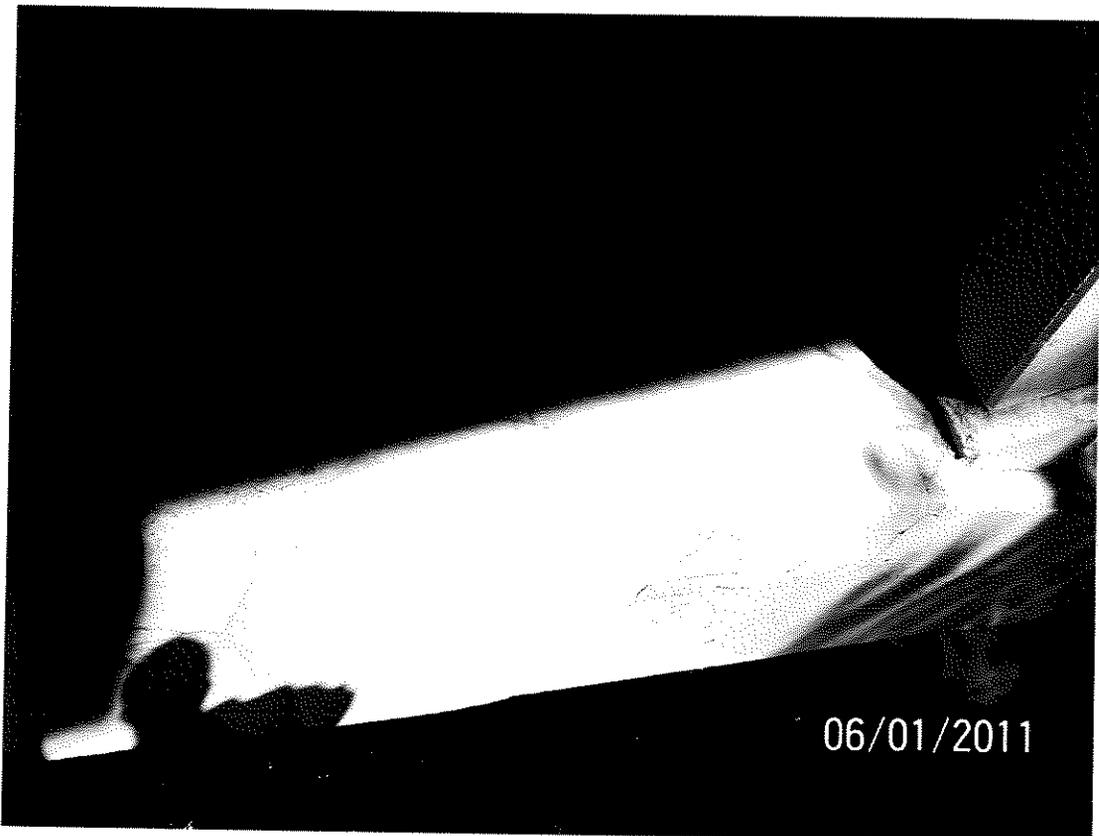
Photo 28 - West Arch Between Spandrel Columns 1 & 2

There is an area of cracked and deteriorated concrete top west side of the arch between spandrel columns 1 and 2 (Photo 28). These cracks are rust stained. The remaining top face of the arch has no significant spalls or cracks.

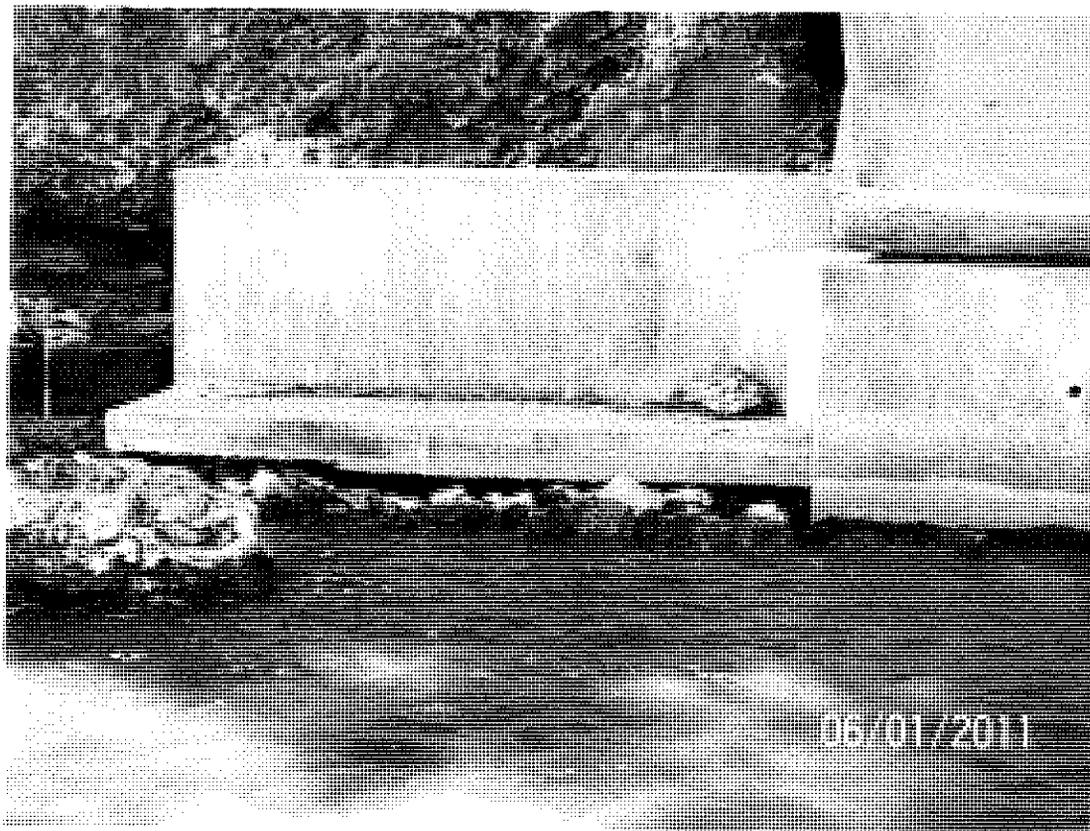
Photo 30 - South End of Arch East Footing

The apron that was added to the east side of the south end of the arch is undermining (Photos 30 & 31). The undermining extends from 2' up to 6' past the end of the apron (Photo 32).
