UNDERWATER BRIDGE INSPECTION REPORT

STRUCTURE NO. 58520

KETTLE RIVER

PREPARED FOR THE
MINNESOTA DEPARTMENT OF TRANSPORTATION

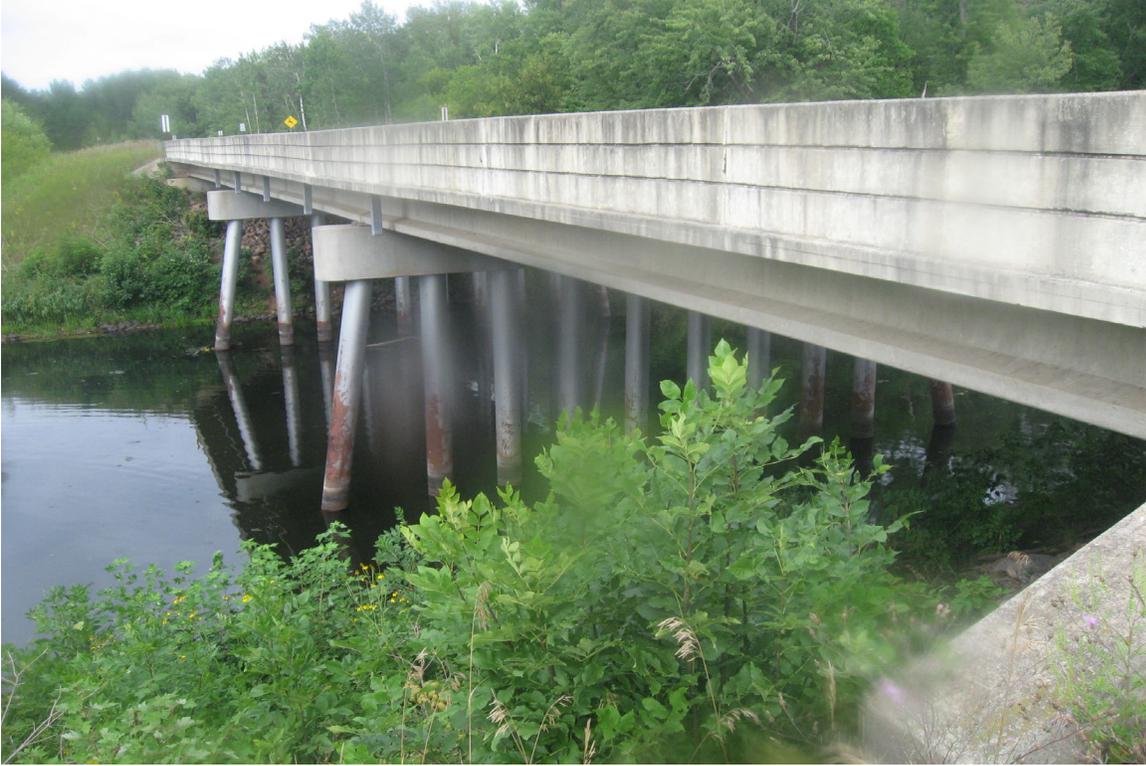
Photograph 1. View of Structure, Looking Northeast.

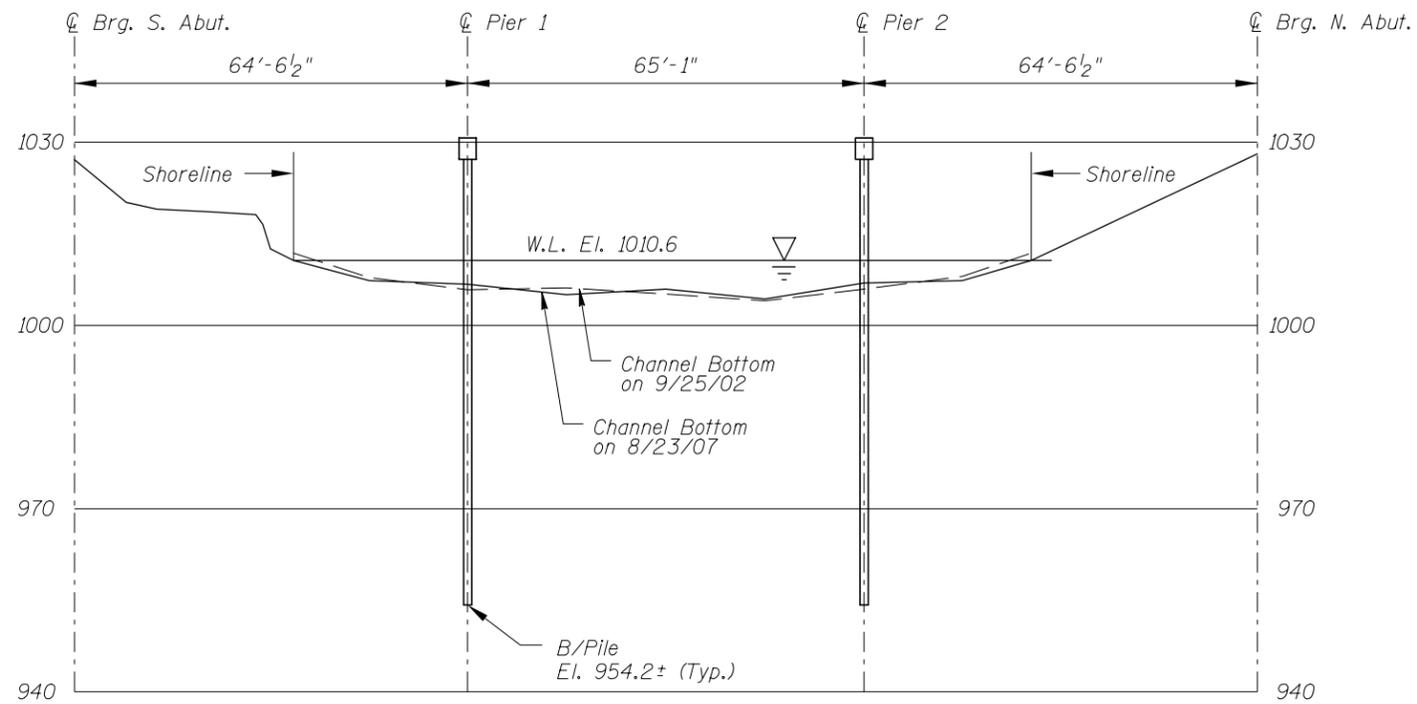
UPSTREAM FASCIA PROFILE

- ① The steel piles exhibited coating failure on 80 to 100 percent of the surface area from 4 feet above the waterline to the channel bottom.
- ② The steel piles exhibited light surface corrosion with rust nodules and up to 3/16 inch of pitting on up to 50 percent of the surface area from 3 feet above the waterline to the channel bottom. Deterioration was heaviest from 1 foot above waterline to 1 foot below waterline.
- ③ The channel bottom material consisted of sandy gravel and approximately 4-inch-diameter cobbles with random larger rocks on banks with up to 2 inches of probe rod penetration.
- ④ A moderate accumulation of timber debris consisting of 1 foot diameter and smaller logs and branches, including a 12-inch-diameter tree, was observed at the downstream end of Pier 1.
- ⑤ An 18-inch-diameter tree was observed along the south side of Pier 2.
