UNDERWATER BRIDGE INSPECTION REPORT

STRUCTURE NO. 31509

MISSISSIPPI RIVER

OCTOBER 1, 2012

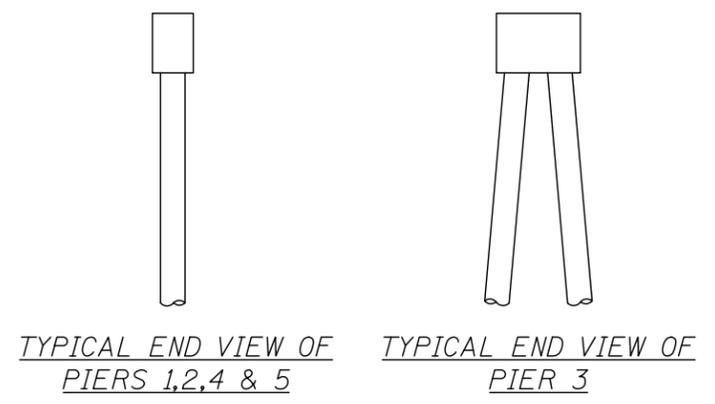
- INSPECTION NOTES:**
- 1 Channel bottom consists of soft silty sand with gravel and cobbles, allowing up to 6 inches of probe rod penetration.
  - 2 Coating failure, corrosion, and rust nodules, were observed from 6 inches above the waterline to the channel bottom on approximately 80 to 100 percent of the surface area of all piles. Typical pitting penetrations of the rust nodules were 1/32 inch, with infrequent instances of 1/16 inch and 1/8 inch penetrations observed on the steel shell piles.

- 3 A large steel 5 feet diameter by 10 feet long corrugated metal pipe piece of debris was observed with random 6 inch diameter timber debris and 8 inch diameter posts in and around the pipe.

- 4 Timber drift consisting of scattered 6 to 8 inch diameter and smaller timber debris was observed at the mudline.
  - 5 3/4 inch diameter steel cables were observed to be wrapped around the pile.
