UNDERWATER BRIDGE INSPECTION REPORT

STRUCTURE NO. 69518

CSAH 4

ST. LOUIS RIVER

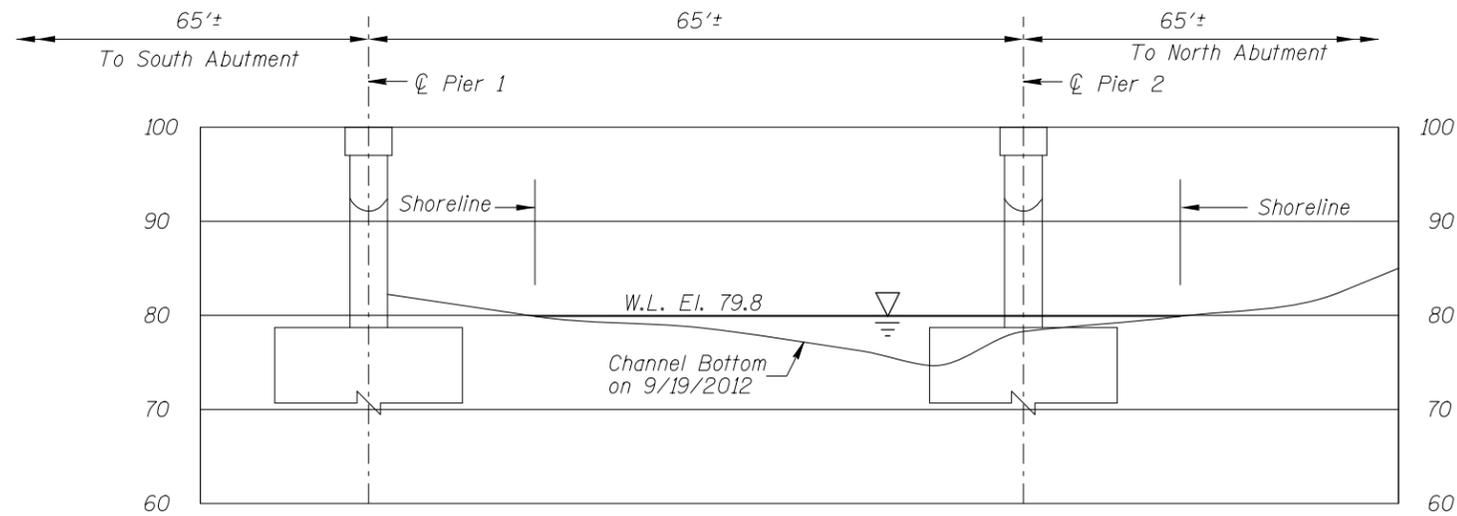
DOWNSTREAM FASCIA PROFILE

- ④ A 2 foot deep scour pocket was observed that extended 8 feet off the upstream and downstream nose and along the entire south face of Pier 2. Within the scour pocket the concrete footing of Pier 2 was exposed with a maximum vertical exposure of 4.4 feet at the upstream south corner.

- ⑤ A 10 inch diameter tree was observed extending from the upstream nose of Pier 2 to the north shoreline as shown.
- ⑥ The upstream and downstream shorelines were heavily eroded with a maximum undercutting of 10 feet.
