UNDERWATER BRIDGE INSPECTION REPORT

STRUCTURE NO. 69592

WHITEFACE RIVER

MINNESOTA DEPARTMENT OF TRANSPORTATION
UNDERWATER BRIDGE INSPECTION

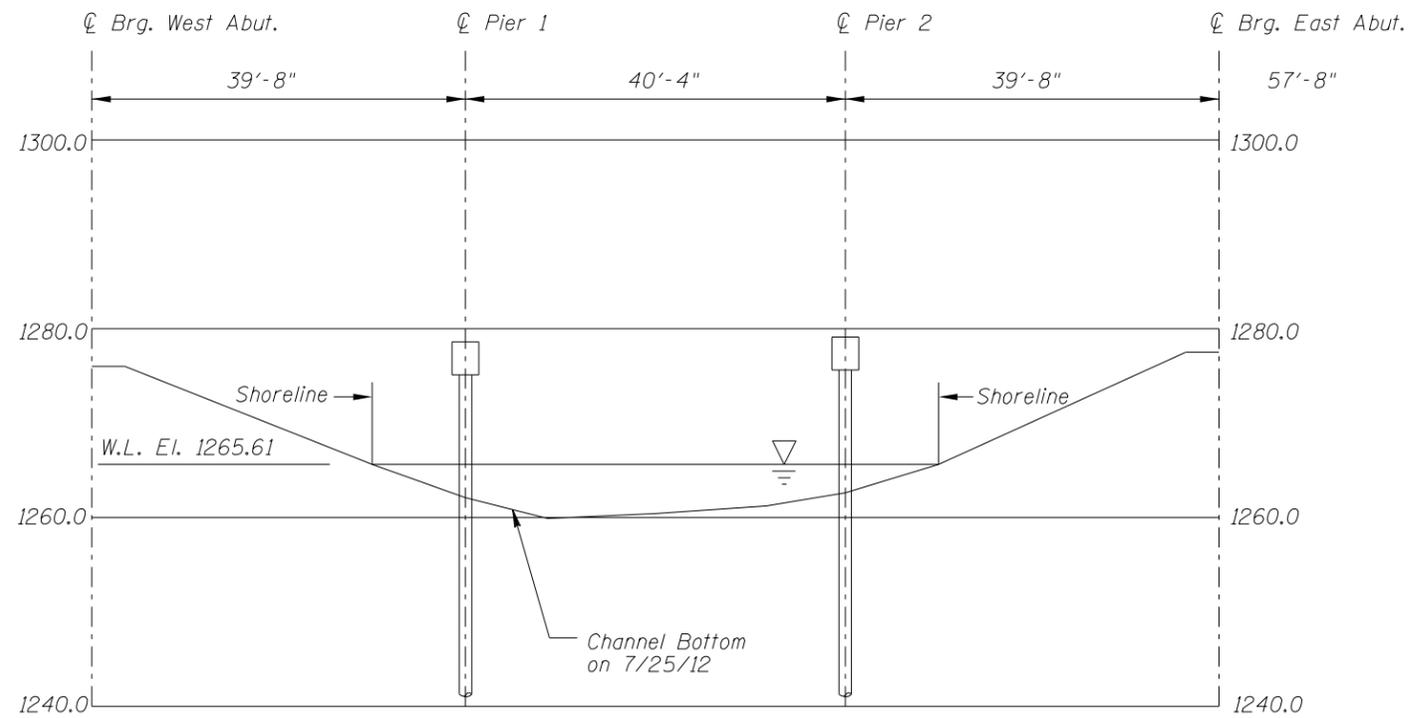
UPSTREAM FASCIA PROFILE

- ① The channel bottom material consisted of sand allowing up to 4 inches of probe rod penetration.
- ② All steel pipe piles typically exhibited surface corrosion from 2 feet above the waterline to channel bottom, with no measurable section loss.
- ③ A moderate accumulation of timber debris, consisting of logs and branches 12 inch diameter and smaller, was observed from the shore out 20 feet to the upstream nose of Pier 1, and along the east face of the pier, extending off the face up to 10 feet. The debris extended from the channel bottom to 5 feet above the waterline.
