UNDERWATER BRIDGE INSPECTION REPORT

STRUCTURE NO. L4198

CR 666

SECOND CREEK

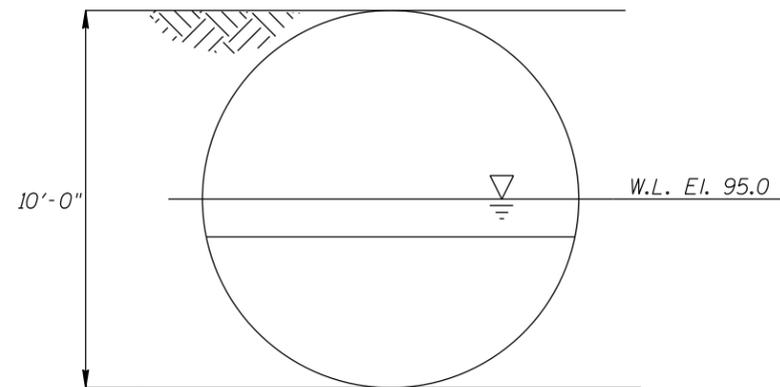
UPSTREAM PROFILE

- INSPECTION NOTES:
- ① The channel bottom material through the culvert consisted of a layer of silt, approximately 8 inches thick, over firm sand. At the openings the channel bottom material consisted of a layer of silt, approximately 12 to 18 inches thick, over scattered rocks.
  - ② A light to moderate timber debris accumulation was observed at both ends of the culvert and extended across the width of the opening resulting in a somewhat obstructed flow.
  - ③ The corrugated steel pipe exhibited light surface corrosion from 2 feet above to 2 feet below the waterline with no significant loss of section. The joints and alignment was satisfactory with no deflection or distortion.
