2017 UNDERWATER BRIDGE INSPECTION REPORT

BRIDGE # 36514 CSAH 18 over RAPID RIVER

DISTRICT: District 1 COUNTY: Koochiching CITY/TOWNSHIP: T - 160 R - 29
STATE: Minnesota

Date of Inspection: 08/03/2016

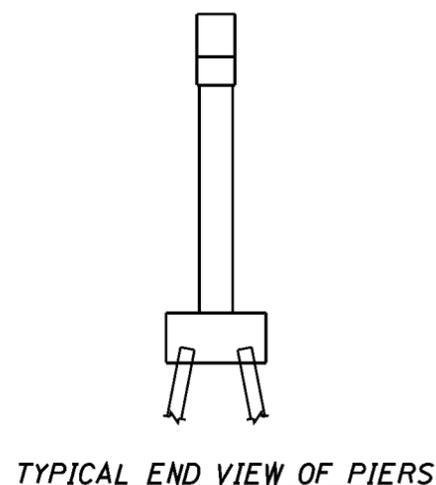
SOUNDING PLAN

1. Piers 1 and 2 were inspected underwater at this bridge.
2. At the time of inspection on August 3, 2016, the waterline was located approximately 14.3 feet below the top of pier cap at north fascia of Pier 2. This corresponds with a waterline elevation of 1069.9 feet based on design drawings.
3. Soundings indicate the water depth at the time of inspection and are measured in feet. All soundings based on 2016 waterline location.
4. Soundings were taken parallel to the bridge at 1/4 points between the substructure units.
