# 2016 UNDERWATER BRIDGE INSPECTION REPORT

## BRIDGE # 36517 CSAH 75 over LITTLE FORK RIVER

Date of Inspection: 06/01/2016

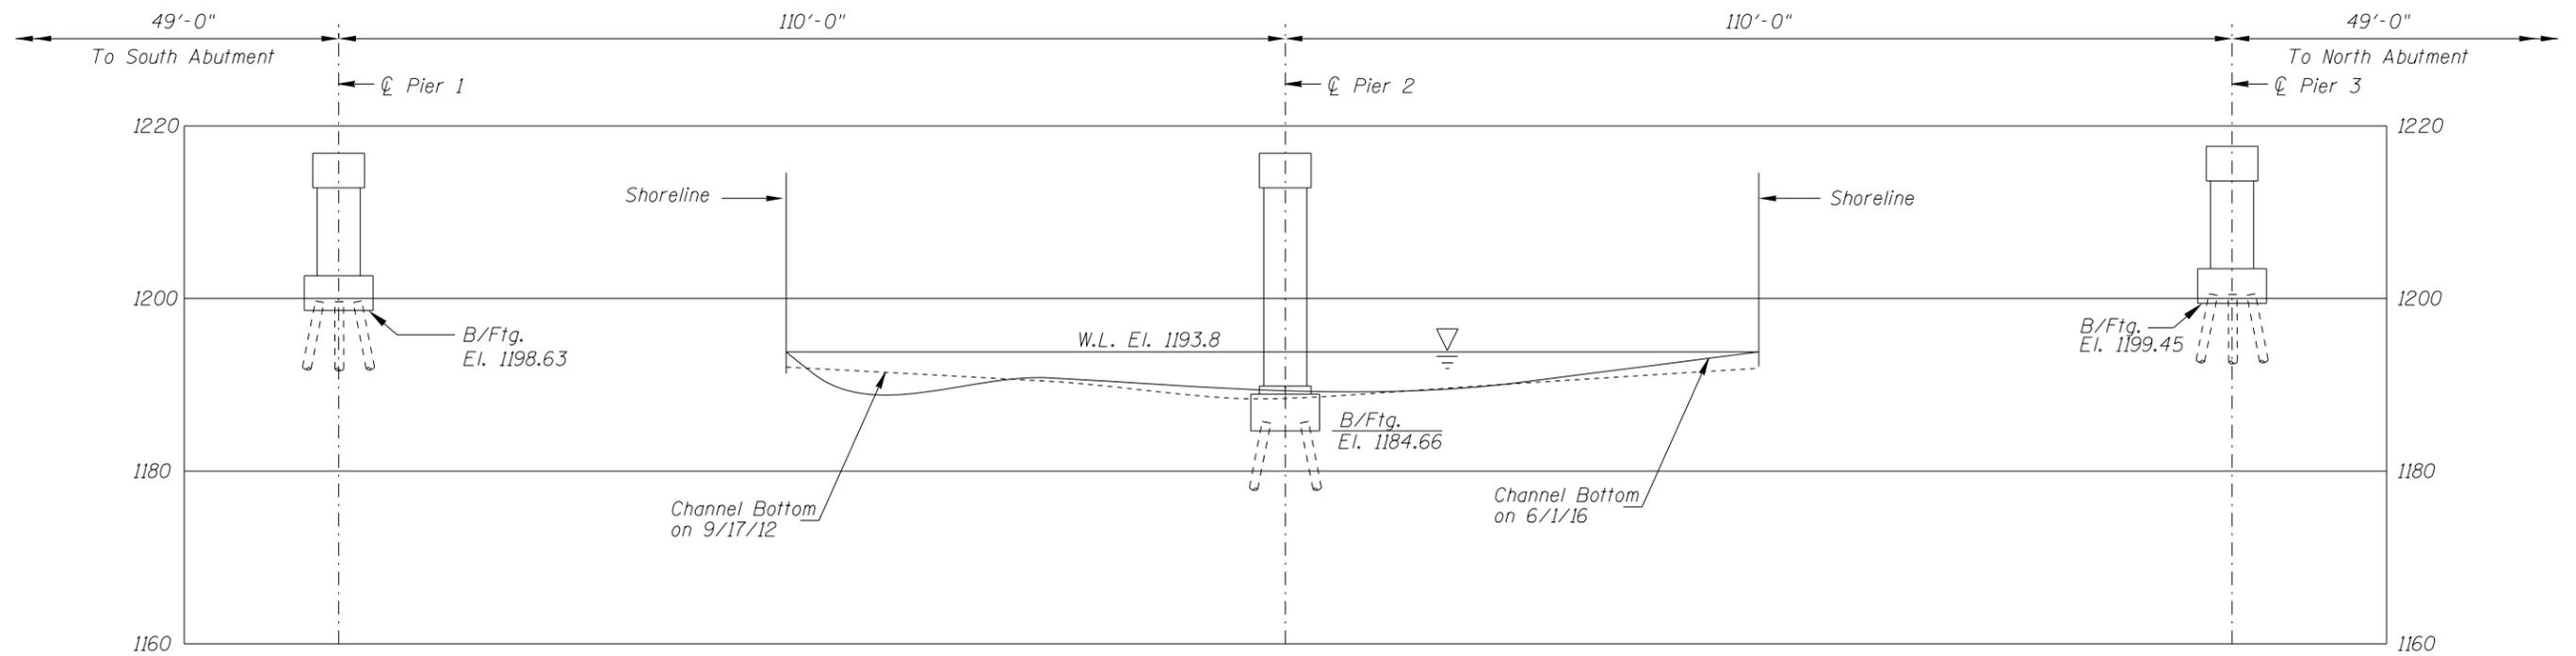
UPSTREAM FASCIA PROFILE

(A) The channel bottom material consisted of a firm, sandy gravel and riprap up to 1-foot-diameter allowing up to 1 inch of probe rod penetration. (B) A band of minor concrete scaling was present 2 feet above the waterline to 3 feet below water with 1/4 inch maximum penetration. (C) The footing was exposed at the upstream nose of the pier. The exposure was only the top of the footing with no vertical exposure. (D) A minor scour depression was present around the upstream nose with an approximate 10-foot-radius and 1 foot depth. (E) A 6-inch-diameter tree branch was located across the upstream nose of the pier.
