2016 UNDERWATER BRIDGE INSPECTION REPORT

BRIDGE # 7183 CSAH 100 over ST LOUIS RIVER

Date of Inspection: 06/23/2016

Contractor: Collins Engineers, Inc.

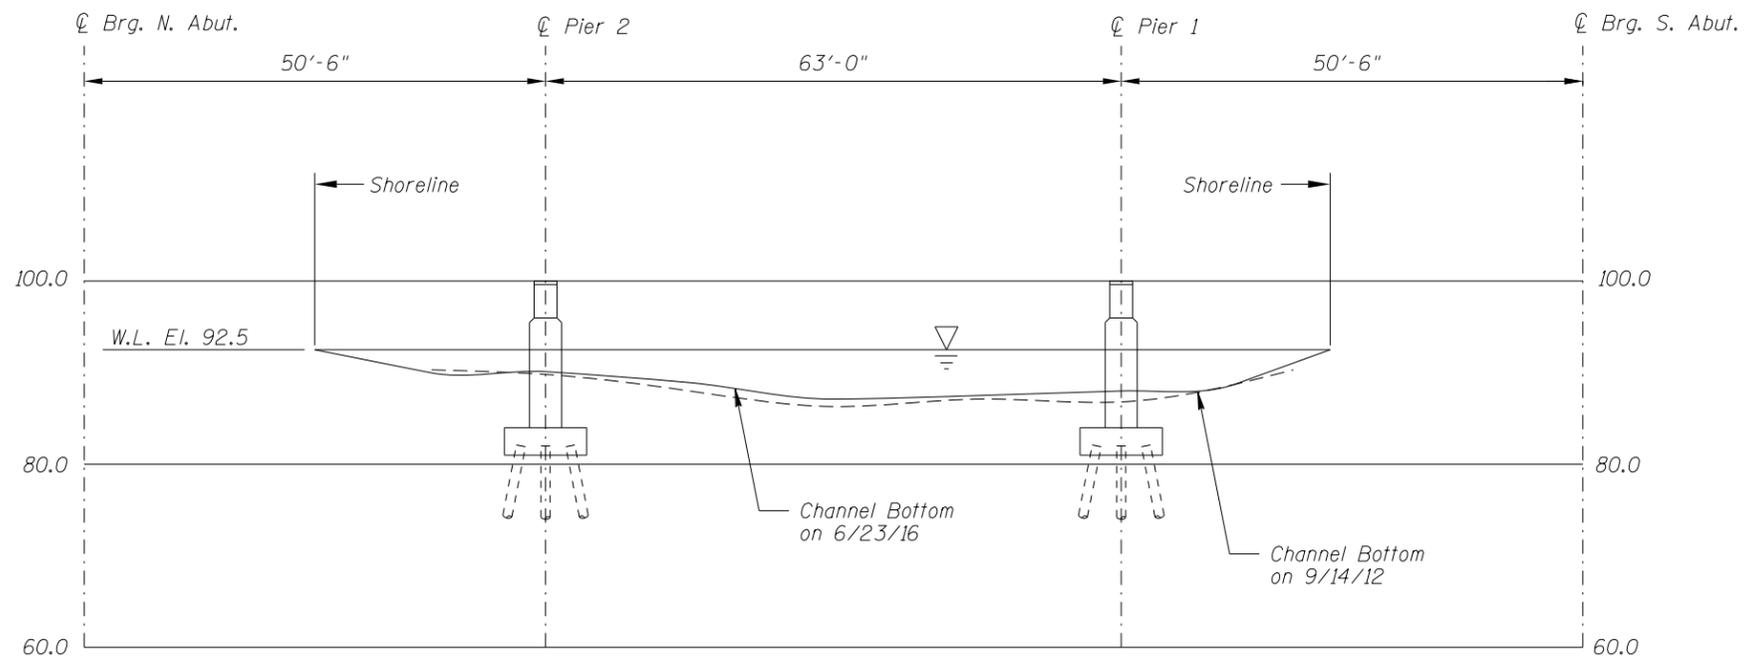
UPSTREAM FASCIA PROFILE

(C) Moderate scaling with large aggregate exposure from 3 feet above the waterline to 1.5 feet below the waterline with typical penetrations of 1/8 to 1/4 inch and up to 1 inch maximum was observed around all columns of both piers.

(D) An area of heavy scaling/section loss was observed around the downstream column of Pier 1, 2 foot high by 2.5 feet wide extending from the waterline to 2 feet below the waterline with a maximum penetration of 2.5 inches. The concrete within this area was flaky and unsound.

(E) A scour depression measuring 5 feet in radius with a depth of 3 feet, was observed at the downstream column of Pier 2 and the upstream and downstream column of Pier 1.

(F) A 6 to 12 inch diameter log was observed from the channel bottom to the waterline along the upstream column of Pier 1.

(A) Consideration should be given to repairing the concrete defects at the columns of Piers 1 and 2. Until the repairs are implemented, the defected areas should be monitored during future underwater inspections for any progression of section loss and/or exposure of reinforcing steel.
