# 2016 UNDERWATER BRIDGE INSPECTION REPORT

## BRIDGE # 88620 CSAH 133 over JOULA CREEK

Date of Inspection: 06/24/2016

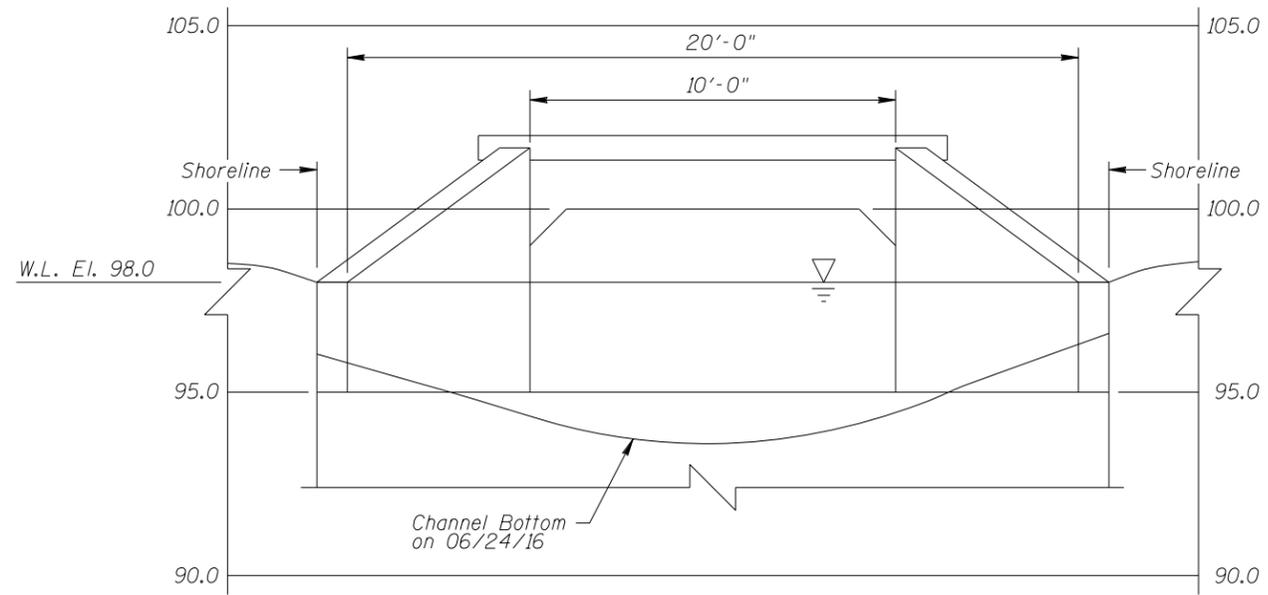
UPSTREAM FASCIA PROFILE

(C) A spall with exposed reinforcing steel measured 2 feet wide by 6 inches long along the bottom of the upstream headwall. Exposed reinforcing steel typically exhibited less than 5 percent section loss.

(C) Monitor the concrete deterioration during future underwater inspections.
