2016 UNDERWATER BRIDGE INSPECTION REPORT

BRIDGE # 88631 CR 958 over STREAM

Date of Inspection: 06/22/2016

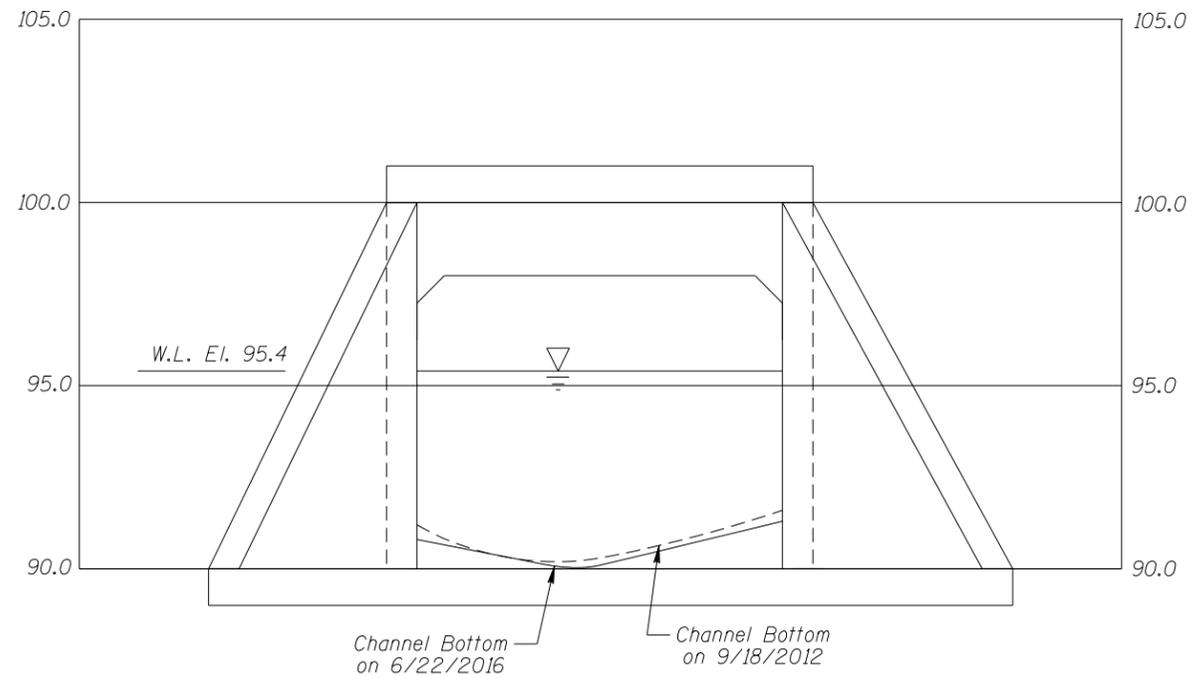
UPSTREAM OPENING PROFILE

- (F) A 3 foot diameter area of apron was exposed at the upstream end of the culvert. Only the top of the apron was exposed, no vertical exposure was observed.
