2016 UNDERWATER BRIDGE INSPECTION REPORT

BRIDGE # L4198 CR 666 over SECOND CREEK

Date of Inspection: 06/23/2016

Contractor: Collins Engineers, Inc.

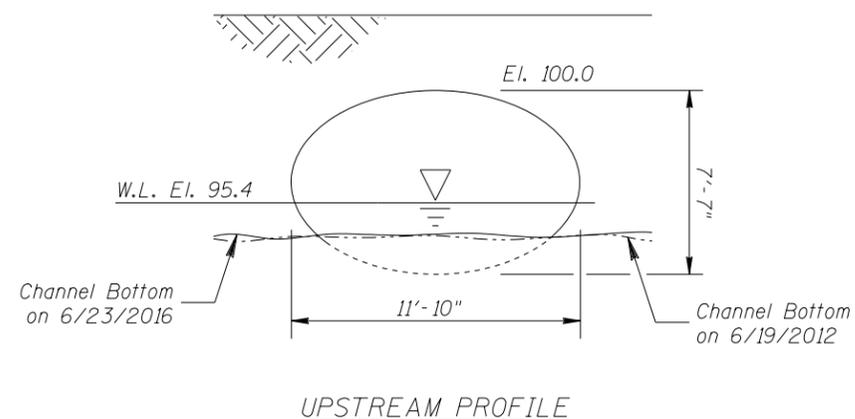
UPSTREAM PROFILE

(B) A light timber debris accumulation was observed at both ends of the culvert and extended across the width of the opening.

(C) The corrugated steel pipe exhibited light surface corrosion from 3 feet above the waterline to the channel bottom with no significant loss of section. The joints and alignment was satisfactory with no deflection or distortion.
