UNDERWATER BRIDGE INSPECTION REPORT

STRUCTURE NO. 18506

RABBIT LAKE

MINNESOTA DEPARTMENT OF TRANSPORTATION
UNDERWATER BRIDGE INSPECTION

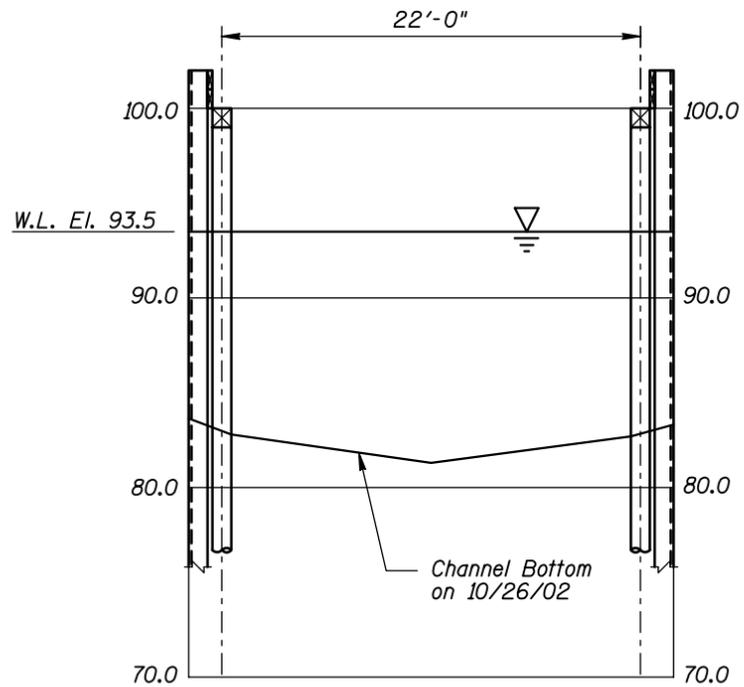
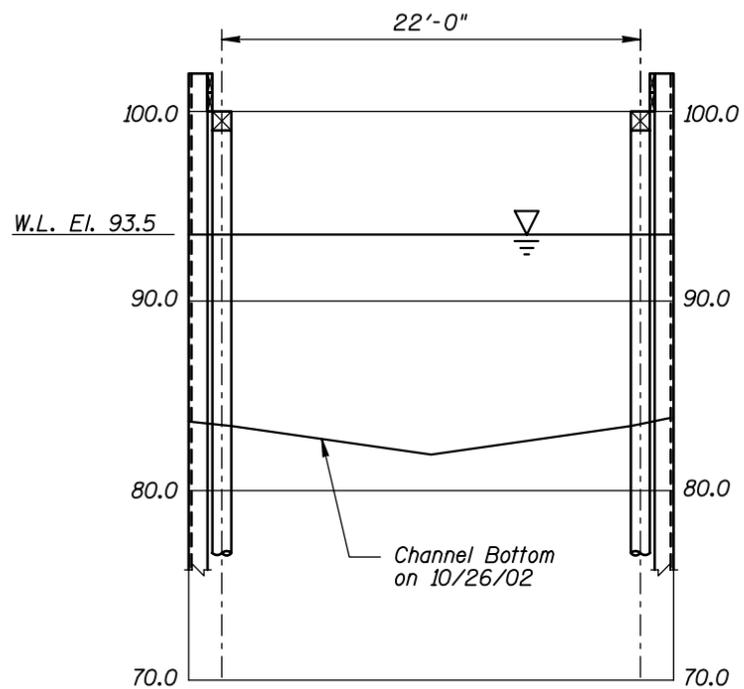
- ① Channel bottom consisted of silty sand with 2 to 4 inches of probe rod penetration.
- ② Very minor checking with width generally less than 1/8 inch on all timber members.
- ③ Light aquatic growth on the steel sheeting below the waterline.

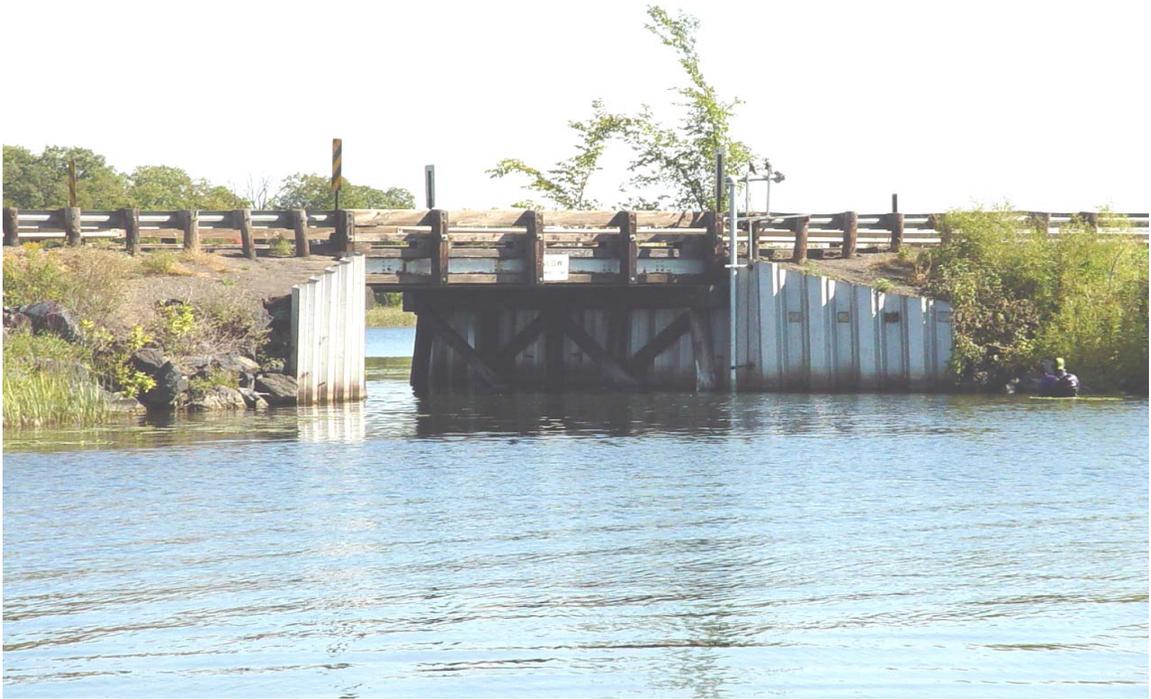
Photograph 1. Overall View of the Structure, Looking Southeast.
