# 2016 UNDERWATER BRIDGE INSPECTION REPORT

## BRIDGE # 30507 CSAH 5 over RUM RIVER

Date of Inspection: 05/24/2016

Contractor: Collins Engineers, Inc.

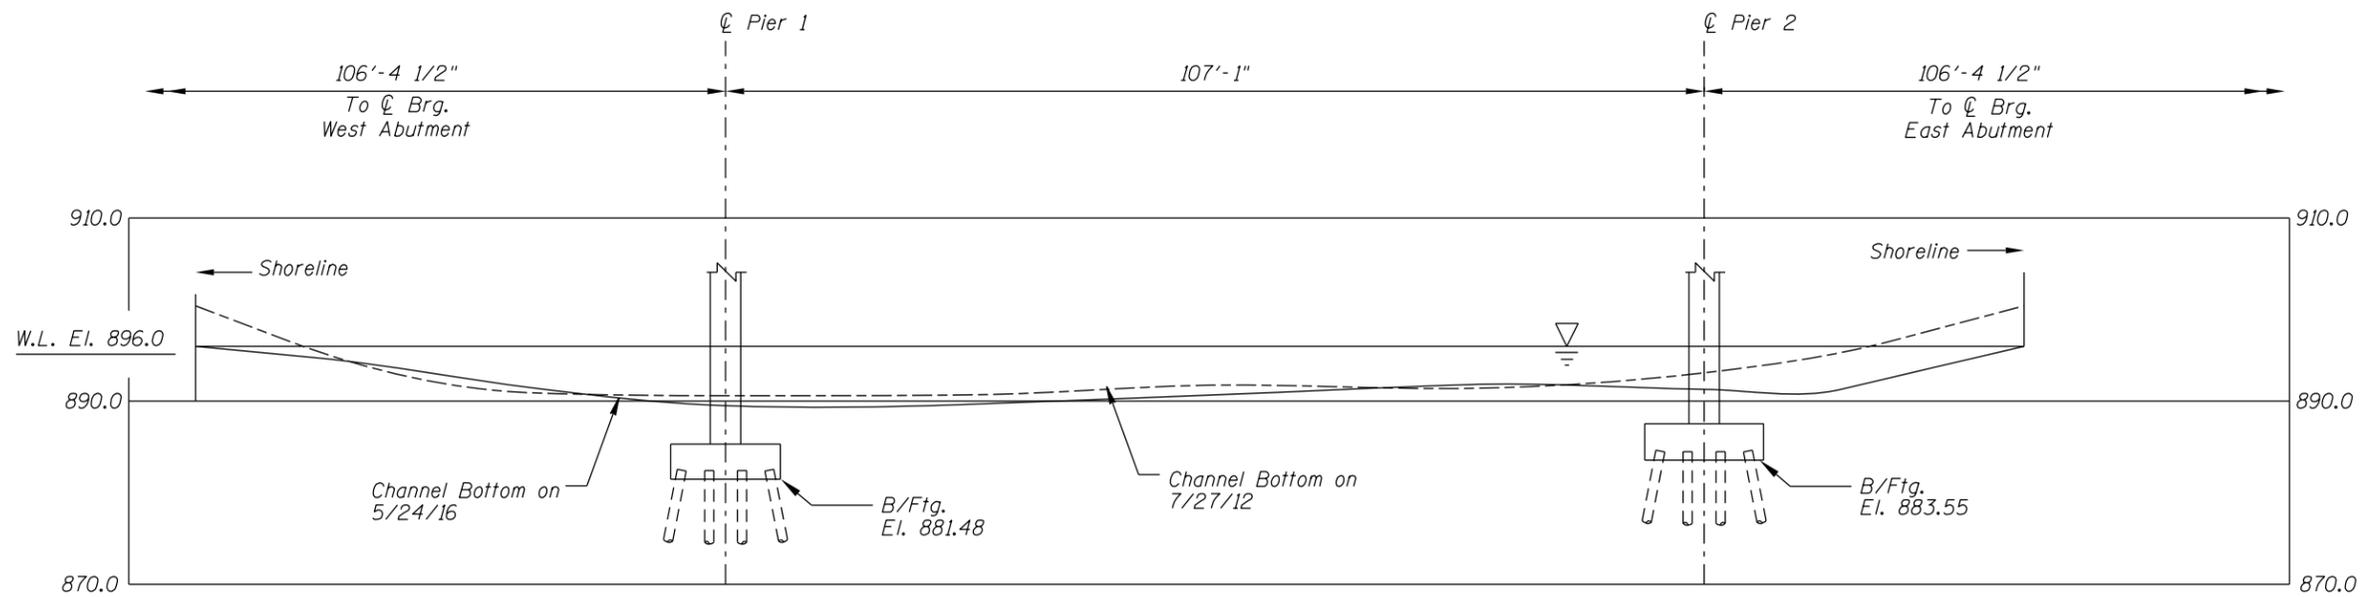
UPSTREAM FASCIA PROFILE

(B) A light accumulation of timber debris consisting of 4 inch diameter and smaller logs and branches extended along the entire west face of Pier 2 and from the channel bottom up 2 feet.

(C) A 5 foot wide, 3 foot deep scour pocket was observed along the entire west side of Pier 2.

(A) Monitor the timber drift that has accumulated around the piers, and if found to be progressing to the point of influencing or becoming excessive, then removal operations may become necessary.

(B) Reinspect the submerged substructure units at the normal maximum recommended (NBIS) interval of sixty (60) months. Continue to monitor the footing exposure at Pier 2 during future inspections.

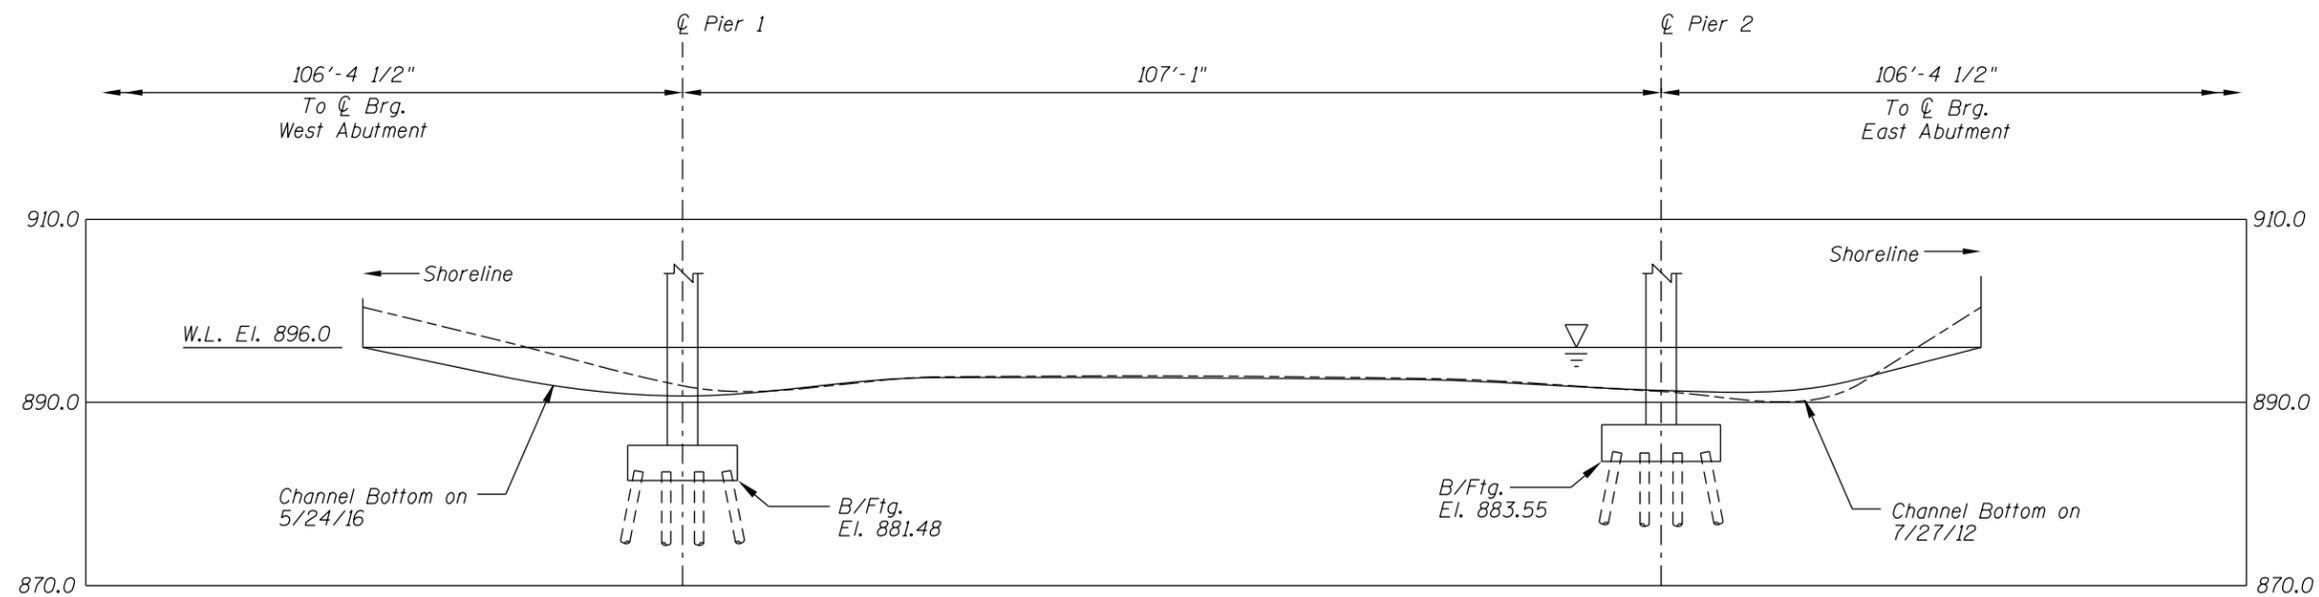
DOWNSTREAM FASCIA PROFILE

(G) A light to moderate accumulation of 8 inch diameter and smaller timber debris was observed at the upstream nose of Pier 1 and extended from the channel bottom up 4 feet.
