# 2016 UNDERWATER BRIDGE INSPECTION REPORT

## BRIDGE # 7164 CSAH 5 over N FK CROW RIVER

Date of Inspection: 05/27/2016

Contractor: Collins Engineers, Inc.

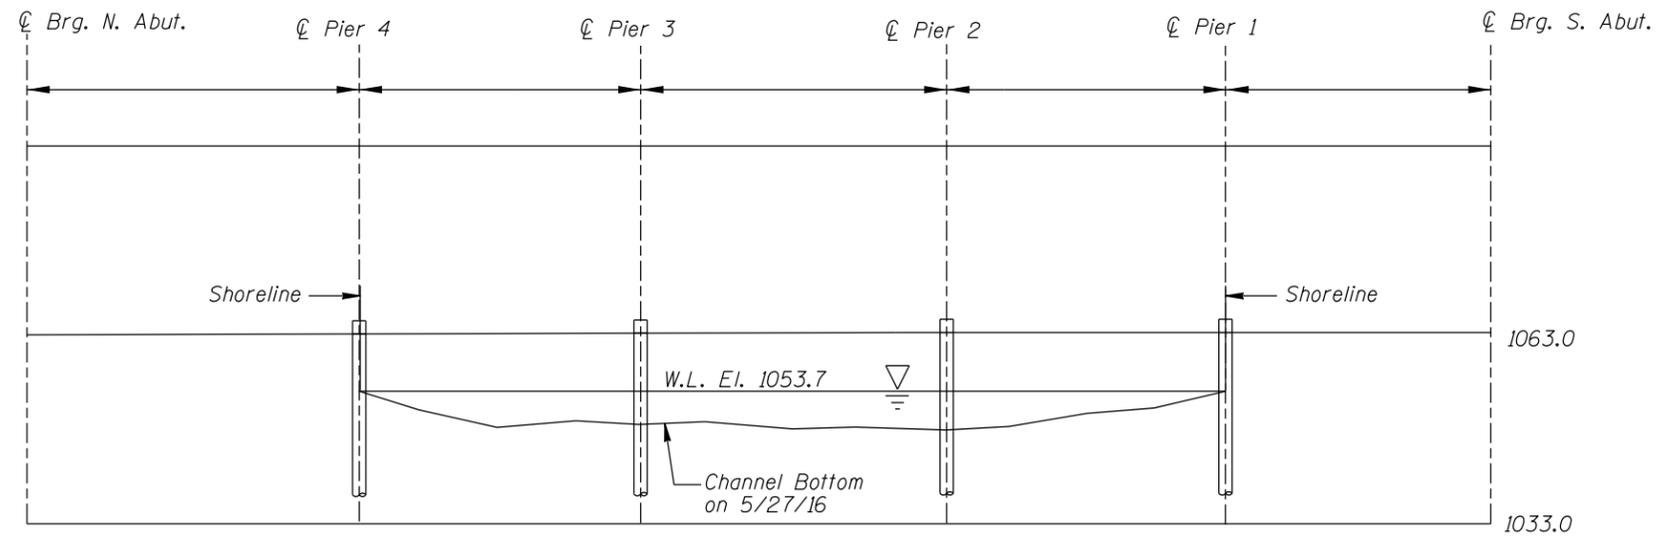
UPSTREAM FASCIA PROFILE

The substructure units inspected at Bridge No. 7164, Piers 1, 2, 3 and 4, were found to be generally in satisfactory condition with minor to moderate deterioration. The timber pilings displayed moderate weathering and minor decay. Timber debris was found at the south face of Piers 2 and 3.

(A) The bottom of the channel, at Piers 2 and 3, was found to be sandy organic material with up to 12 inches of probe rod penetration.

(C) Light timber debris was found along the south face of both Piers 2 and 3.

(A) Reinspect the submerged substructure units at the normal maximum recommended (NBIS) interval of sixty (60) months.

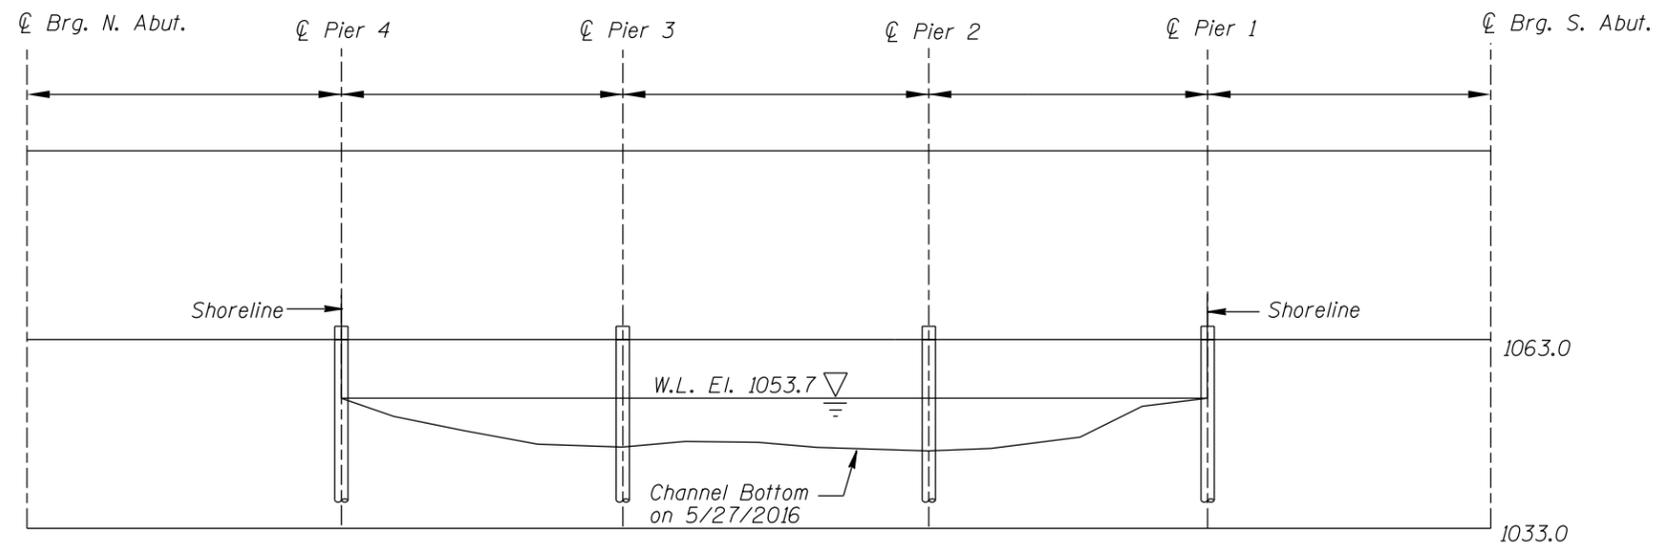
DOWNSTREAM FASCIA PROFILE

(B) The bottom at Piers 1 and 4 was made up of organic material with up to 12 inches of probe rod penetration.
