# 2016 UNDERWATER BRIDGE INSPECTION REPORT

## BRIDGE # 7170 CSAH 12 over CROW WING RIVER

Date of Inspection: 06/05/2016

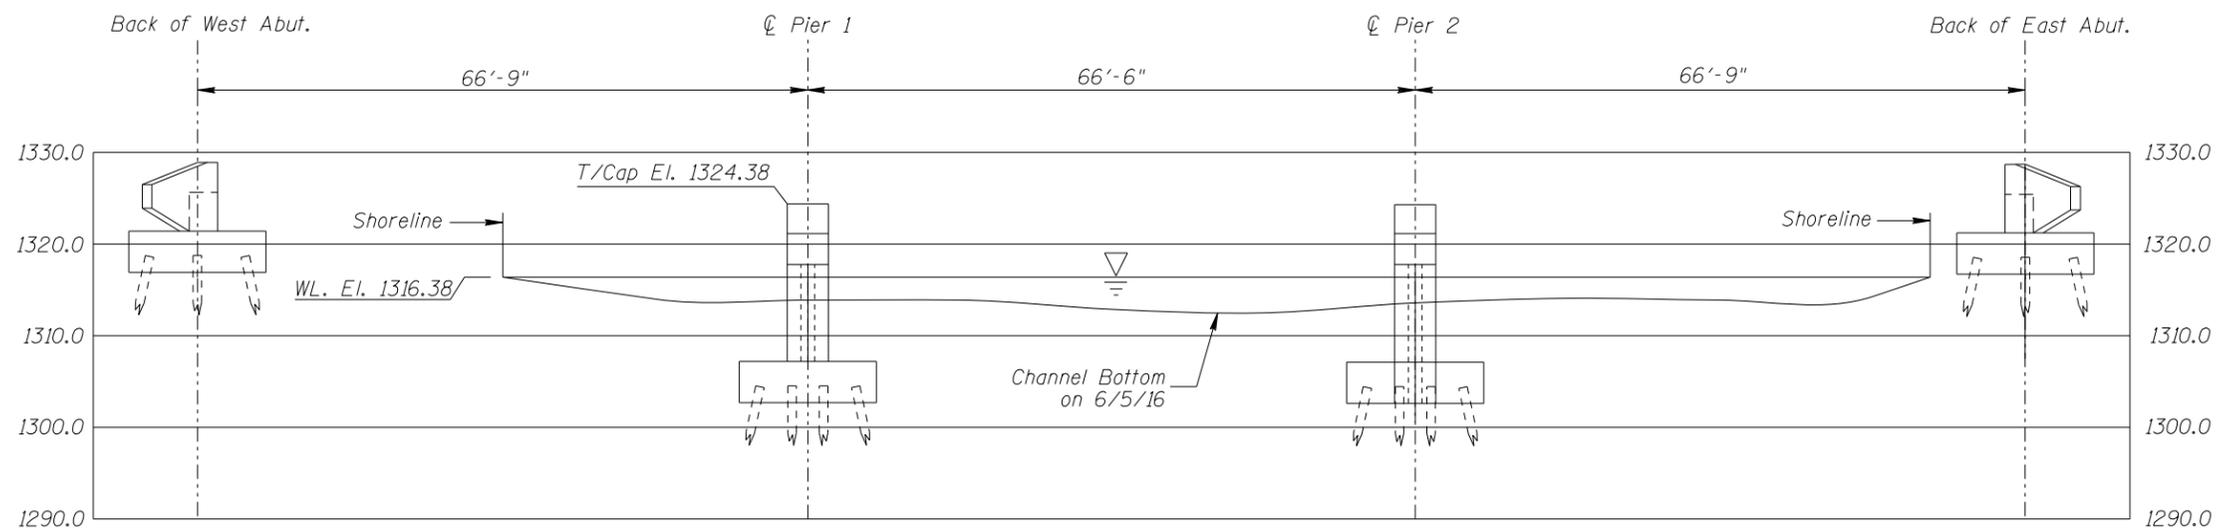
UPSTREAM FASCIA PROFILE

(A) The concrete pier columns exhibited scaling from the waterline to 2 feet below the waterline with up to 1 inch of penetration and exposed aggregate.

(C) A scour depression with a radius of 5 feet and up to 2 feet deep was present at the upstream column nose of Pier 1.

(A) Reinspect the submerged substructure units at the normal maximum recommended (NBIS) interval of sixty (60) months.
