2017 UNDERWATER BRIDGE INSPECTION REPORT

BRIDGE # L9181 CR 67 over WILLOW RIVER

Date of Inspection: 09/26/2016

Contractor: Collins Engineers, Inc.

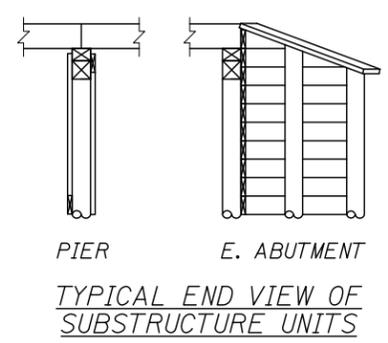
- 10 Timber cross brace connection was failed at Pile 7 on the west side of Pier 3.
 - 11 Timber cross brace was split at Pile 3 and not connected along the east side of Pier 3 from Pile 3 to the downstream end of the pier.
