2016 UNDERWATER BRIDGE INSPECTION REPORT

BRIDGE # 14510 CSAH 12 over RED RIVER OF THE NORTH

Date of Inspection: 11/01/2016

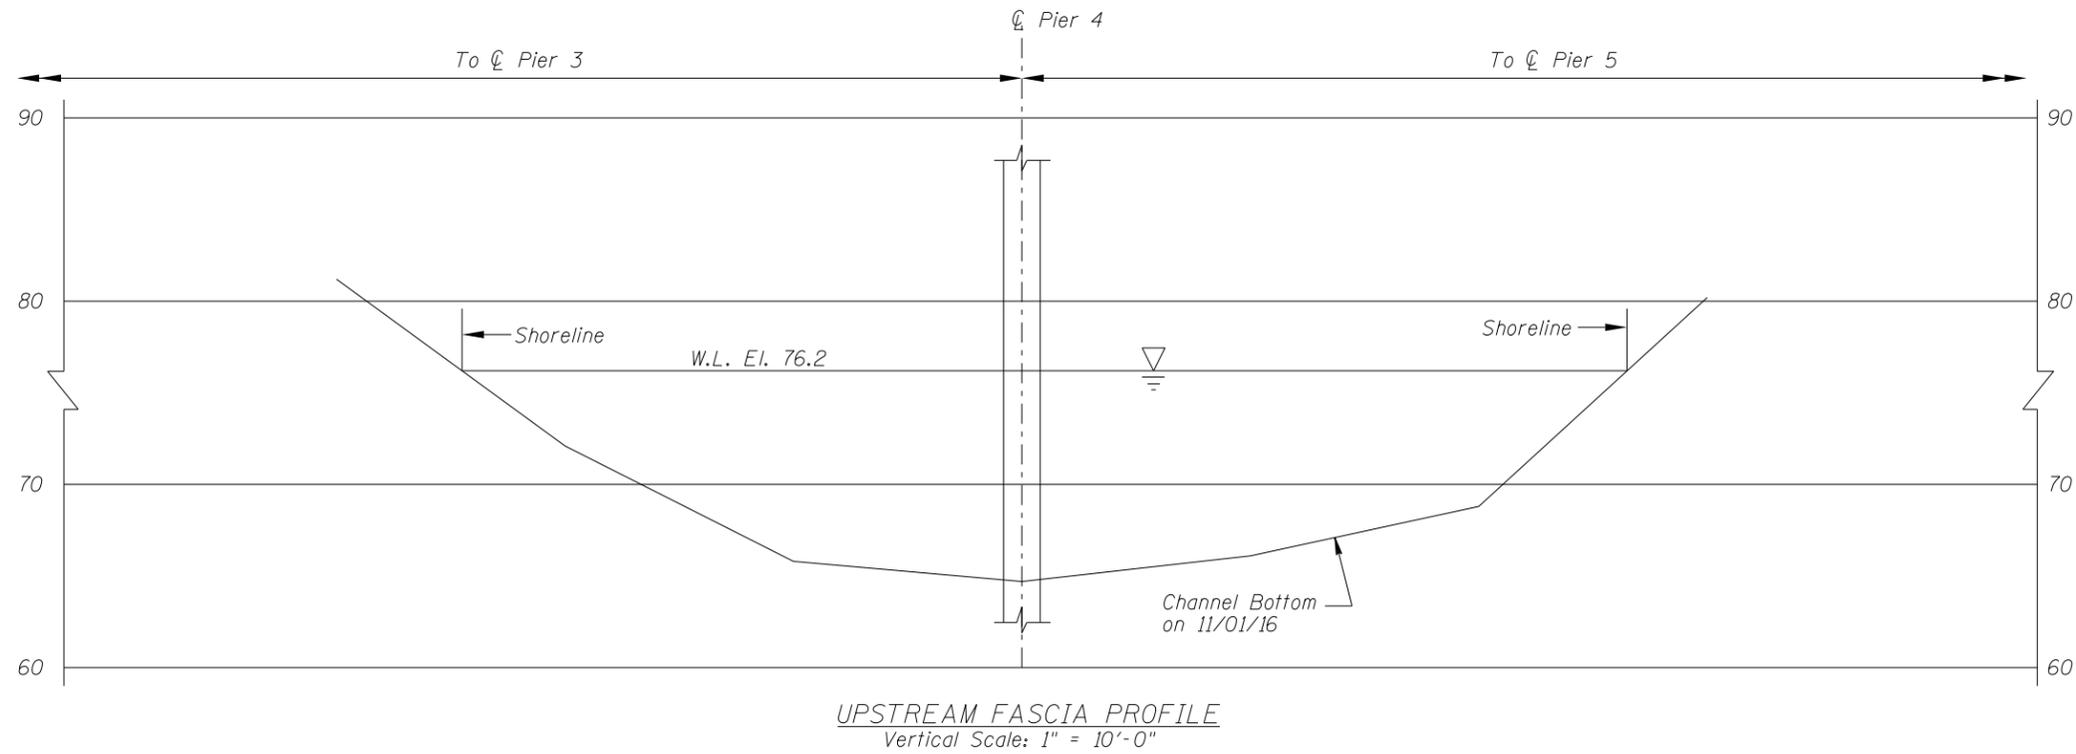
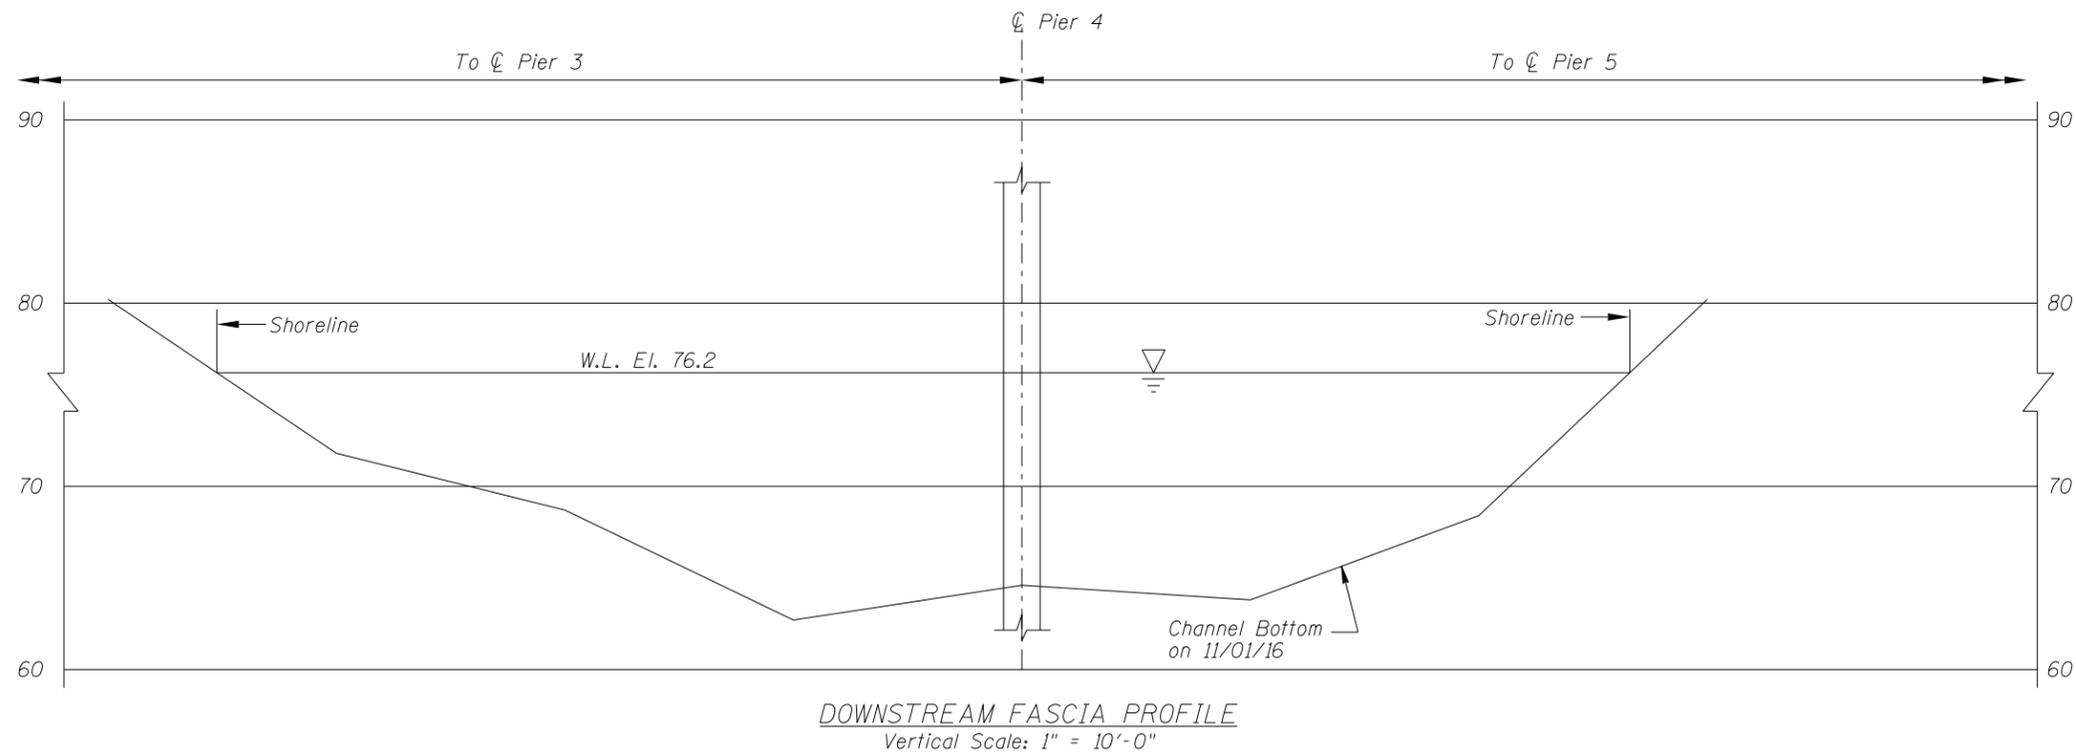
MINNESOTA DEPARTMENT OF TRANSPORTATION UNDERWATER BRIDGE INSPECTION	
STRUCTURE NO. 14-510 OVER THE RED RIVER OF THE NORTH DISTRICT 4, CLAY COUNTY	
UPSTREAM AND DOWNSTREAM FASCIA PROFILES	
Drawn By: JCK	Date: NOV., 2016
Checked By: BKS	Scale: As Noted
Project: 63-9687	Figure No.: 2

- (A) Debris accumulation was observed from the streambed to water surface extending 8 feet from Pier 4.
- (B) The streambed was composed of silt with 1 foot probe rod penetration.
- (C) The top of the concrete footing was exposed at the downstream nose of Pier 4.
