UNDERWATER BRIDGE INSPECTION REPORT

STRUCTURE NO. 66512  
PEDESTRIAN WALKWAY  
OVER THE  
CANNON RIVER  
DISTRICT 6 - RICE COUNTY

PREPARED FOR THE  
MINNESOTA DEPARTMENT OF TRANSPORTATION  
BY  
COLLINS ENGINEERS, INC.  
JOB NO. 5221

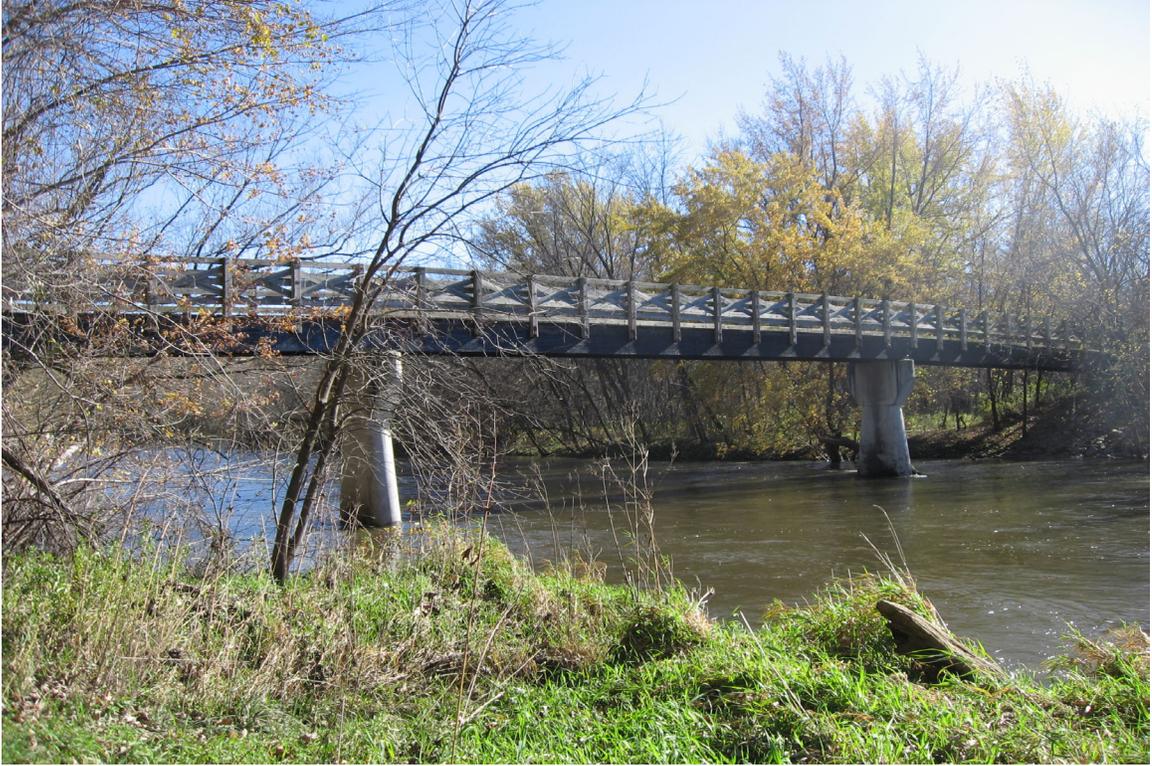
Photograph 1. Overall View of Structure, Looking Southeast.

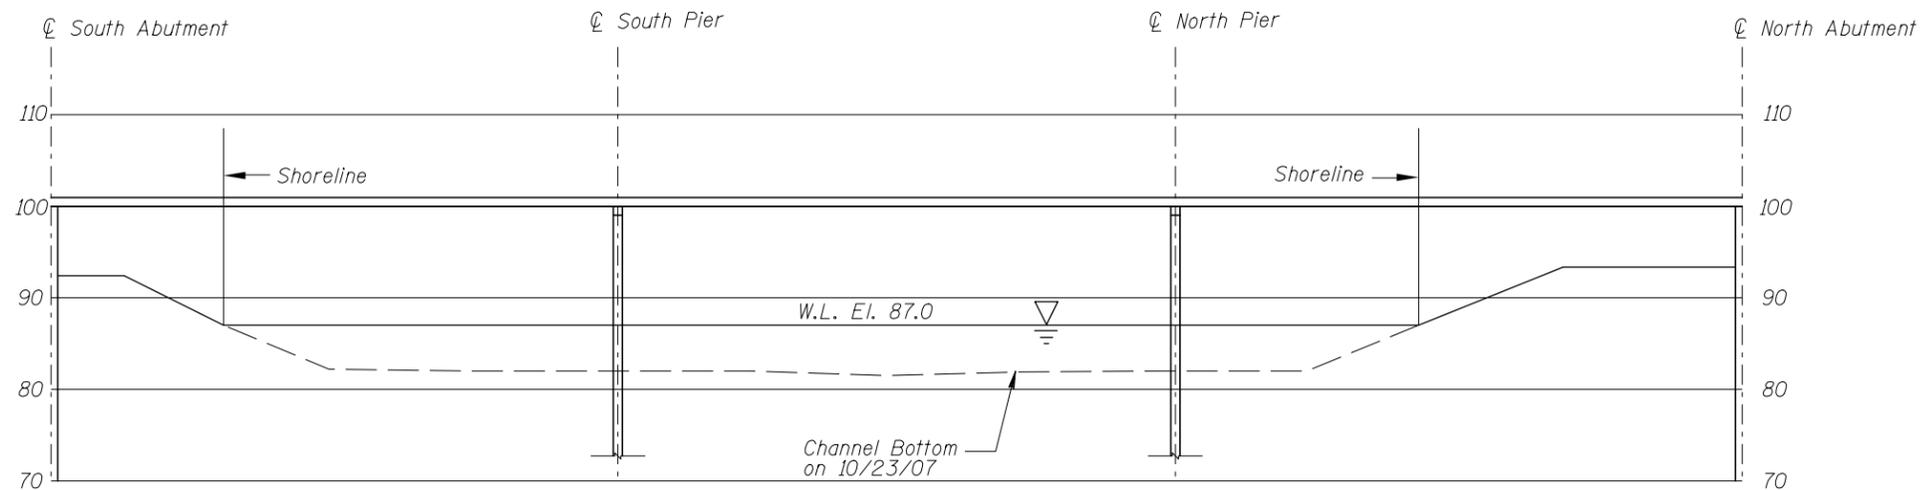
UPSTREAM FASCIA PROFILE

- ① The channel bottom at North and South Piers consisted of rock and gravel with no appreciable probe rod penetration.
- ② A 3 foot diameter tree trunk was found at the upstream nose and along the south side of South Pier.
- ③ Overall concrete was smooth and sound with no notable defects.
