UNDERWATER BRIDGE INSPECTION REPORT

STRUCTURE NO. 25552

NORTH BRANCH MIDDLE FORK ZUMBRO RIVER

JOB NO. 7423

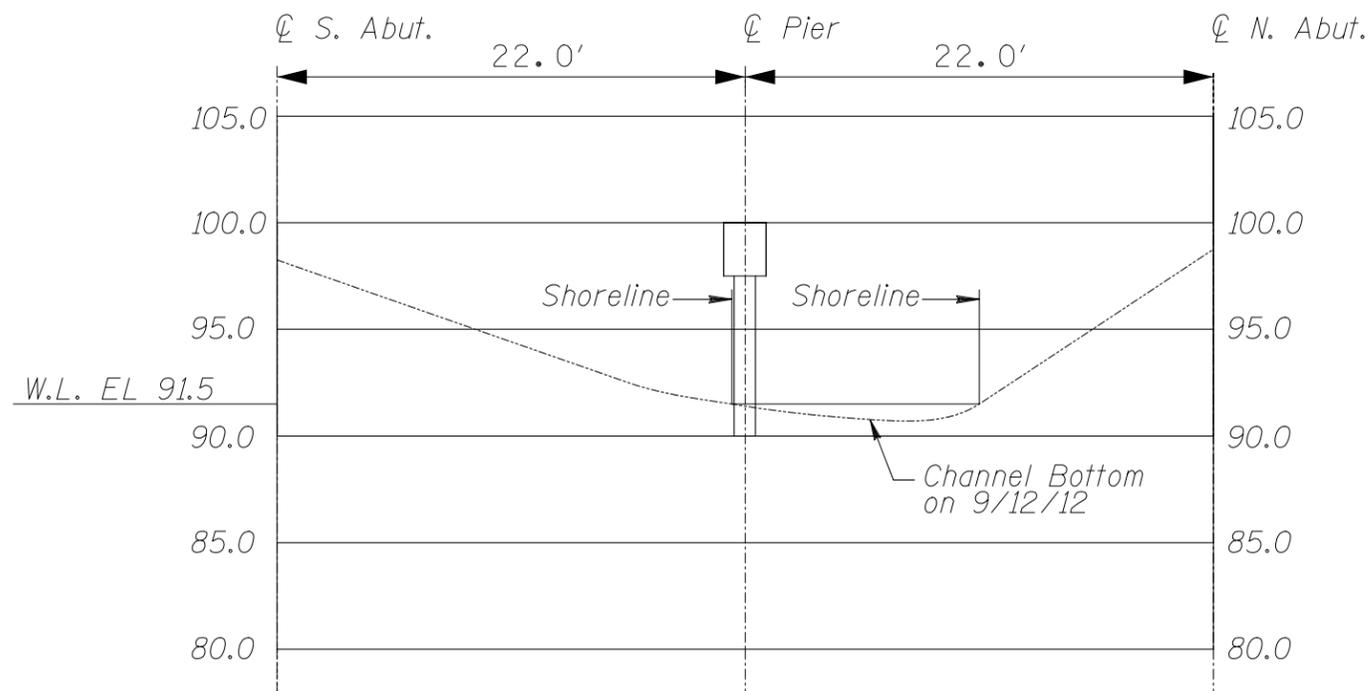
UPSTREAM FASCIA PROFILE

- ① All steel piles were in good condition with paint coating intact.
- ② The channel bottom material consisted of silty sand allowing 6 inch of penetration.
- ③ Timber debris accumulation was observed at the upstream end and along the north face of the pier extending from the channel bottom to 4 feet above the waterline.
