UNDERWATER BRIDGE INSPECTION REPORT

STRUCTURE NO. 5833  
LOST LOOP ROAD  
OVER THE  
NORTH BRANCH ROOT RIVER  
FILLMORE COUNTY

OCTOBER 5, 2012  
PREPARED FOR THE  
MINNESOTA DEPARTMENT OF TRANSPORTATION  
BY  
COLLINS ENGINEERS, INC.  
JOB NO. 7423

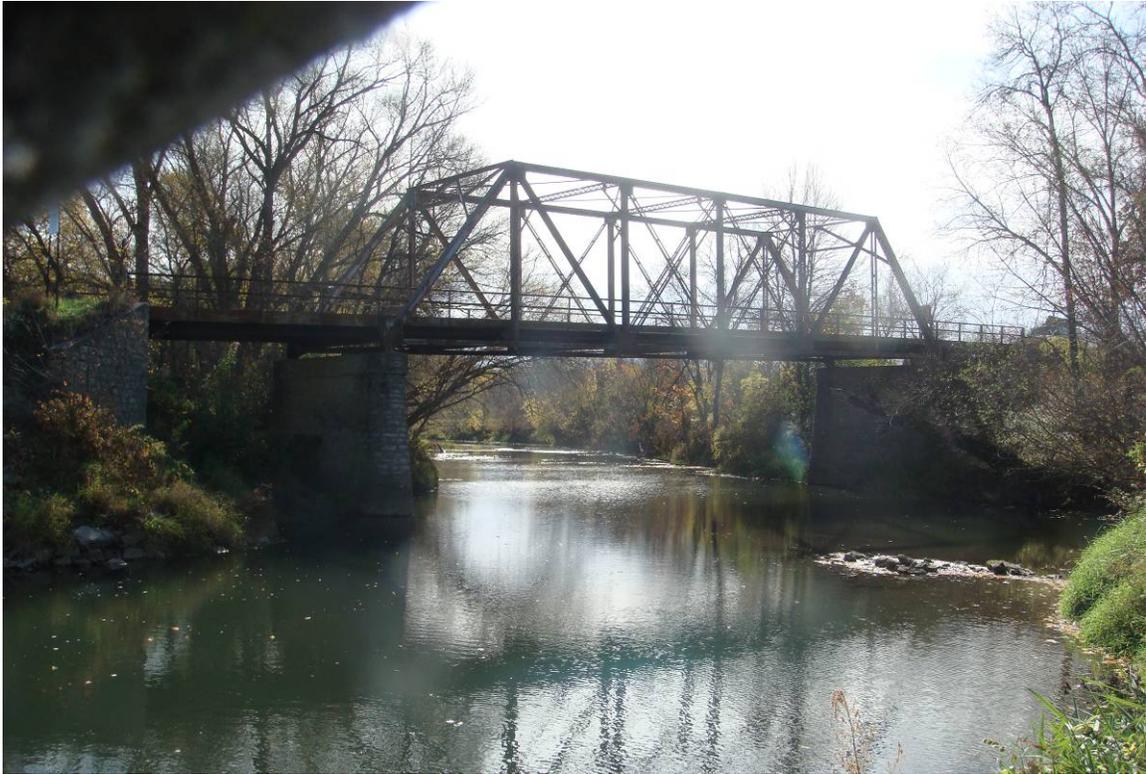
Photograph 1. Overall View of the Structure, Looking Northwest.

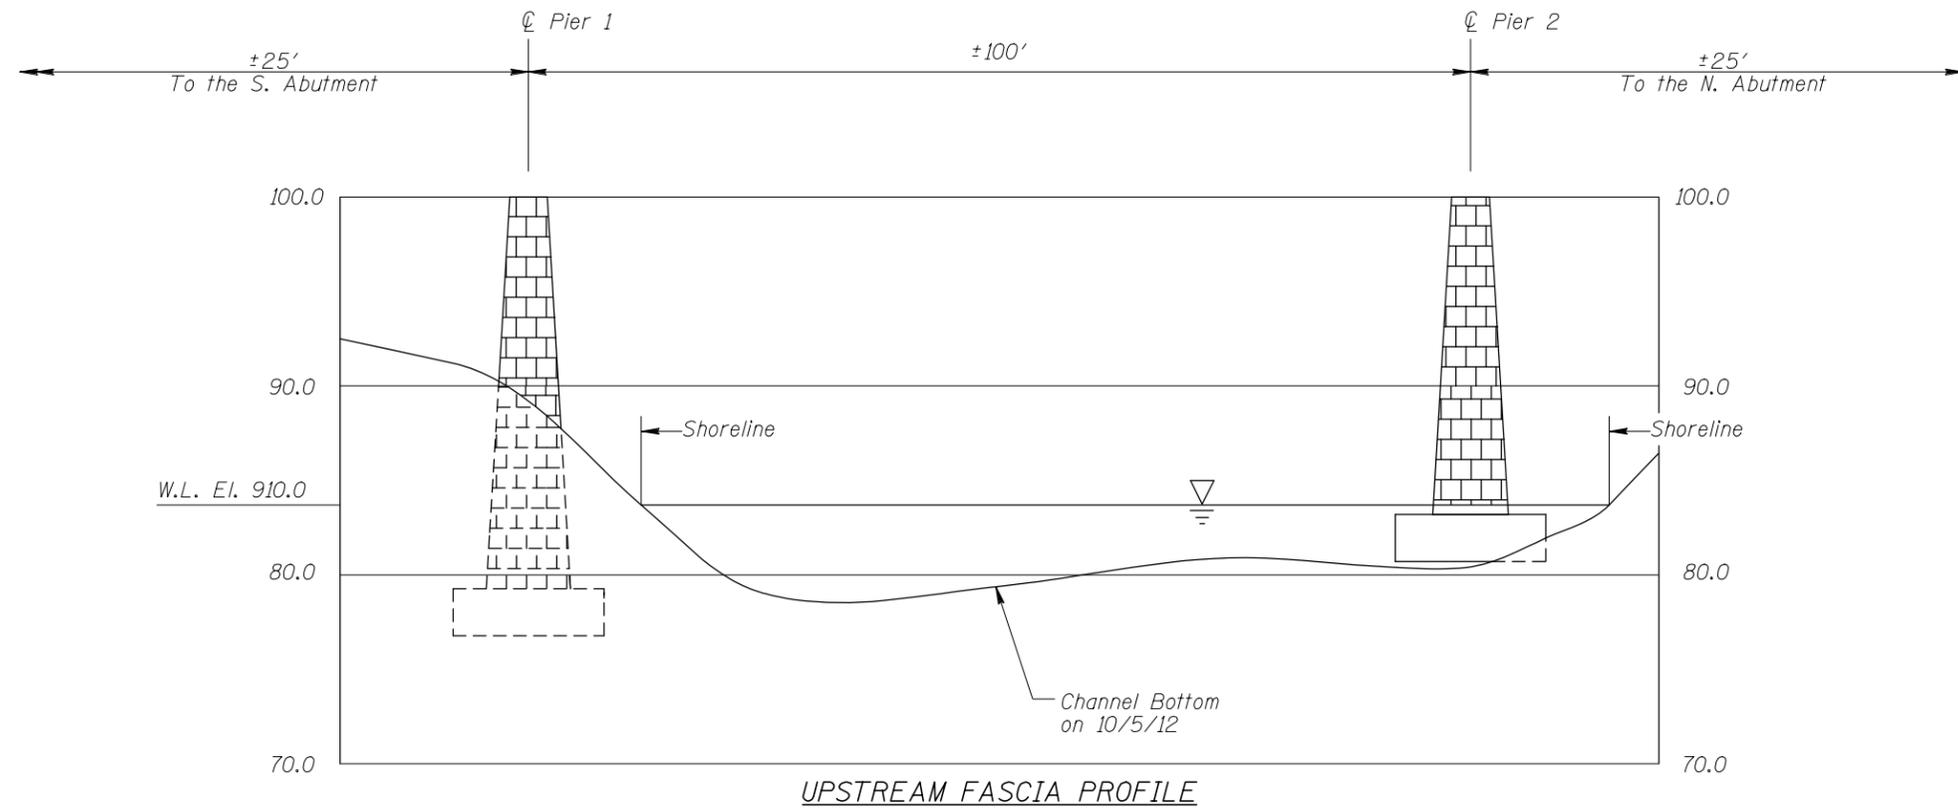
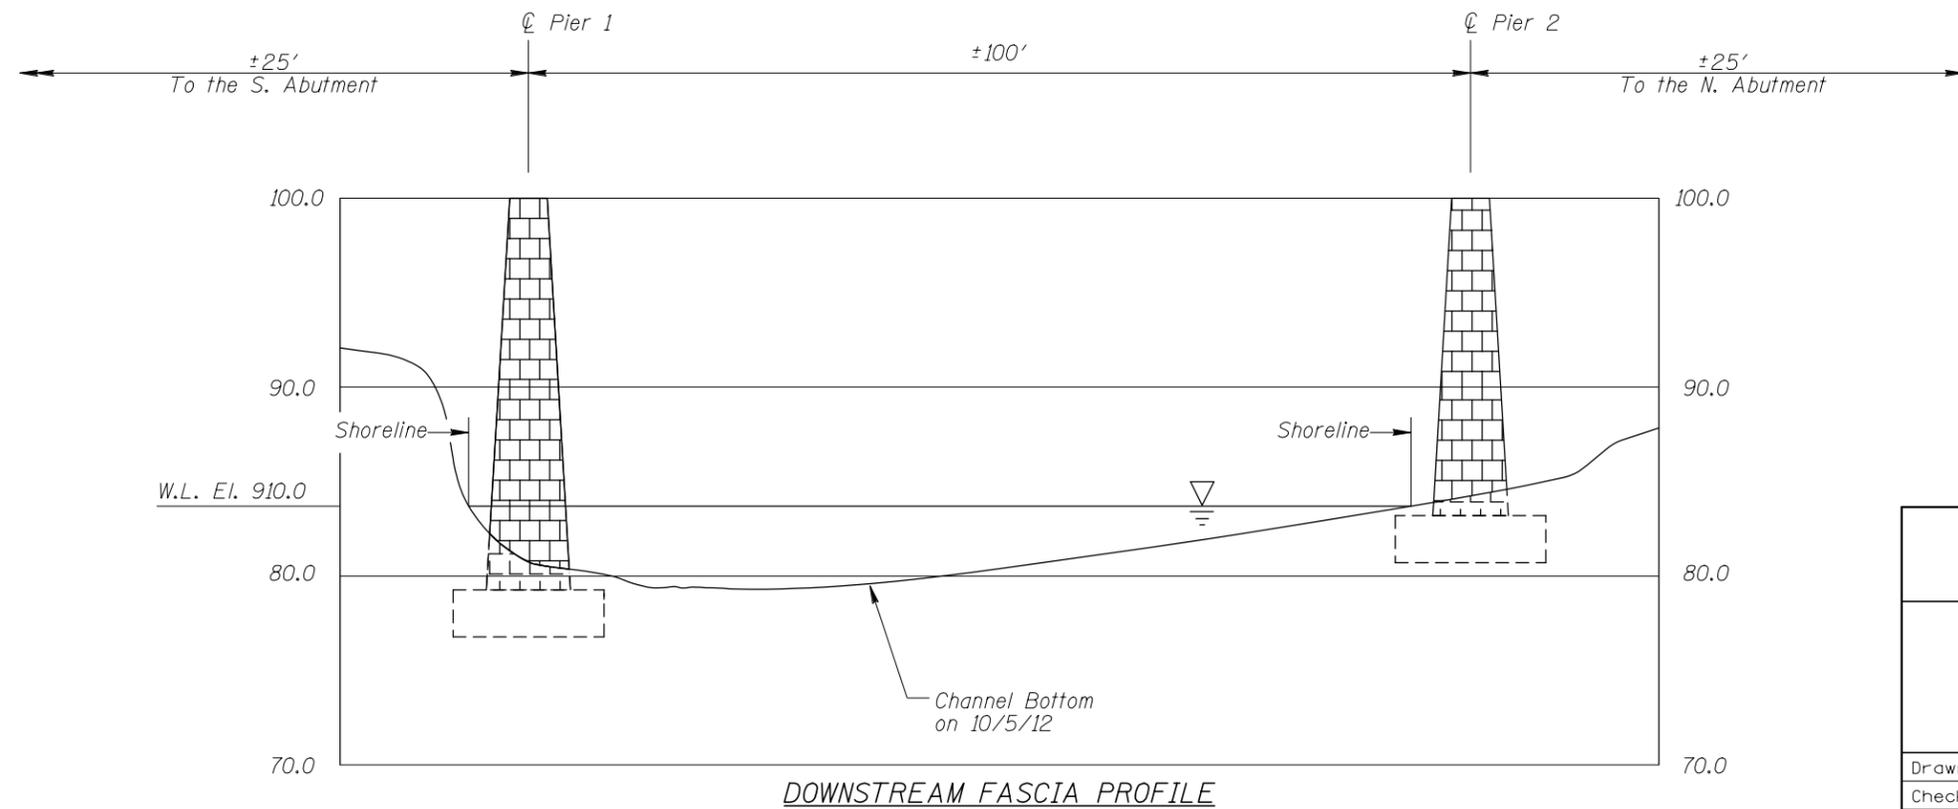
- (D) The footing of Pier 2 was exposed along the south face of the pier from the upstream nose to the downstream quarter point. The maximum vertical face exposure reached 2.5 feet (the height of the footing), and the footing was undermined at the southwest corner measuring a maximum vertical height of 3 inches and allowing up to 1.5 feet of horizontal penetration. The channel bottom material within the undermining cavity consisted of soft silt allowing up to 2 feet of penetration.

Monitor the footing exposure and extend of undermining during future underwater inspection and if found to be increasing, scour countermeasures may be warranted.
