2017 UNDERWATER BRIDGE INSPECTION REPORT

BRIDGE # 08527 CSAH 13 over MINNESOTA RIVER

Date of Inspection: 05/03/2017

Contractor: Collins Engineers, Inc.

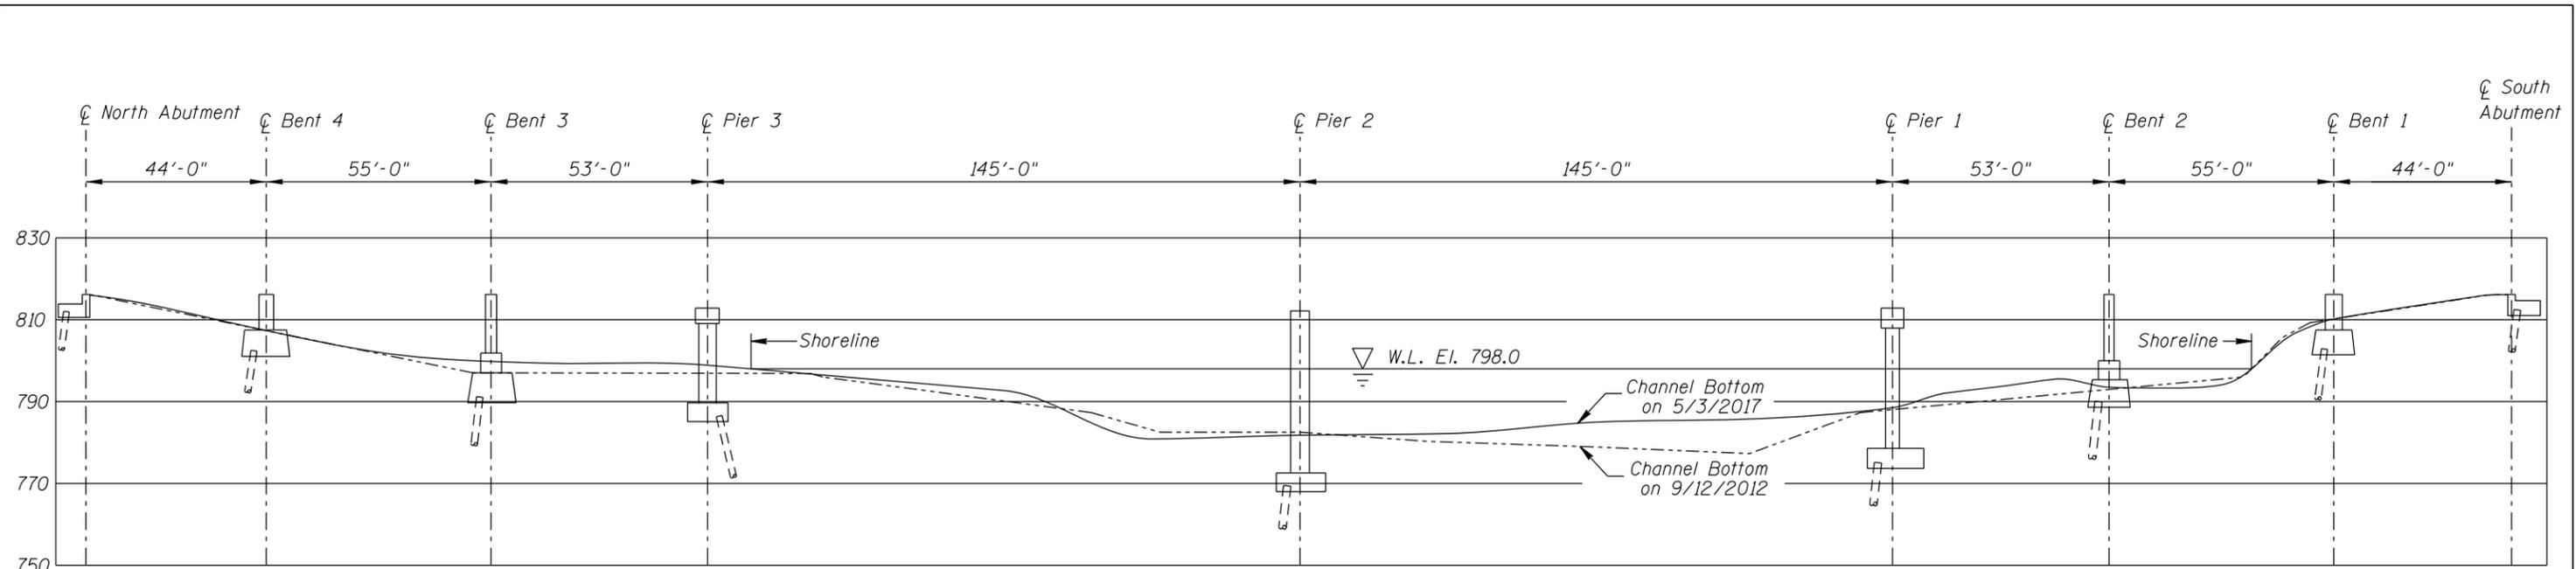
UPSTREAM FASCIA PROFILE

- (A) Channel bottom material consisted of silty sand with 1.5 feet of maximum probe rod penetration.
- (B) Minor scour depression observed, with a 5 foot radius and a 1 to 2 foot depth, at the upstream end of Pier 2.
- (C) Moderate accumulation of timber debris consisting of 1 foot diameter and smaller logs and branches was observed at the upstream end of Pier 2 from the channel bottom up 5 feet.
