UNDERWATER BRIDGE INSPECTION REPORT

STRUCTURE NO. 87513

MINNESOTA RIVER

DISTRICT 8 - YELLOW MEDICINE COUNTY

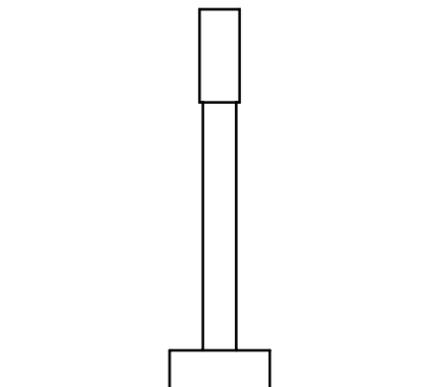
TYPICAL END VIEW OF PIERS

- ① The channel bottom consisted of soft silt over gravel with up to 2 feet of probe rod penetration.
- ② The channel bottom consisted of bedrock overlaid with up to 4 inches of silt.
- ③ The footing was exposed along the west face, around the upstream nose, and along the east face of Pier 2 with up to 2.5 feet of vertical face exposure at the upstream nose.
- ④ Two 12-inch-diameter logs were observed on the channel bottom along the east face of Pier 2.
- ⑤ The concrete surfaces were in good and sound condition with no structurally significant defects.

- (A) Monitor the footing/bedrock interface at Pier 2 during future inspections for any detrimental erosion and/or gaps along the interface.
