UNDERWATER BRIDGE INSPECTION REPORT

STRUCTURE NO. 27608
BROADWAY AVENUE
OVER
THE MISSISSIPPI RIVER
DISTRICT 5 - HENNEPIN COUNTY

PREPARED FOR THE
MINNESOTA DEPARTMENT OF TRANSPORTATION
BY
COLLINS ENGINEERS, INC.
JOB NO. 3512 (CEI 116)

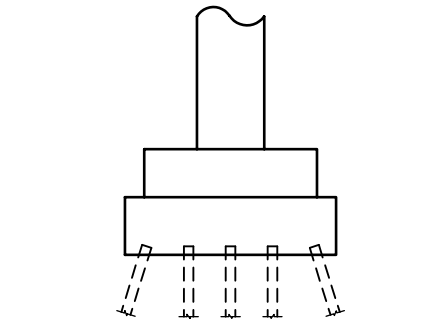
- 3 Scattered riprap, up to 4 feet in diameter, and steel debris was observed on the channel bottom along the downstream east face of Pier 3.
- 4 A vertical hairline crack extended from the top of the above water step in the shaft portion on the pier to the waterline.

- 5 A moderate accumulation of timber debris, with pieces up to 2 feet in diameter, was observed at the upstream end of Pier 1 and extending along the west face of the pier.

- 6 A light accumulation of timber debris, with pieces up to 1 foot in diameter, was observed at the upstream end of Pier 2.
- 7 Timber debris consisting of two tree trunks, 18 inches in diameter, was observed along the west face of Pier 3.

- 8 Timber debris consisting of four tree trunks, up to 2 feet in diameter, was observed along the east face of Pier 3.

- (A) Monitor the timber debris at all of the piers, and if found to be increasing in the future, removal operations may become warranted.

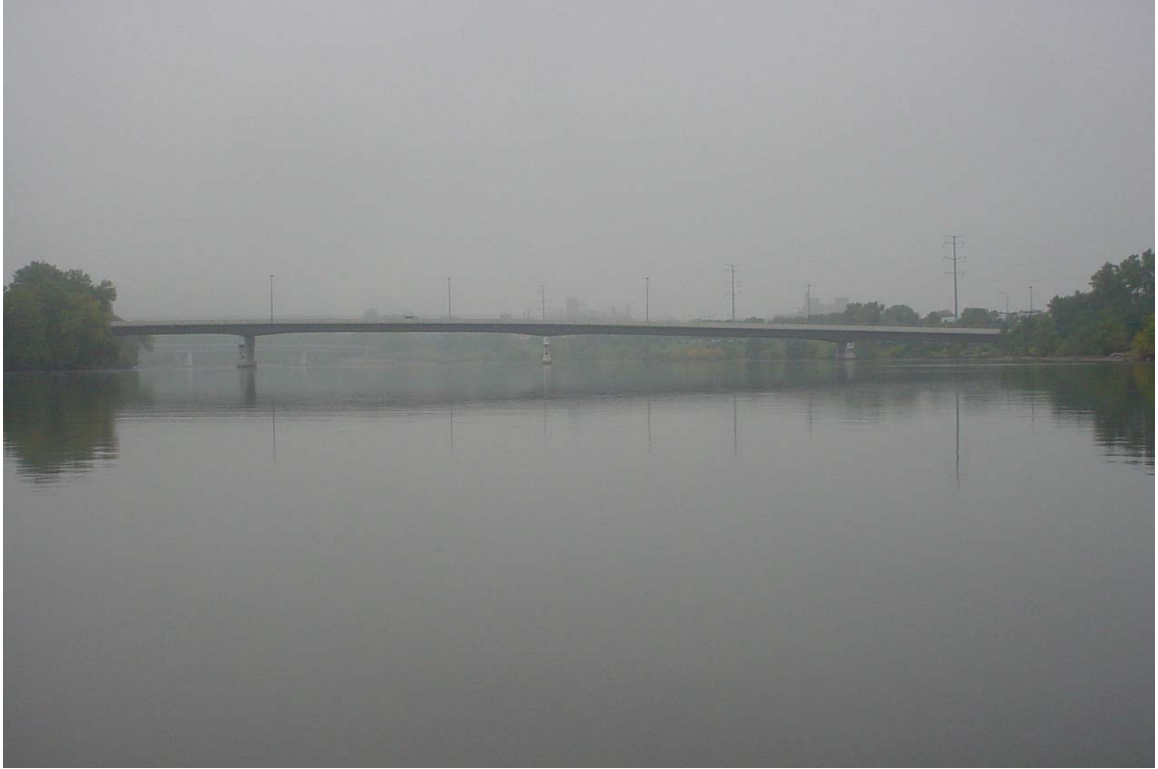
Photograph 1. Overall View of the Structure, Looking South.
