UNDERWATER BRIDGE INSPECTION REPORT

STRUCTURE NO. 9360

MISSISSIPPI RIVER

MINNESOTA DEPARTMENT OF TRANSPORTATION
UNDERWATER BRIDGE INSPECTION

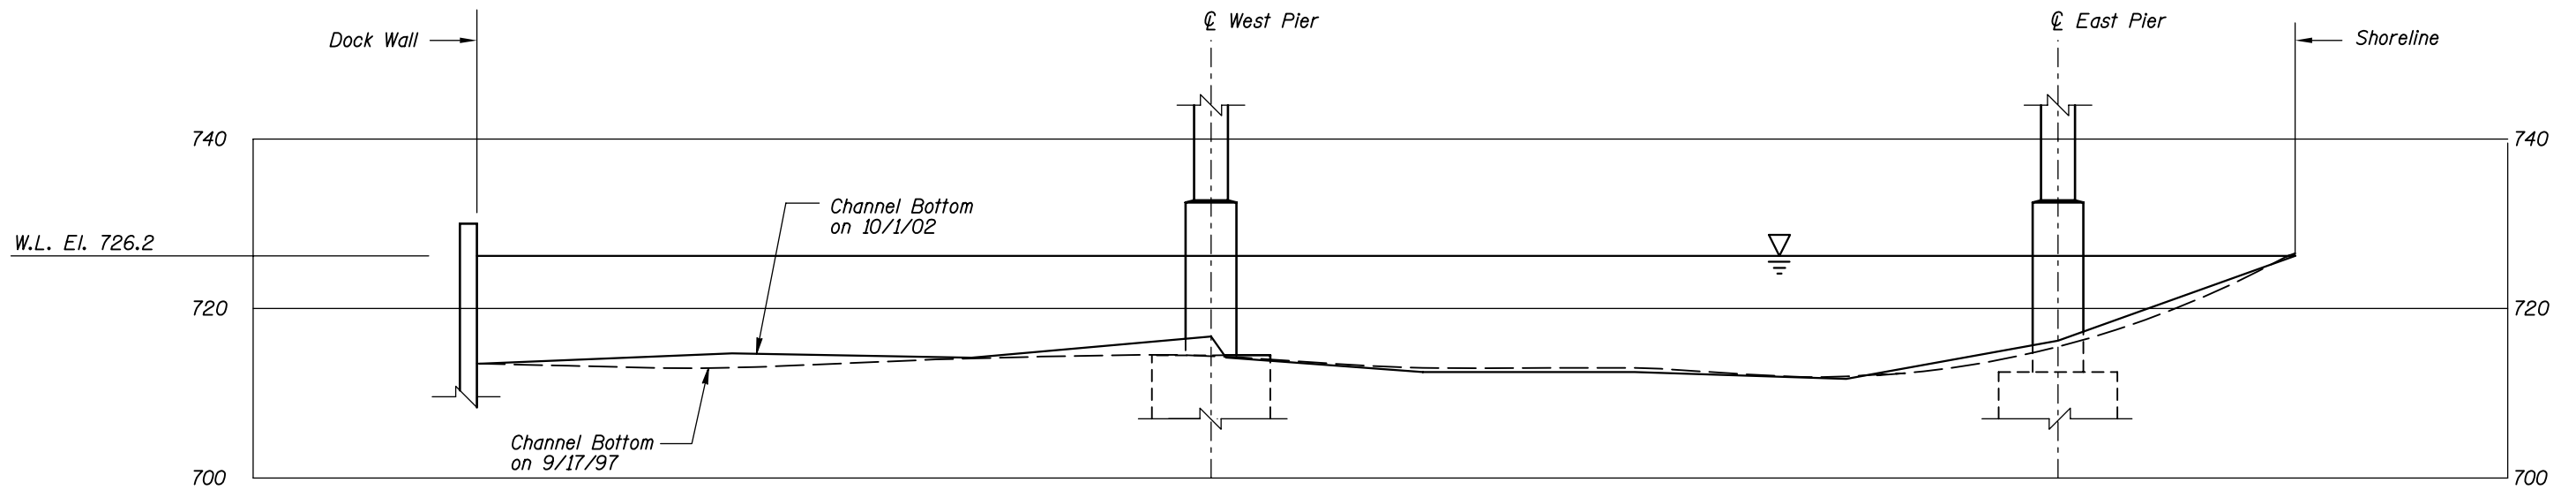
- 4 Vertical hairline crack with efflorescence from the top of the web wall to the waterline with 1/16 inch maximum width.
- 5 Footing exposure all along the east face of the West Pier with 3 feet maximum vertical exposure and protruding reinforcing steel.

- 6 Horizontal hairline cracks in random areas along the west face of East Pier.
- 7 A spall was observed along a joint at 1 foot below the waterline down 2 feet and was 2 inches wide with up to 1 inch of penetration.

- 8 Minor accumulation of 4 to 6 inch diameter timber debris around the upstream nose of the West Pier. Sheet piling was observed along the edge of the footing and reinforcing steel was protruding from the top of the footing.

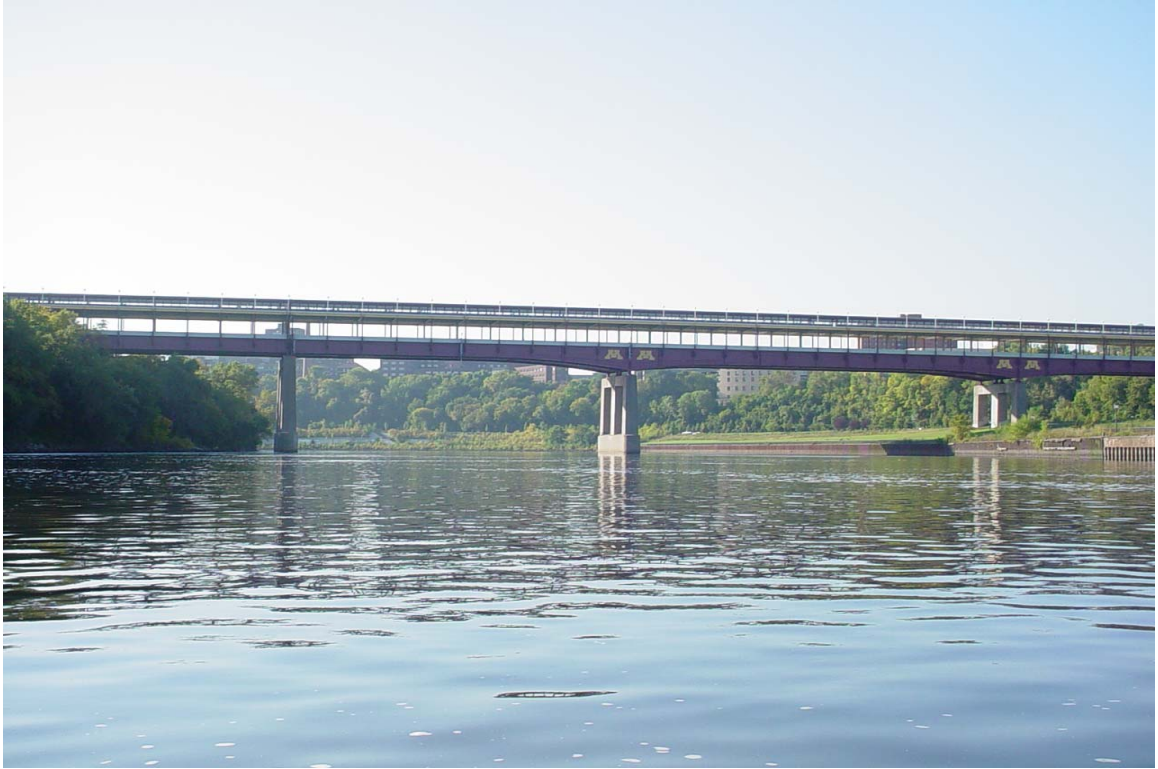
Photograph 1. Overall View of the Structure, Looking South.
