UNDERWATER BRIDGE INSPECTION REPORT

STRUCTURE NO. 4175
PEDESTRIAN WALKWAY (OLD 169)
OVER THE
MINNESOTA RIVER
SCOTT COUNTY

MAY 21, 2012
PREPARED FOR THE
MINNESOTA DEPARTMENT OF TRANSPORTATION
BY
COLLINS ENGINEERS, INC.
JOB NO. 7423

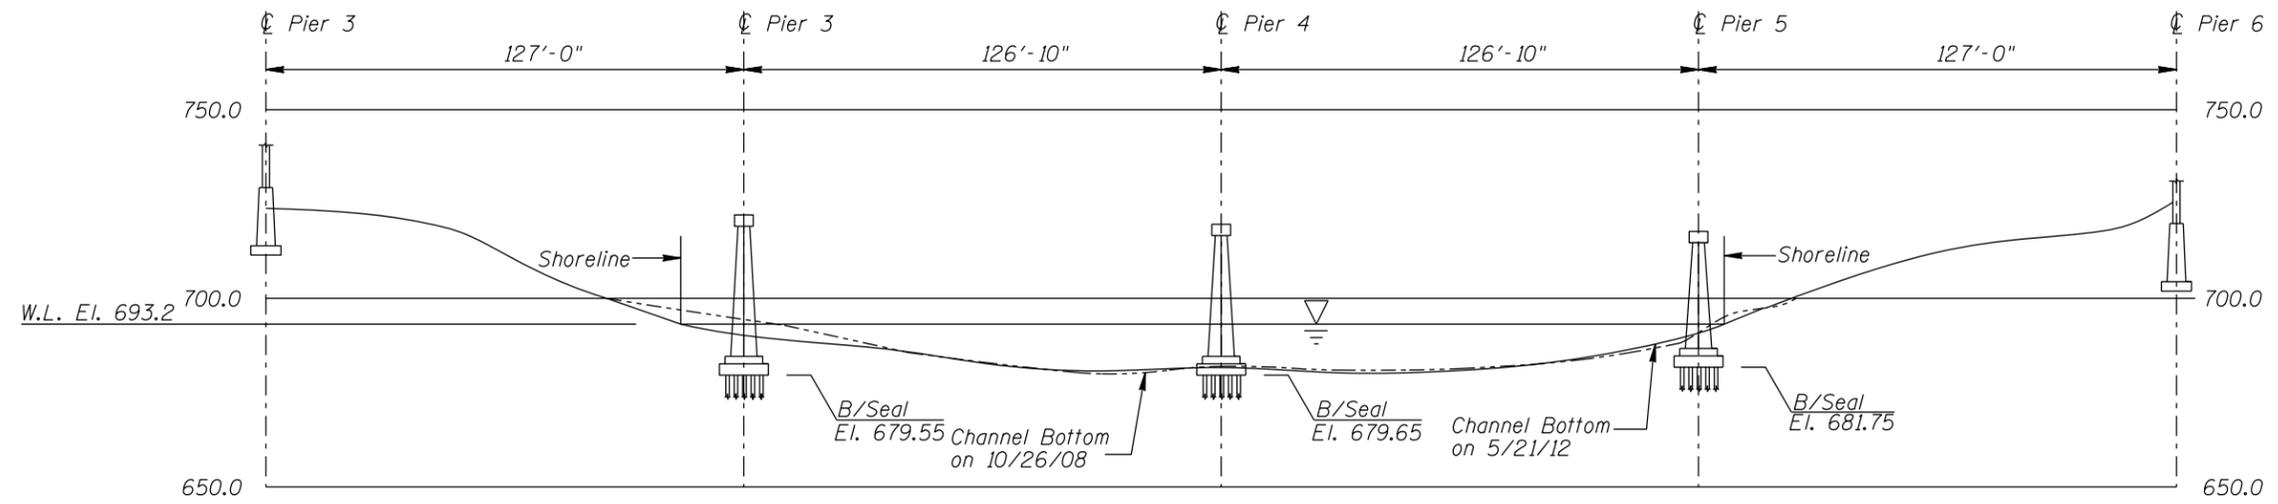
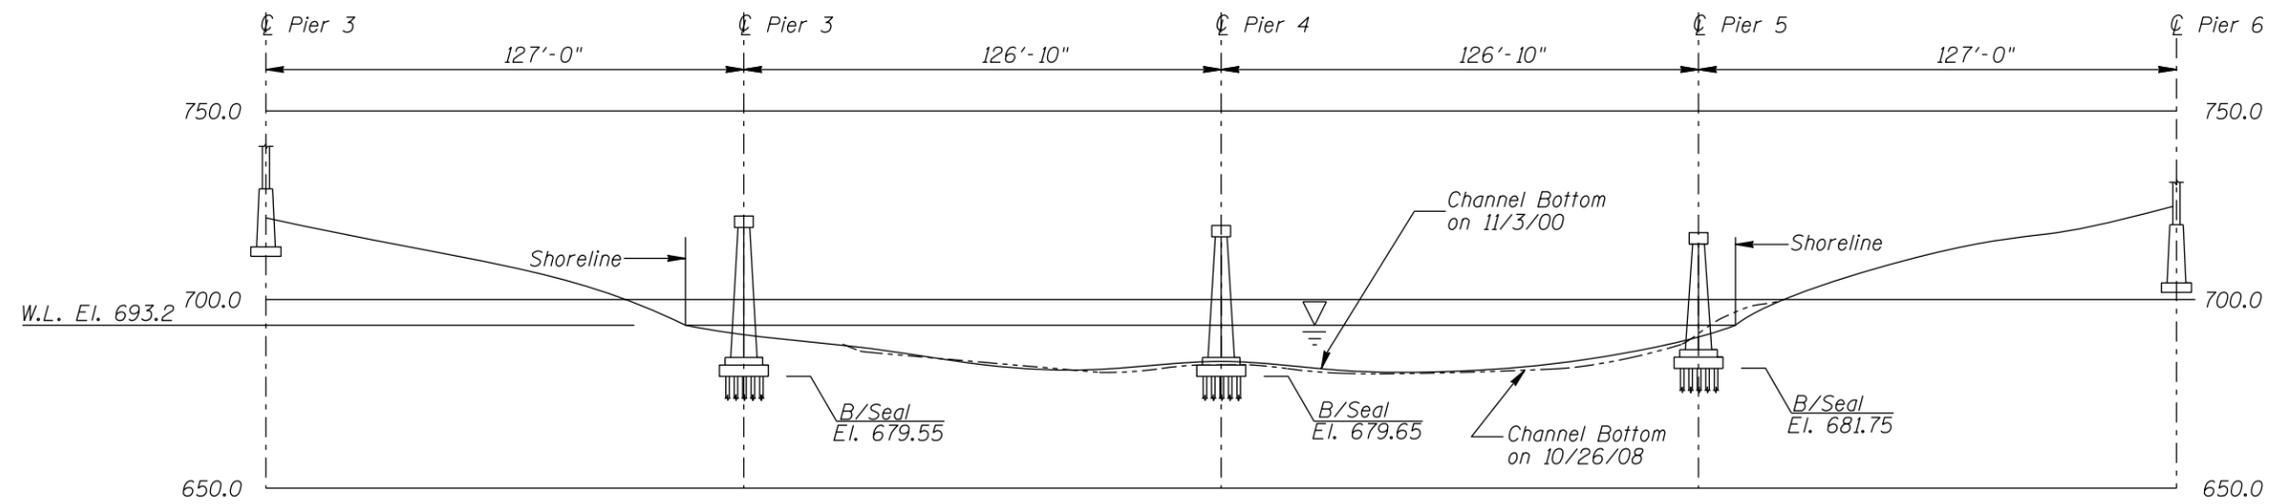
- 3 A moderate to heavy accumulation of timber debris, consisting of up to 18 inches diameter pieces of drift, was observed at the upstream nose and along the south and north faces of the pier extending from channel bottom to 10 feet above waterline.

- 5 Spalls were observed at the waterline on the downstream nose and midpoint of the north face of Pier 3. The spalls were 6 inches in diameter with a maximum penetration of 1 inch.

- 6 A spall was observed on the downstream quarter-point of the south face of Pier 5 extending from the waterline down 1.5 feet. The spall was 6 inches wide with a maximum penetration of 2 inches.

Monitor footing and/or seal exposure during future inspections, and if exposure is found to be increasing to significant extent, countermeasures may become warranted at that time.
