2016 UNDERWATER BRIDGE INSPECTION REPORT

BRIDGE # 3575 CSAH 42(FORD PKY) over MISS R; MISS BL

Date of Inspection: 11/04/2016

Contractor: Collins Engineers, Inc.

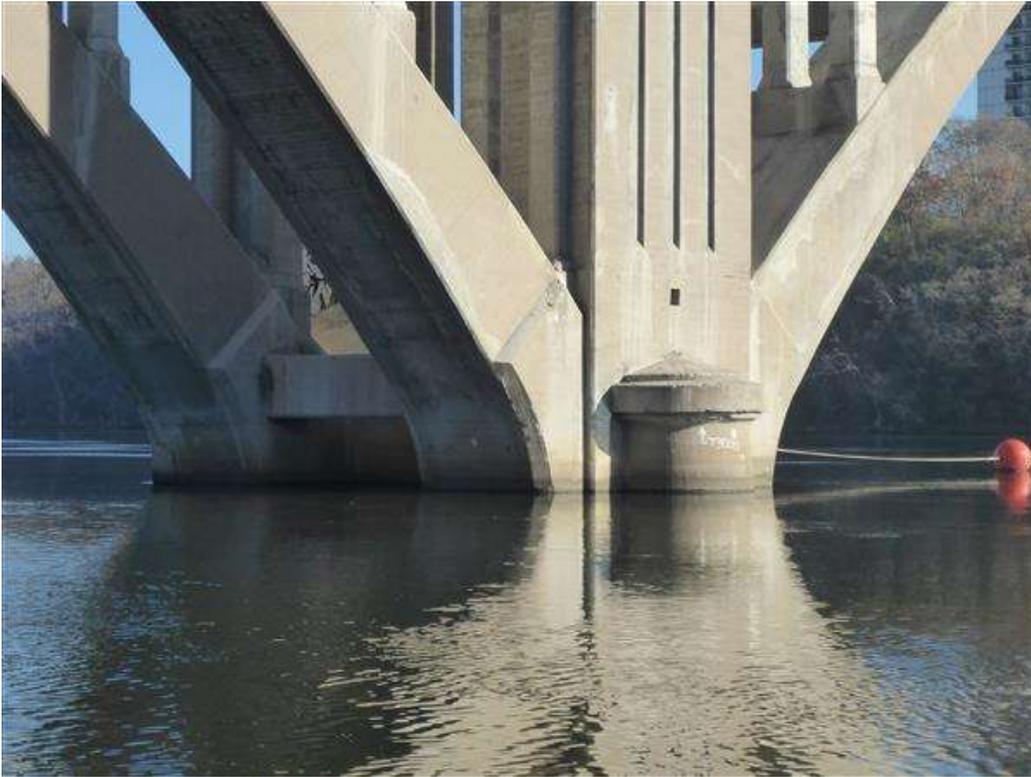
Photo 7 - View of Pier 9 Looking Northeast

(H) Localized scour depressions were observed around the upstream end of Piers 8 and 9 with typical depths of 5 to 10 feet, and concrete rubble with protruding reinforcing steel was found on the base of the scour depression.

(A) Monitor footing exposures at Piers 8 and 9 and undermining and voiding at Pier 8 during future underwater inspections for further vertical face exposure and/or undermining. The extent of footing exposure/undermining does not appear to be structurally significant at this time since the piers are founded on deep driven caissons (as per bridge plans).
