Pavement Condition Report

Bigfork Municipal Airport (FOZ)

December 2016

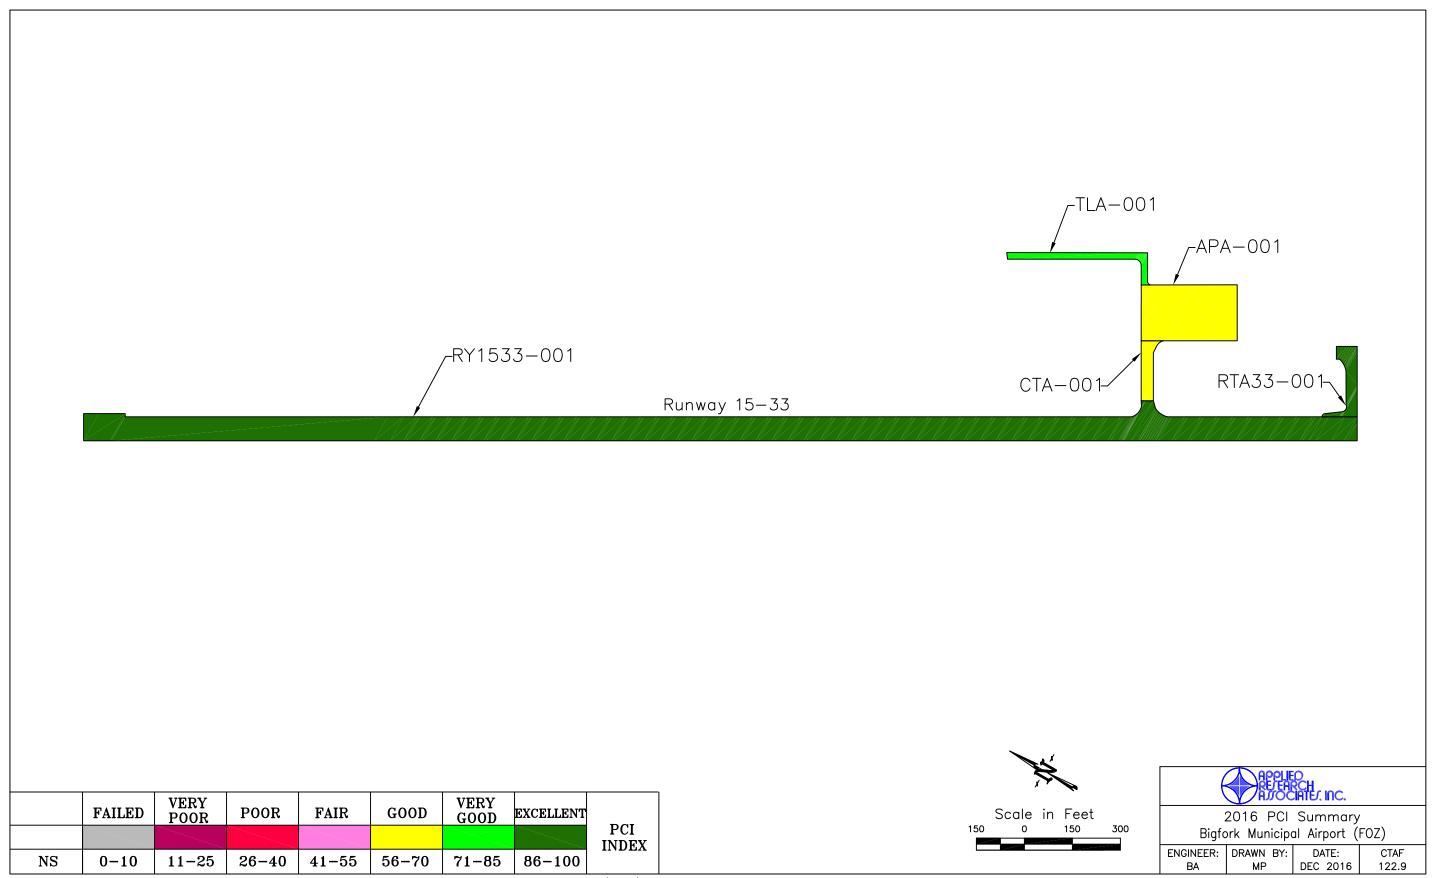
Figure 4. 2016 Pavement Condition Index Rating at Bigfork Municipal Airport (FOZ).

The results of the 2016 PCI inspection are presented in figure 4. The overall area-weighted, inspected PCI for FOZ is 82. When summarizing PCI values, an area-weighted calculation is used instead of a straight mathematical average because the area-weighted calculations eliminate the skewing of the PCI due to the disparity of the section sizes.

Local maintenance such as crack sealing and patching has occurred at the airport since last inspection resulting in higher PCI's for some sections.

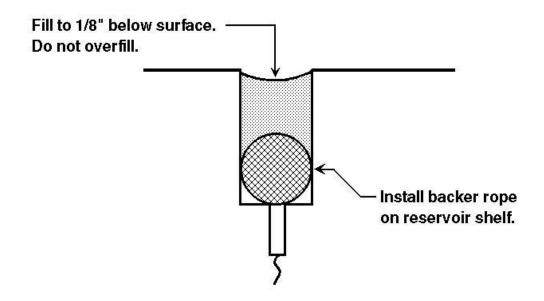
Figure 6. PCC joint/crack repair.

Typical joint with deficient sealant and a collection of debris & incompressibles.

- Rout a reservoir for the sealant. Sealant reservoir should be ½ inch wide and 1 inch deep.
- For cracks wider than ½ inch, the reservoir should be ¼ inch wider than the crack. Depth should be such that sealant above the backer rope is at most equal to reservoir width, or as recommended by manufacturer.

- Routed cracks should be sand cleaned, using fine sand at reduced pressure. Proper cleaning will expose fresh, vital pavement on the vertical crack edge.

Rout out old sealant, debris and incompressibles. Clean joint sides to expose fresh, clean concrete and stone. Retain existing reservoir shape.
