Pavement Condition Report

Moorhead Municipal Airport (JKJ)

December 2018

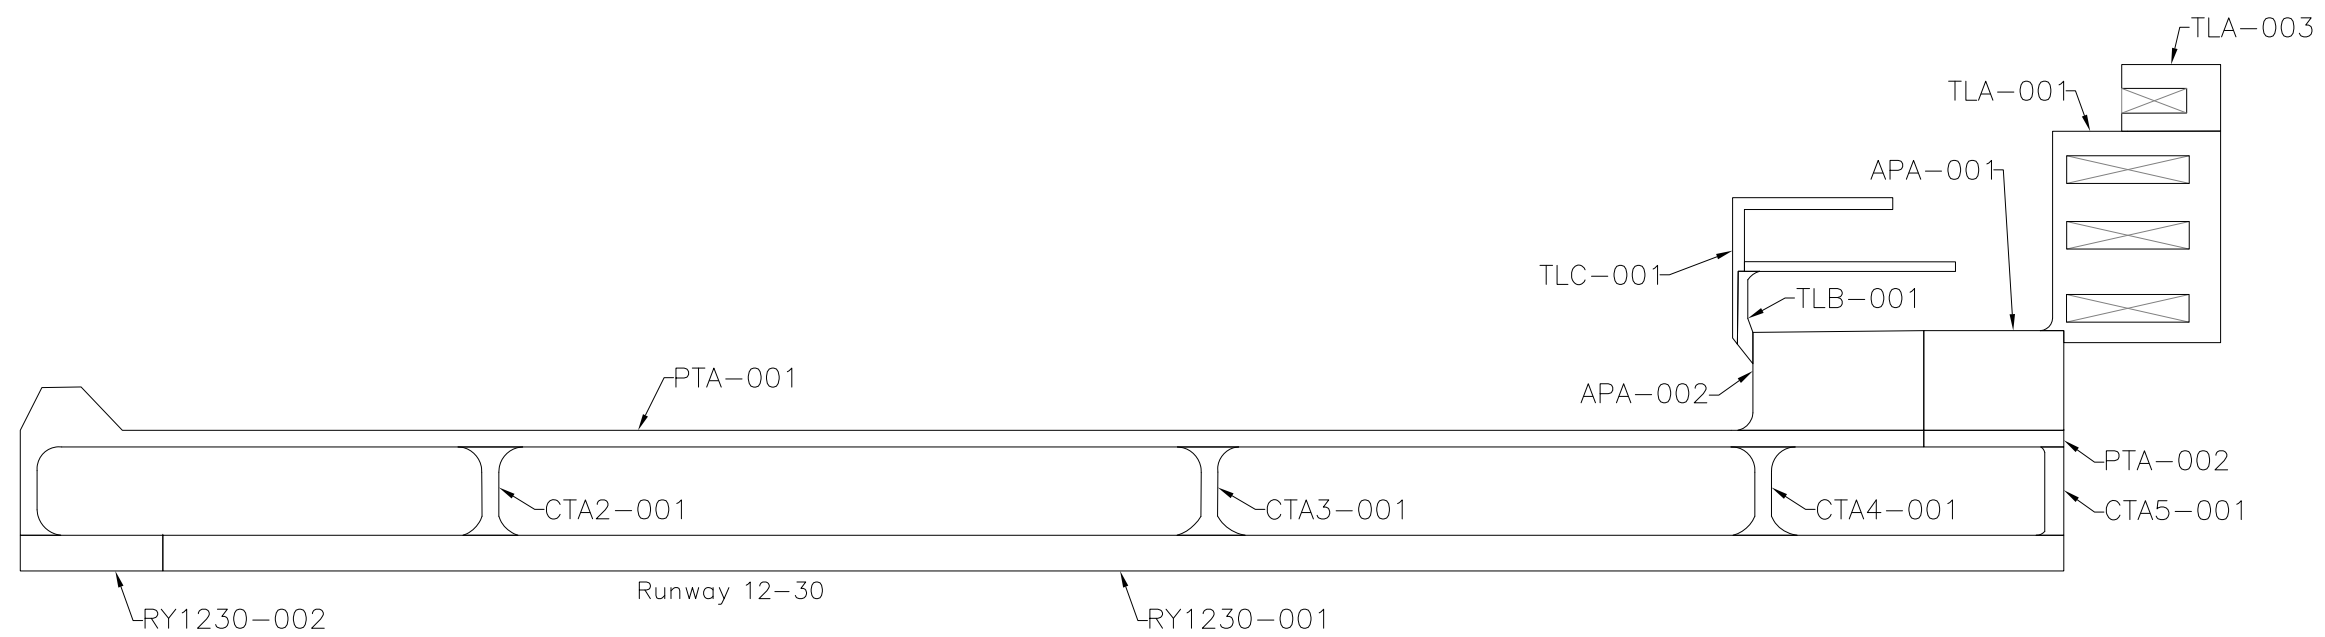
Figure 2. Network Definition at Moorhead Municipal Airport (JKJ).

Figure 2 presents the network definition for JKJ and represents the pavements included in the APMS. Some privately built/maintained pavements and “driveways” leading into hangars may not be included here because they are considered outside the scope of work.

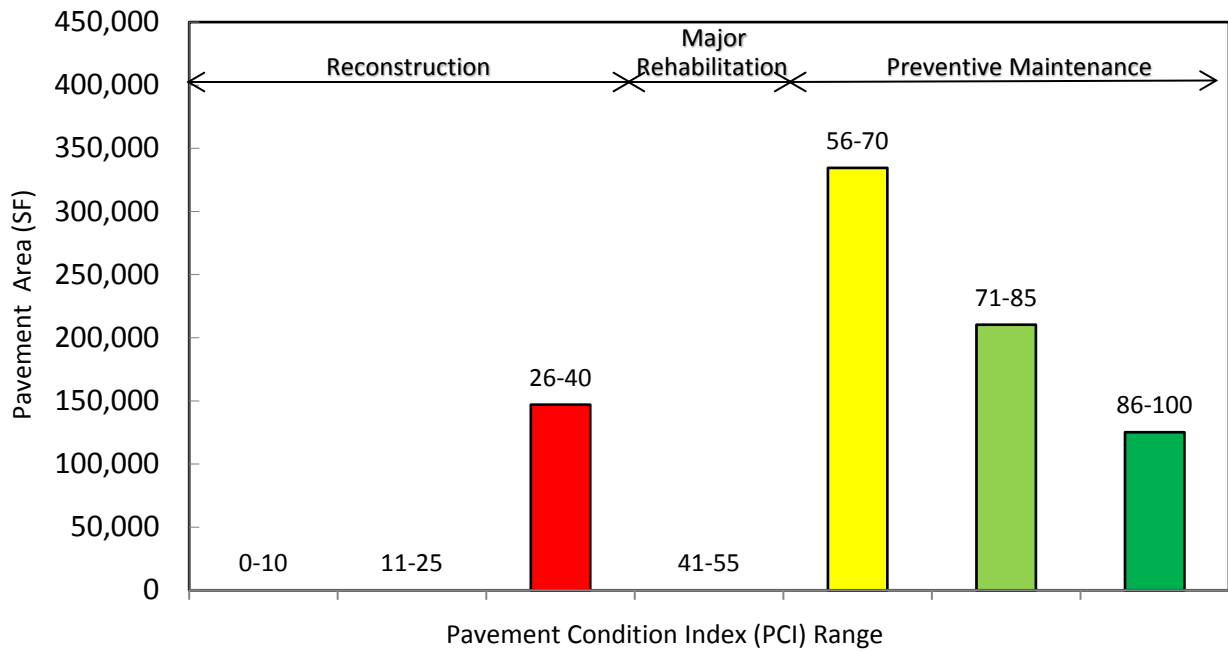
Figure 5. Condition distribution.

Figures 5 and 6 present the overall PCI for JKJ by area distribution and pavement use, respectively. Table 3 presents the PCI summary for each section at JKJ, including the drop in PCI per year. Generally, pavement sections will deteriorate between 1 and 3 PCI points per year. Sections deteriorating at higher rates may need maintenance above the normal application rates and should be closely monitored in case major repairs become necessary earlier than expected.

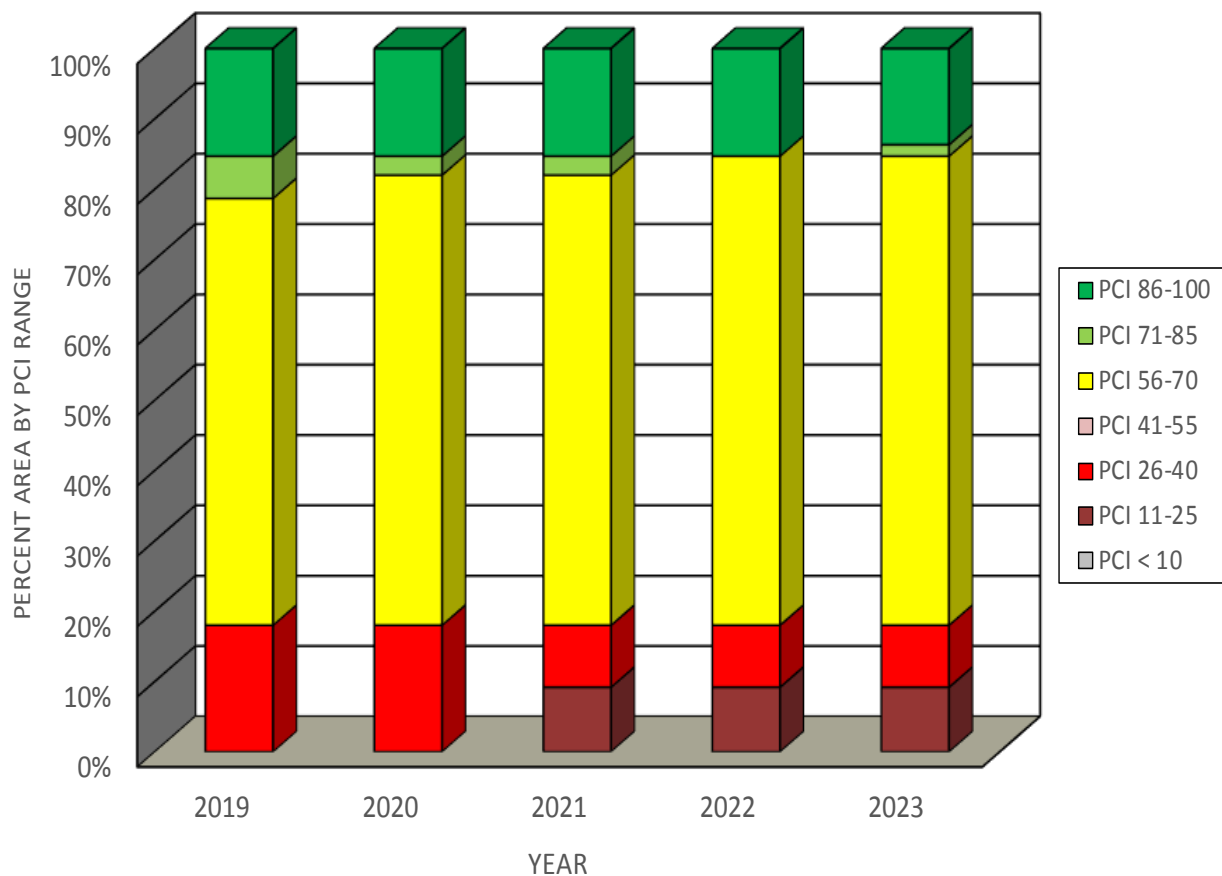
Figure 7. Projected PCI by percent area.

Figure 7 shows the projected PCI at JKJ by percent area for the next 5 years assuming no major repairs (overlays, reconstruction, etc.) are performed during that period. It shows how quickly a pavement network can deteriorate when no capital improvements are made.
