Pavement Condition Report

Moose Lake-Carlton County Airport (MZH)

December 2018

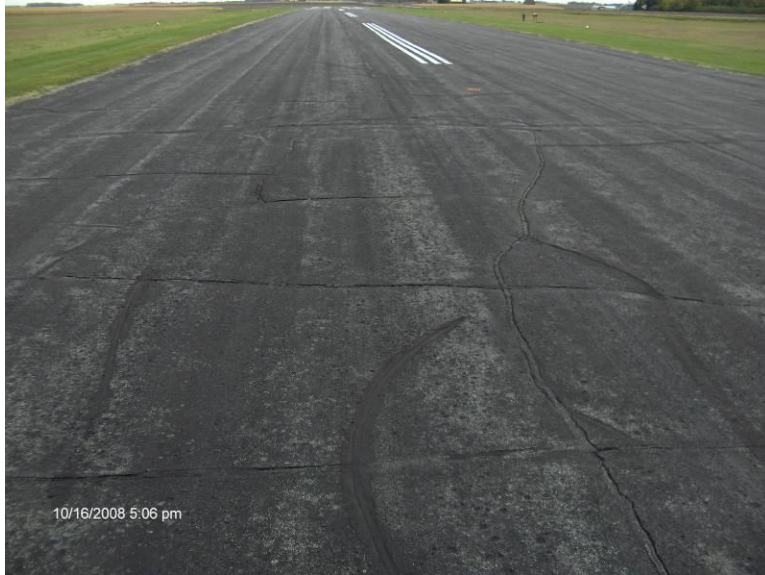
Example of Block Cracking

Block cracking is longitudinal and transverse cracking that has established a pattern of blocks ranging in size from 1ft x 1ft to 10ft x 10ft. This distress typically happens in older asphalt pavements and is an indication that the bituminous binder has lost most of its flexibility. The severity determination is basically determined by the crack width criteria defined for longitudinal and transverse cracking. Crack sealing typically is used to repair block cracking; however, the amount of required sealant can be extensive due to the high density of cracks.

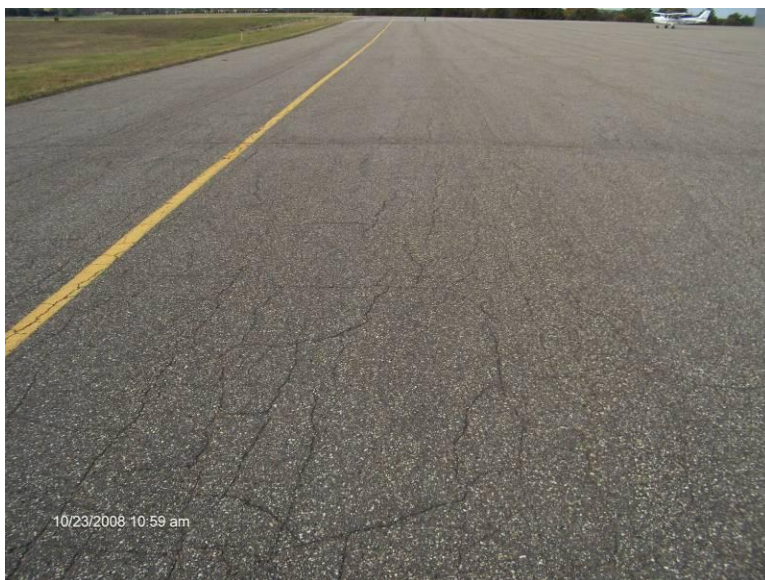
Example of Alligator Cracking

Alligator (or fatigue) cracks are a series of interconnected load-related cracks caused by fatigue of the asphalt surface. Alligator cracking is a significant structural distress and develops only in places subject to traffic loads. These cracks typically initiate at the bottom of the asphalt layer (where tensile strains

are highest) and propagate upward - so once a fatigue crack is visible, significant damage has already occurred.
