Pavement Condition Report

Waseca Municipal Airport (ACQ)

December 2019

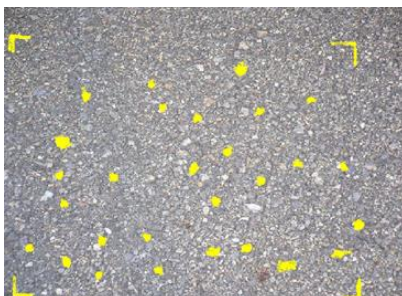
Raveling – At low severity, the number of missing coarse aggregates (> 3/8 inch) is between 5-20 missing/yd², medium severity (pictured below where the missing coarse aggregates have been dotted with yellow paint) is 21-40 missing/yd², and high severity is > 40 missing/yd².
