Asset Management Memorandum

Re: *Asset Management*
TH 11 Corridor Assessment
WSB Project No. 03063-000

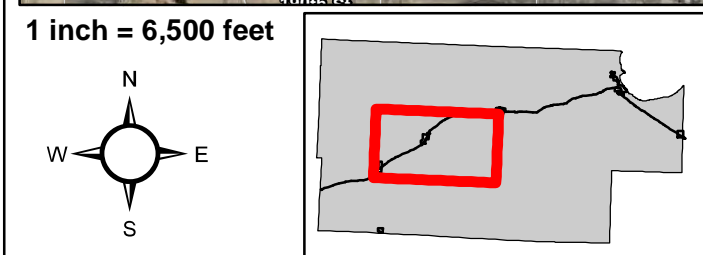
Figure 2
2014 Pavement Condition
Greenbush-Badger

As of 2014, nearly the entire TH 11 corridor was considered to have good pavement condition. Only two segments had an RQI below 3.1. Segment 5 has an RQI of 2.3. This segment is a 1.2 mile segment of TH 11 in the center of Roseau, from TH 89/TH 310 to 14th Avenue NE. The RQI for this segment indicates an immediate need for reconditioning. No pavement reconditioning activities have occurred since 2006.

Segment 10 has an RQI of 3, at the upper limit of fair pavement condition. This is an 800-foot segment of TH 11 at the southern city limits of Warroad (300 feet north of CSAH 5 to 500 feet southeast of CSAH 5). The most recent maintenance on this segment was a thin mill and overlay in 2008. MnDOT is completing a 2 inch mill and overlay on segments 8-10 in 2015. Following the mill and overlay RQI is expected to be at 4.0 or above, which should extend the life of these segments until 2030. Pavement maintenance history on TH 11 indicates that the life of a mill and overlay is approximately 15 years. While **Table 1** shows that a thin mill and overlay was performed on segments 8-10 in 2008, the pavement seams near the wheel path have rapidly raveled between 2013 and 2014. As a result, MnDOT plans to accelerate the normal maintenance schedule for this segment.

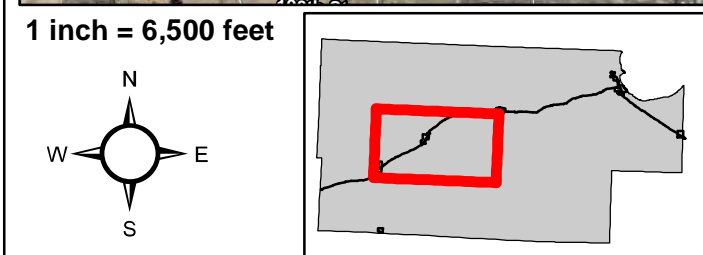
Figure 5
Predicted 2020 Pavement Condition
Greenbush-Badger

Based on the data presented in Table 3, MnDOT is predicting that three segments of TH 11 will have good pavement condition (RQI of 3.1 or greater). Those include Segments 2 and 3 at the western end of the corridor between TH 32 in Greenbush and 360th Avenue near Roseau and Segment 7. Segment 7 includes the area just west of the Warroad city limits to TH 313/Cedar Avenue.

As a result of planned maintenance activity before 2020, only one segment of TH 11 will remain below the 2.5 RQI threshold. Segment 5 in the center of Roseau (TH 89/TH 310 to 14th Avenue NE) is predicted to have an RQI of 1.9. No maintenance activities are planned for this segment prior to 2020; however, preventative maintenance is needed on this segment to extend the life of the roadway and reduce the need for roadway reconstruction. It should be noted that RQI measured in urban areas can be skewed because the measure is based on a 50 mph speed. In urban areas, there are also more manholes and utilities in the pavement that affect ride quality.

Following completion of the 2014 pavement condition evaluation and prior to the start of the TH 11 Corridor Study, MnDOT identified proposed pavement projects to address the deficiencies identified in Table 3. These improvements included the sections in Warroad between TH 313 and 500 feet southeast of CSAH 5 (Segments 8-10) in 2015 and a reclaim and overlay in Roseau from CSAH 15 to just east of TH 89 (Segment 4) in 2015. The 2015 improvements should increase RQI above 4.0, with an expected RQI of approximately 3.5-3.9 in 2020.

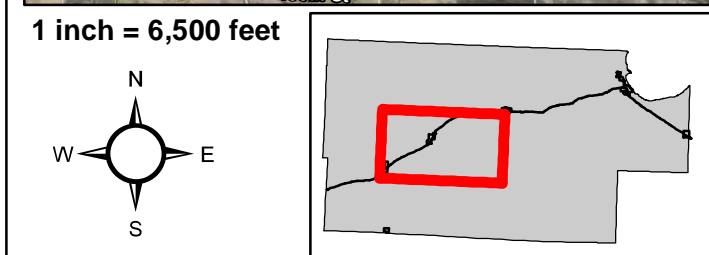
Figure 8
Predicted 2025 Pavement Condition
Greenbush & Badger

Following these maintenance projects, all but one segment of TH 11 is expected to have an RQI above 2.5 in 2030. Segment 1 in Greenbush is expected to have an RQI of 2.3 in 2025. A mill and overlay is recommended on this segment between 2020 and 2025 to address expected pavement condition issues.

To extend pavement life a bit longer on some segments, MnDOT has a few additional mill and overlay projects tentatively planned for 2024. These projects include a mill and overlay/ADA improvements on segment 5, mill and overlay on segment 6 (an 18.2-mile segment from the east city limits of Roseau to 1.5 miles west of TH 313), and a mill and overlay on segment 11 (a 12.4-mile segment from CSAH 5 to the Lake of the Woods County Line). Because these projects are near the end of MnDOT's 10-year plan, they could slip a year or two in either direction. As a result, the improvements will be noted prior to 2025.

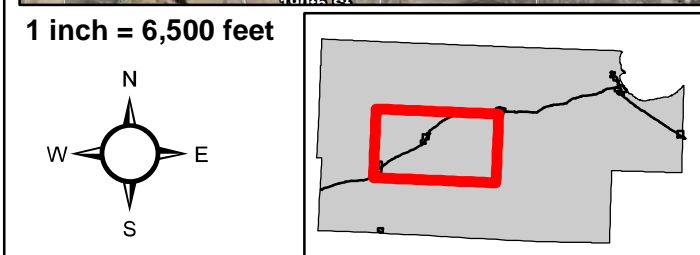
Figure 15
Current Culvert Conditions
Greenbush & Badger

Based on MnDOT culvert inspection reports, there are no immediate needs for culvert rehabilitation or replacement within the study area. All culverts on the corridor are known to be in fair to good condition and will only need ongoing maintenance in the near-term. Culverts in fair condition may need rehabilitation in the prior to 2040 based on the results of future inspections. As noted above, MnDOT hydraulic engineers expect that there are some culverts that may be in poor condition and will require rehabilitation or replacement. These recommendations will be updated following 2015 inspections of culverts in the corridor. It is expected that some culverts will require cleaning, repair of separated joints, lining, or full replacement.
