Observation of Recycling Partnership Test Sections

70th in Otsego and Albertville, Minnesota

5 June, 2020

E. Johnson, P. Nolan, M. Vrtis – MnDOT MRR

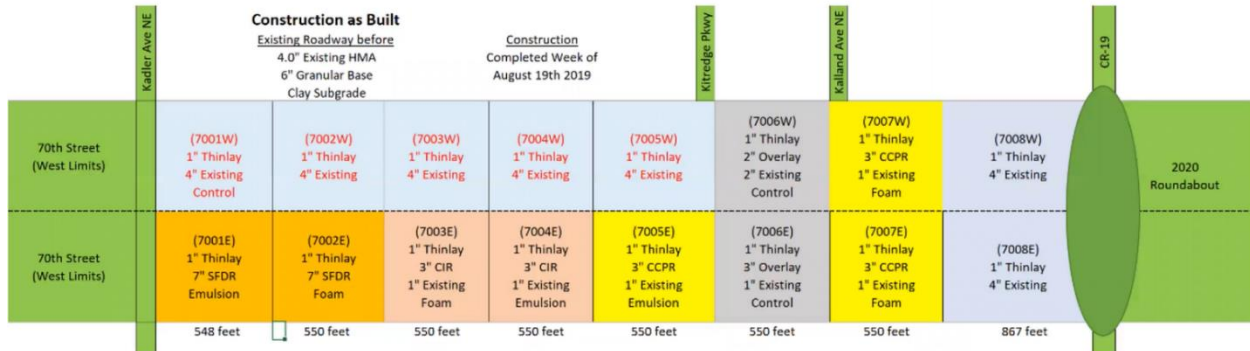
Figure 4 Test Section Layout

The research layout (Figure 4) included sixteen 500-ft test sections separated by 50-ft transition zones. The sections can be grouped into four categories:

- Seven sections of 1-in. Thinlay above 4-in. Existing Pavement (Control)
- Two sections of 1-in. Thinlay above X-in. Mill-Overlay above Existing Pavement
 - Mill-Overlay depths were 2-in. and 3 in.

- Two sections of 1-in. Thinlay above 7-in. Stabilized Full Depth Recycled Base
 - Stabilization done with either Foam or Emulsion
- Five sections of 1-in. Thinlay above 3-in. Cold In-Place Recycle or Cold Central Plant Recycle above 1-in. Existing Pavement
 - Two CIR sections used Foam or Emulsion
 - Three CCPR sections, two used Foam and one used Emulsion
