UNDERWATER BRIDGE INSPECTION REPORT

STRUCTURE NO. 7635

CSAH 4

BEAVER RIVER

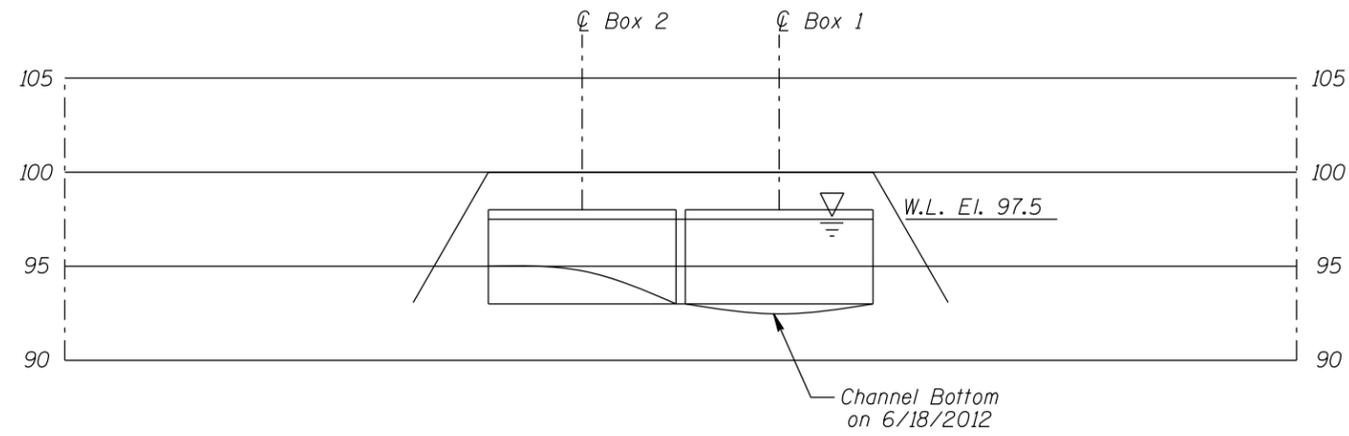
UPSTREAM FASCIA PROFILE

- 1 Light to moderate scaling was observed on the culvert walls extending from 1 foot below the waterline to the culvert ceiling and on the entire ceiling with a typical penetration of 1/4 inch and a maximum penetration of 1/2 inch.
