UNDERWATER BRIDGE INSPECTION REPORT

STRUCTURE NO. 7799

CR NO. 547

WOLF CREEK

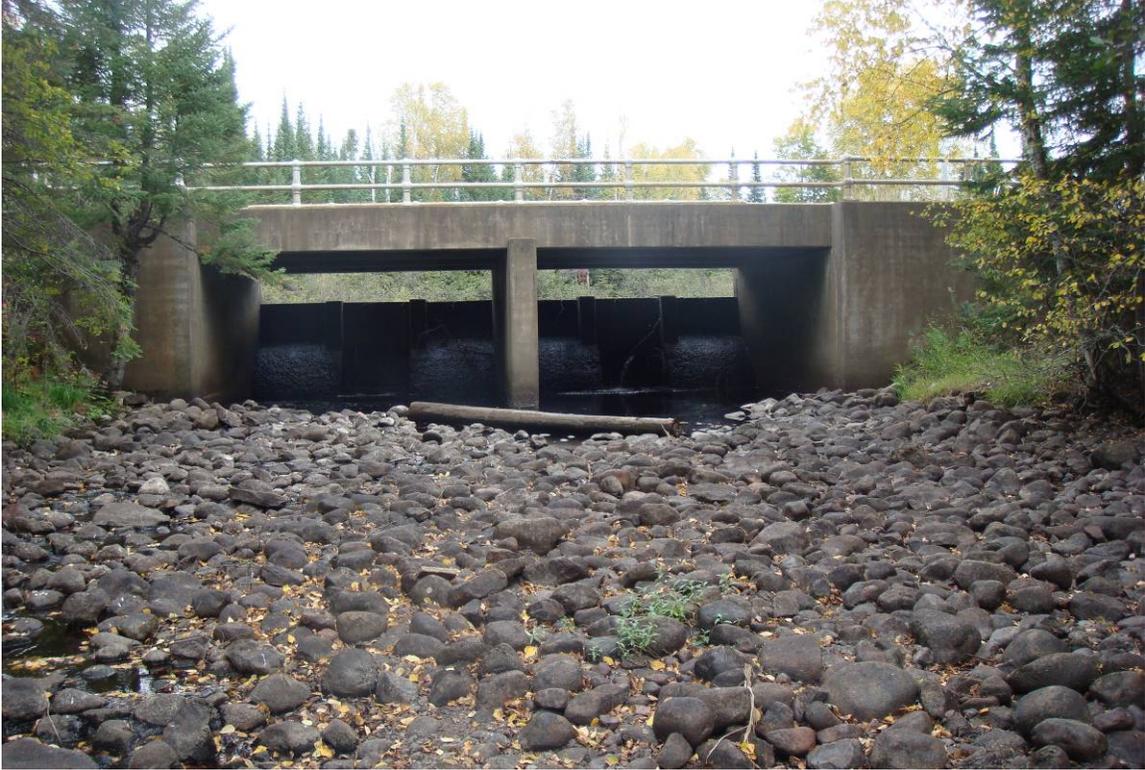
Photograph 1. Overall View of the Structure, Looking North.

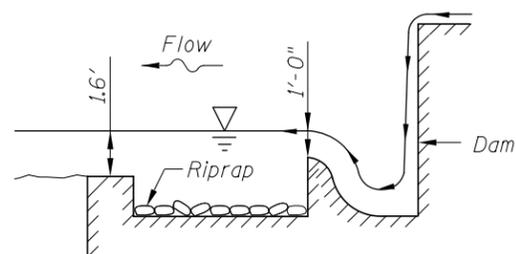
SOUNDING PLAN

- 1 Moderate to heavy scaling was observed on all substructure units from 1.5 foot above the waterline to 6 inches below the waterline with up to 1 inch of penetration.

- 2 Hairline vertical crack, extending from the top corner of the wingwall down full height of wall, with associated minor spalling up to 1/2 inch wide.

- 3 The concrete sill at the base of the upstream dam was observed 4.2 feet below the waterline and was typically covered with a 6 inch layer of silt and a heavy accumulation of 6-inch-diameter and smaller timber debris against the face of the base slab. At the west face of the center wall the face of the sill was exposed up to 1.3 feet vertically.

- 4 Channel bottom consisted of sandy gravel and 0.5- to 1-foot-diameter riprap allowing less than 1 inch of probe rod penetration.
- 5 A hairline vertical crack with efflorescence extended from the bottom of the bridge deck to the lip of the spillway.

- 6 A hairline vertical crack extended from the bottom of the bridge deck to the base slab.
- 7 A vertical crack up to 1/16 inch wide extended from the bottom of the bridge deck to the base slab.

- 8 A vertical crack up to 1/32 inch wide with efflorescence extended from the bottom of the bridge deck to 3 feet above the waterline.

- (A) Monitor timber debris accumulation against the upstream dam sill during future inspections and if found to be increasing, removal operations may need to be considered.
